**Technical Status Memorandum
For
Lakes Limerick and Leprechaun 2016
Aquatic Plant Management**

DECEMBER 28, 2016

Lake Committee
Lake Limerick Country Club

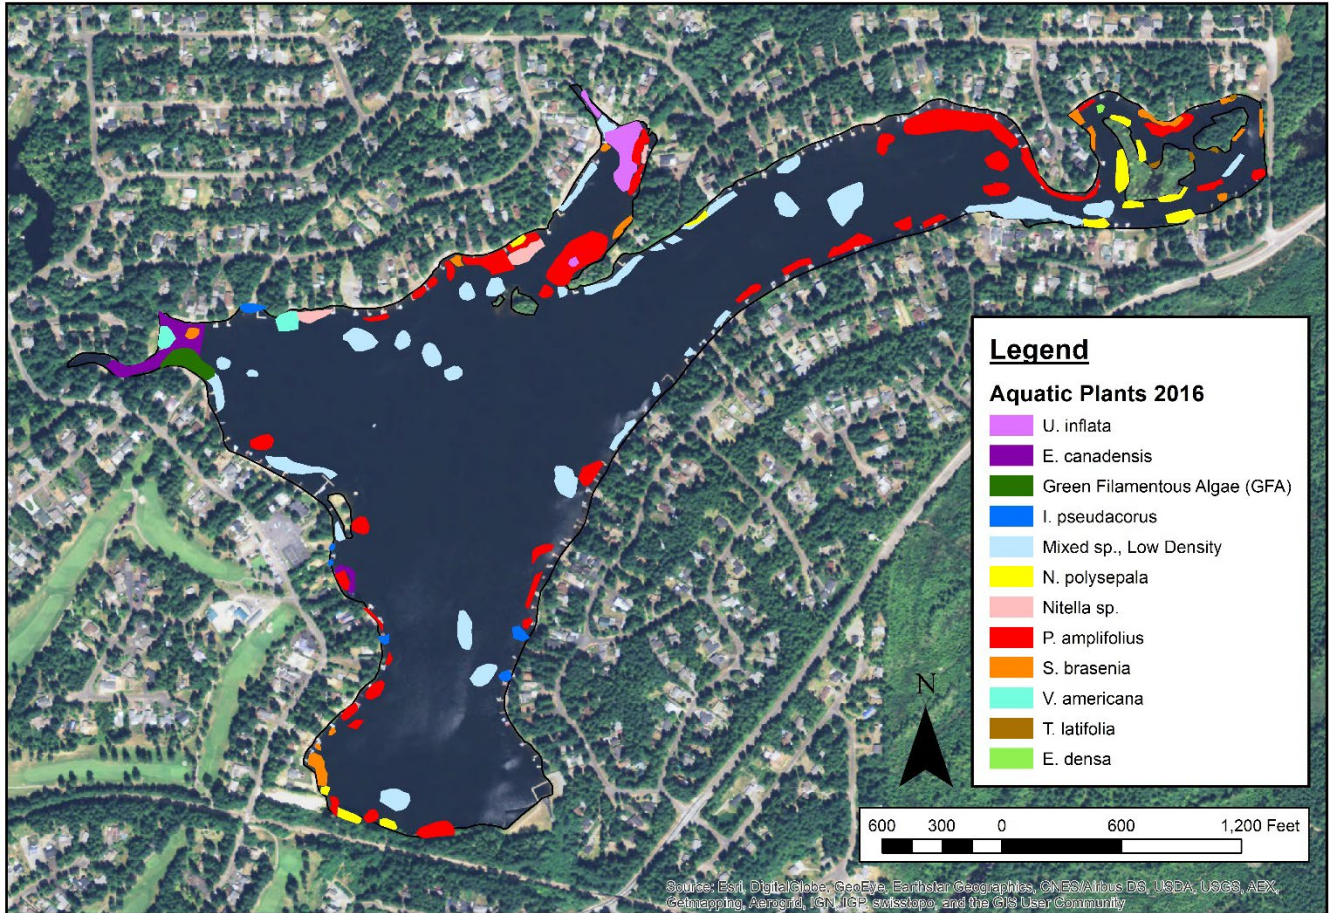
June 2016 Lake Limerick Aquatic Vegetation Survey

In June 2016, the aquatic plant community in Cranberry Cove was dominated by *Elodea canadensis* (Canadian pondweed) (Figure 1), much as it had been in 2015 (Figure 3). However, *Vallisneria americana* (tape grass) was also present, and in the southern portion of the cove there was dense growth of green filamentous algae (Figure 1). When the survey was conducted again in September 2016, dredging had significantly cut back plant growth in this cove – all of the algae was gone and the areal extent of *Elodea canadensis* was greatly reduced (Figure 2).

The composition of the aquatic plant community in King's Cove changed in part between 2015 and 2016. In June 2016, the coverage of mixed species and green filamentous algae within the center of the cove (Figure 1) was reduced compared to in 2015 (Figure 3), and there was much more extensive growth of *Utricularia inflata* (inflated bladderwort) near the inlet (Figure 1). Near Log Toy Park, there continued to be a large patch of *Potamogeton amplifolius* (largeleaf pondweed) and there was a new patch of *Brasenia schreberi* (watershield) (Figure 1). As in Cranberry Cove, dredging activities altered the distribution of

Yellow iris (*Iris pseudacorus*) was observed along the southwestern, eastern, and northwestern shorelines in June 2016 (Figure 1). In September 2016, the yellow iris on the southwestern and northwestern shorelines remained, but the yellow iris on the eastern shoreline had been successfully controlled (Figure 2.) by the 2015 efforts. Efforts to limit the growth of yellow iris in shoreline areas continued in 2016. As in summer 2015, visible patches of yellow iris on the shoreline of Lake Limerick were sprayed with the herbicide Glyphosate in summer 2016. This herbicide was used because of its minimal deleterious effect on other terrestrial and shoreline plants as well as on water quality. Its first-treatment effectiveness in carry-over control will likely range from 50-75% (i.e. not all of the plants will be killed). 2017 treatment and control efforts will need to target not only the plants that survive, but also the new plants that will emerge due to the seed bank in the sediment. It will take two to three years of monitoring and spot control to exhaust this seed bank. During this period LLCC should continue spraying observed patches and should encourage area residents to hand pull individual small clumps.

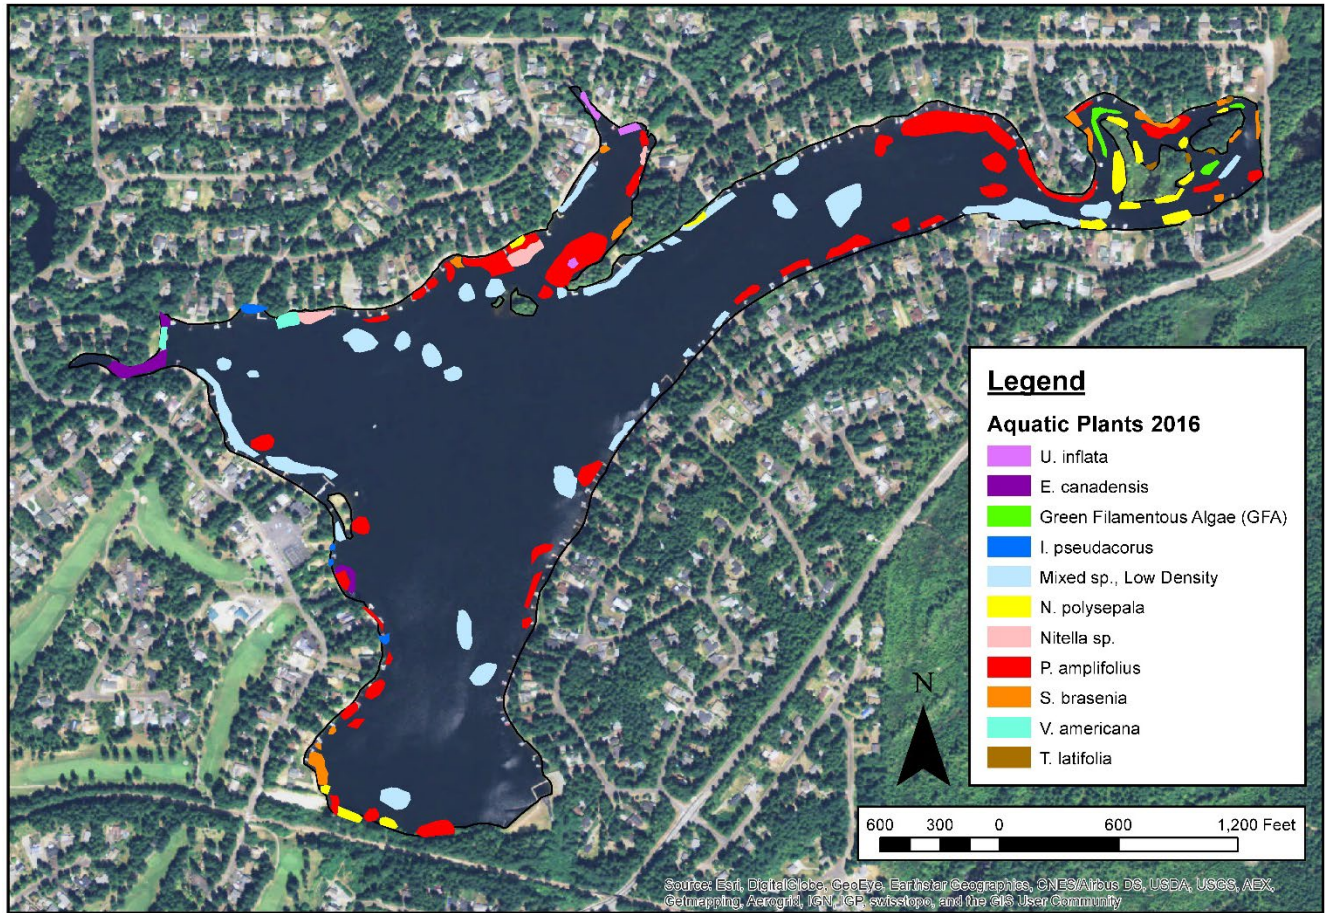
September 2016 Lake Limerick Aquatic Vegetation Survey

plants near the inlet in King's Cove – the patch of *Utricularia inflata* (inflated bladderwort) was much smaller in September 2016 (Figure 2).

The greatest observed change in the density of plant growth in Lake Limerick occurred along the northern shoreline and in the bird sanctuary. Along the northern shoreline (from Log Toy Park to just west of the bird sanctuary) there were patches of mixed species at low density, as in previous years, but at the eastern end of the northern shoreline, just west of the bird sanctuary, dense growth of *Potamogeton amplifolius* (largeleaf pondweed) was observed in both June and September 2016 (Figure 1 and Figure 2). In the bird sanctuary, the density of plant growth had increased since 2015, and the composition had also changed. In June 2016, patches of *Brasenia schreberi* (watershield) and *Nuphar polysepala* (yellow pond lily) were more extensive than in 2015, and *Utricularia inflata* (inflated bladderwort) and *Potamogeton filiformis* (slender-leaved pondweed) were no longer present (Figure 1). In addition, there was one small patch of *Egeria densa* (Brazilian waterweed) (Figure 1). By September, the *Egeria densa* had experienced an early decline and was no longer present, but there was significant new growth of green filamentous algae, further increasing the density of aquatic plant growth in the bird sanctuary (Figure 2).

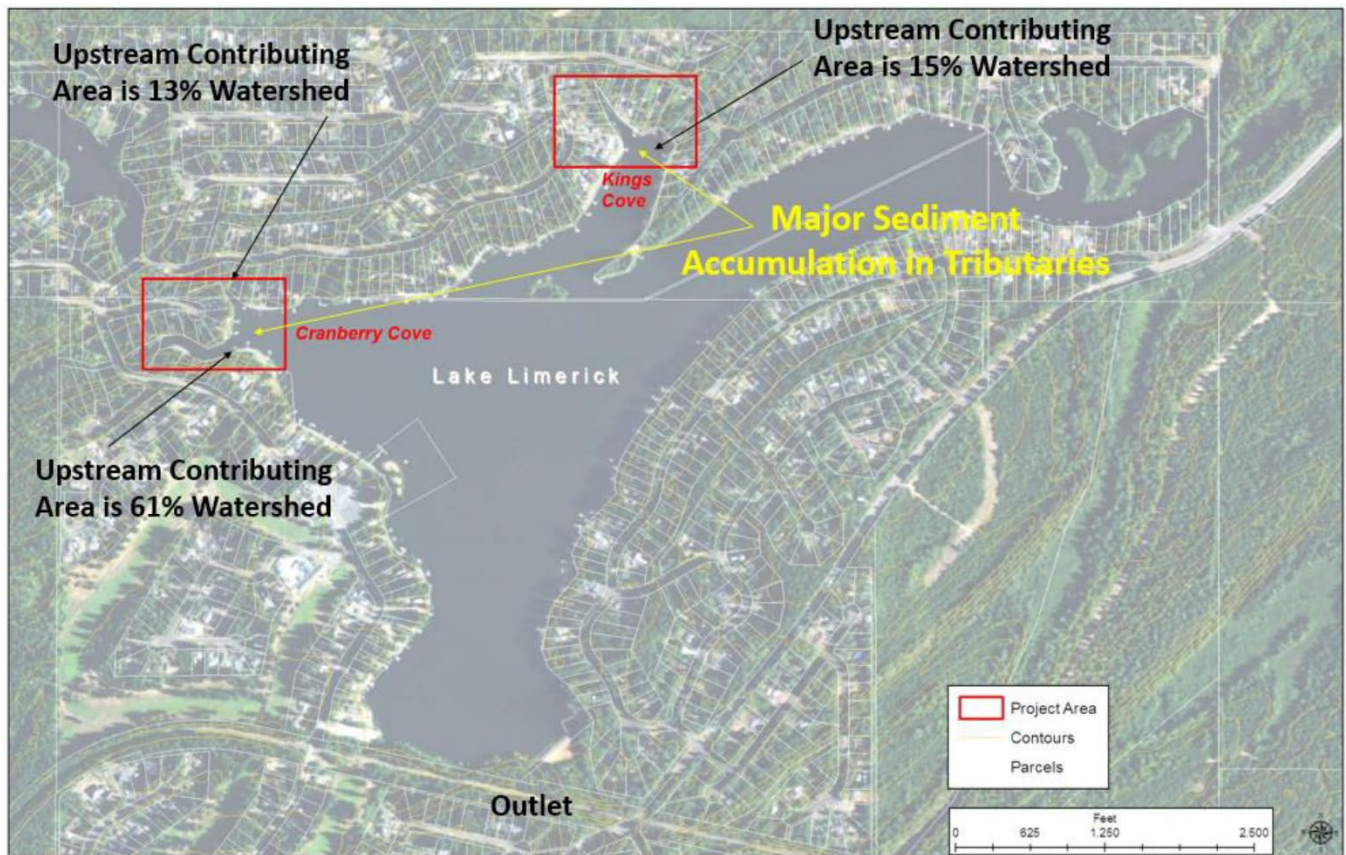
Figure 12 – Locations for dredging in Lake Limerick

During summer 2016, two shallow coves in Lake Limerick – King's Cove and Cranberry Cove – were dredged in order to remove sediment that had accumulated on the lake bottom (Figure 12). Over time, the accumulation of fines (silts and decomposed organic material) at the mouths of the creeks that drain into these coves had covered up potential habitable substrate for aquatic life. In addition, the sediment had filled in the lake bottom, reducing the overall depth of water in these coves by 1 to 5 feet – limiting the ability of boats to access these coves and shrinking the area in which it was possible to swim. The primary objectives of the dredging operation were to a) improve in-lake fisheries habitat and fish access to streams, and b) provide better access to the coves for recreation. Specific goals were to a) remove a total of 5,000 cubic yards of soft sediment from Kings Cove and Cranberry Cove, b) expose hard sediment to improve habitable areas for benthic communities and fish spawning, and c) improve the thalweg gradient in both coves, allowing remaining soft sediments to be moved during future high flow events and preventing the coves from being clogged for an extended time.

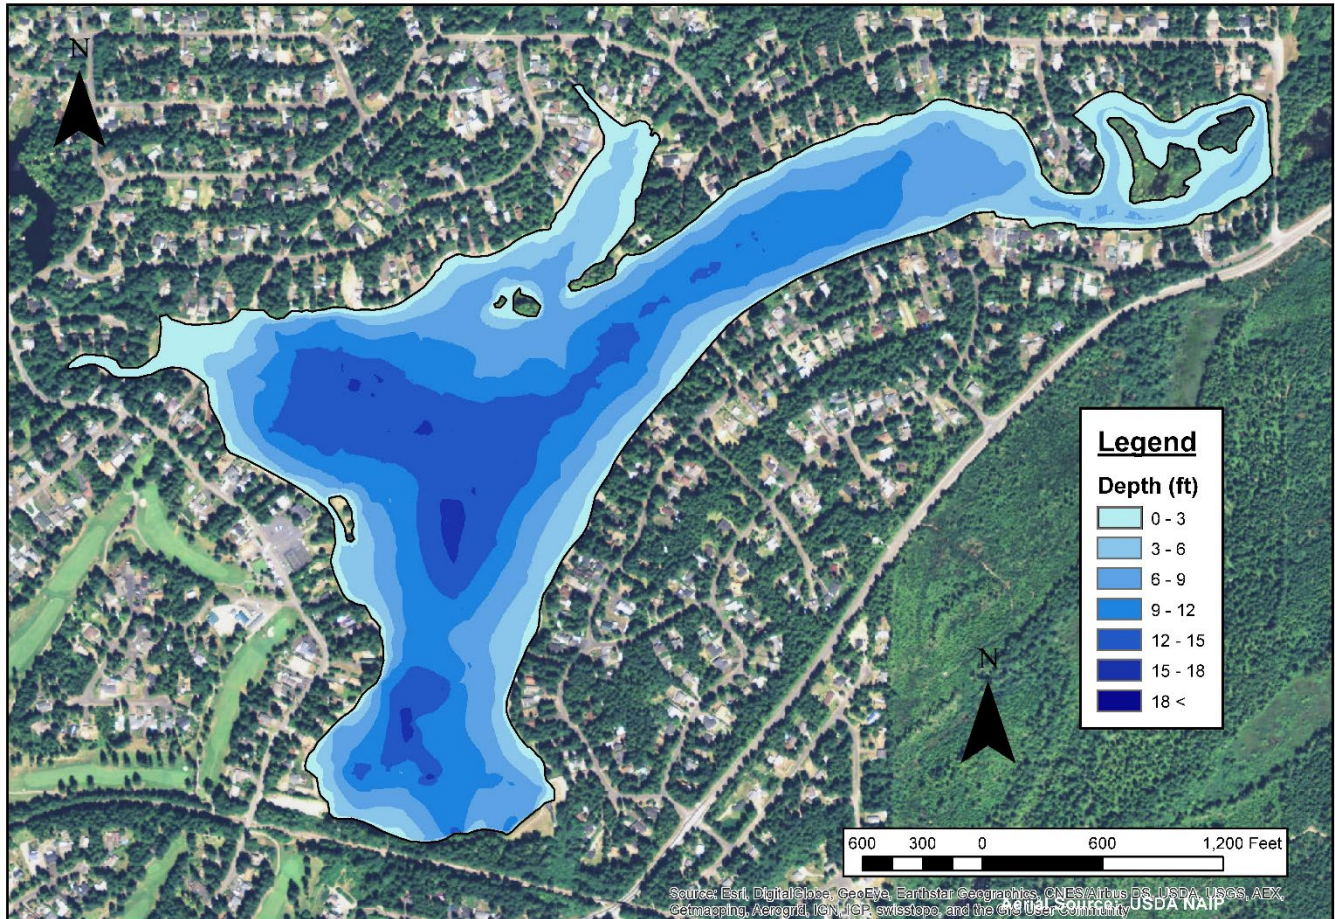
2015 Lake Limerick Bathymetric Survey

On September 11th, 2015, Tetra Tech staff mapped the bathymetry of Lake Limerick using a Lowrance HDS-7 fishfinder/chartplotter with a StructureScan HD sonar imaging system and an LSS-2 HD Transom Transducer. This survey confirmed that the northwest corner, by the outlet of Cranberry Creek, was very shallow, as was the small extension of the lake along the north shore (King Cove) (Figure 13). In 2016, both the dredging contractor (Marine Industrial Construction) and Tetra Tech independently conducted additional, higher resolution bathymetric surveys of Cranberry Cove and King's Cove before and after dredging. The pre-dredge surveys were used to plan dredging activities and to establish dredging transects and document volume and area of sediment removal.

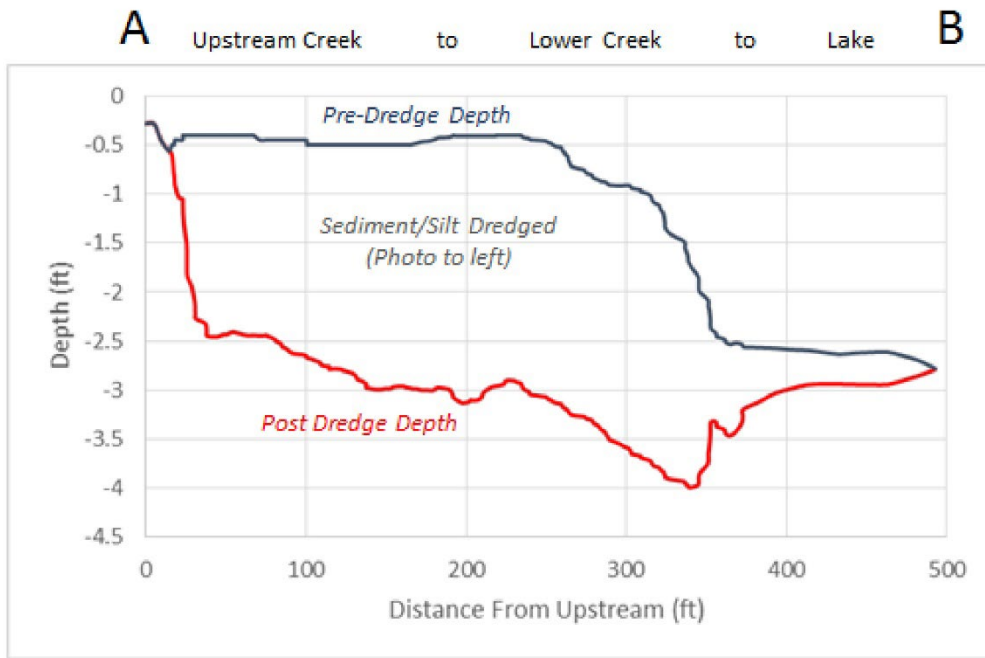
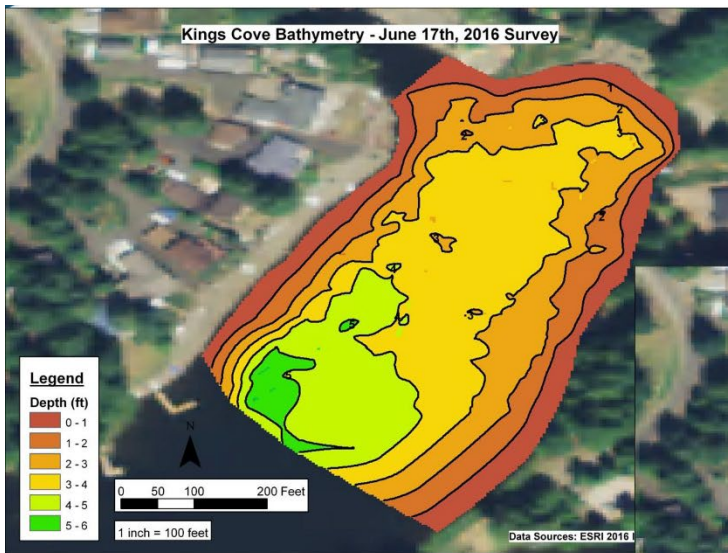
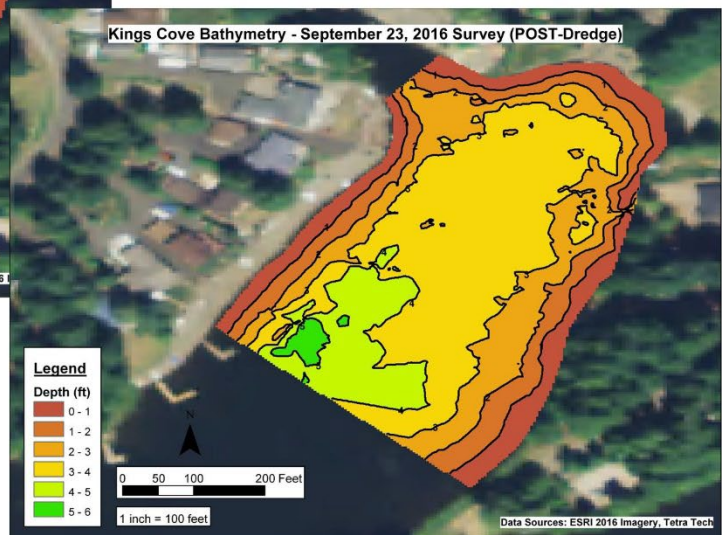
Thalweg Transect: King's Cove

Detailed topographic/bathymetric transect profiles were completed within one week upon completion of dredging in each of the coves. In King's cove, the dredging improved the gradient of the thalweg, increasing the water depth by 2 to 2.5 feet along most of the thalweg (Figures 23 and 24). Dredging increased the depth of the water throughout the northeastern portion of the cove, especially near the mouth of the inlet (Figure 25).

Moving forward, it is recommended that periodic bathymetric surveys be conducted in order to evaluate the effect of sloughing sediments on the transect gradient and channel shape over time, and to evaluate potential long-term maintenance needs. It is expected that the deeper portions of the thalweg transects in both coves will become slightly shallower due to sloughing from the upstream shallow areas.

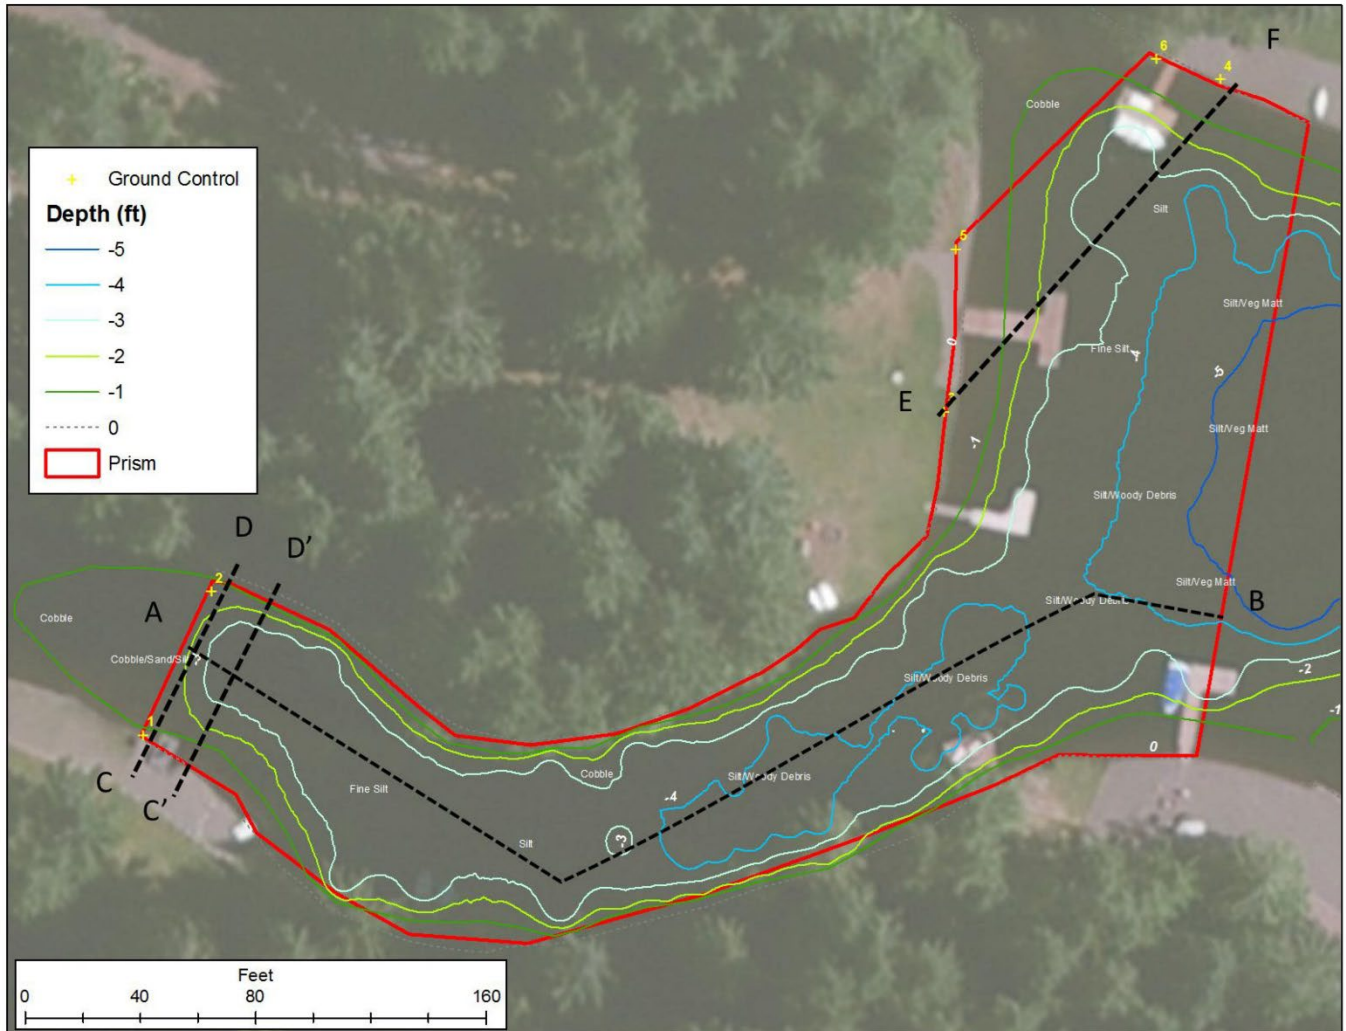
Thalweg Transect: Cranberry Cove

The gradient of the thalweg was also improved in Cranberry Cove (Figures 26 and 27). Water depth increased by approximately 2 feet along the length of the thalweg (Figure 27). In addition, dredging increased the depth of the water throughout the center of the cove, in particular near the Cranberry Creek inlet (Figure 28). The post-dredging substrate in this cove was composed of moderate-to-large round cobbles (MIC 2016).

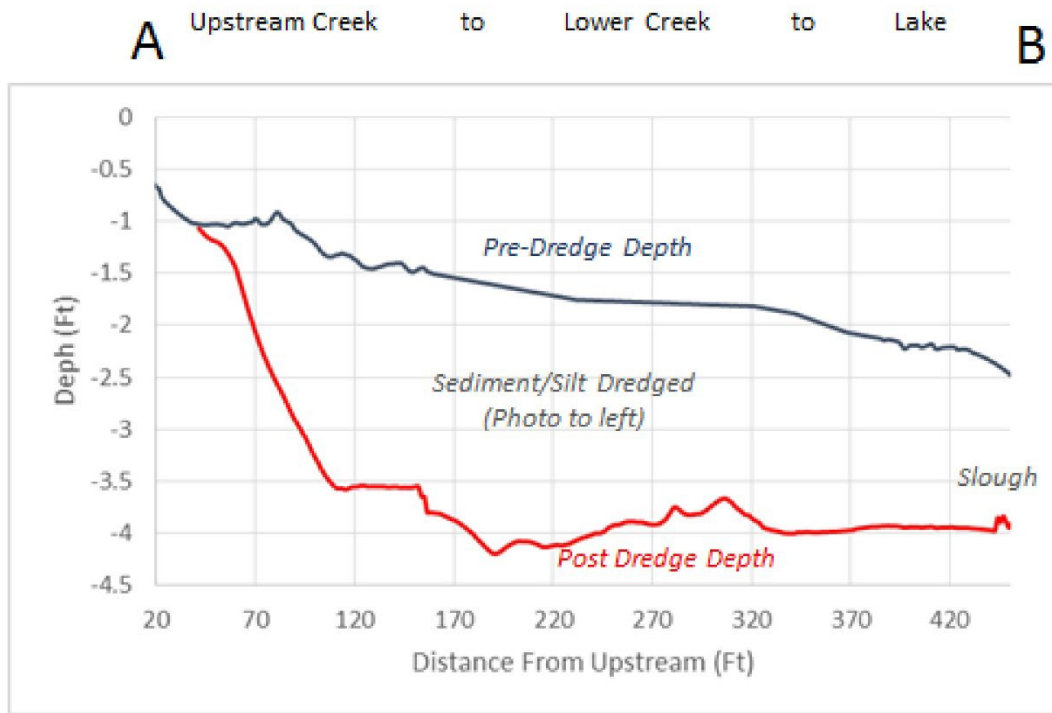
Figure 27 – Thalweg gradient for inflows into Cranberry Cove, before and after dredging

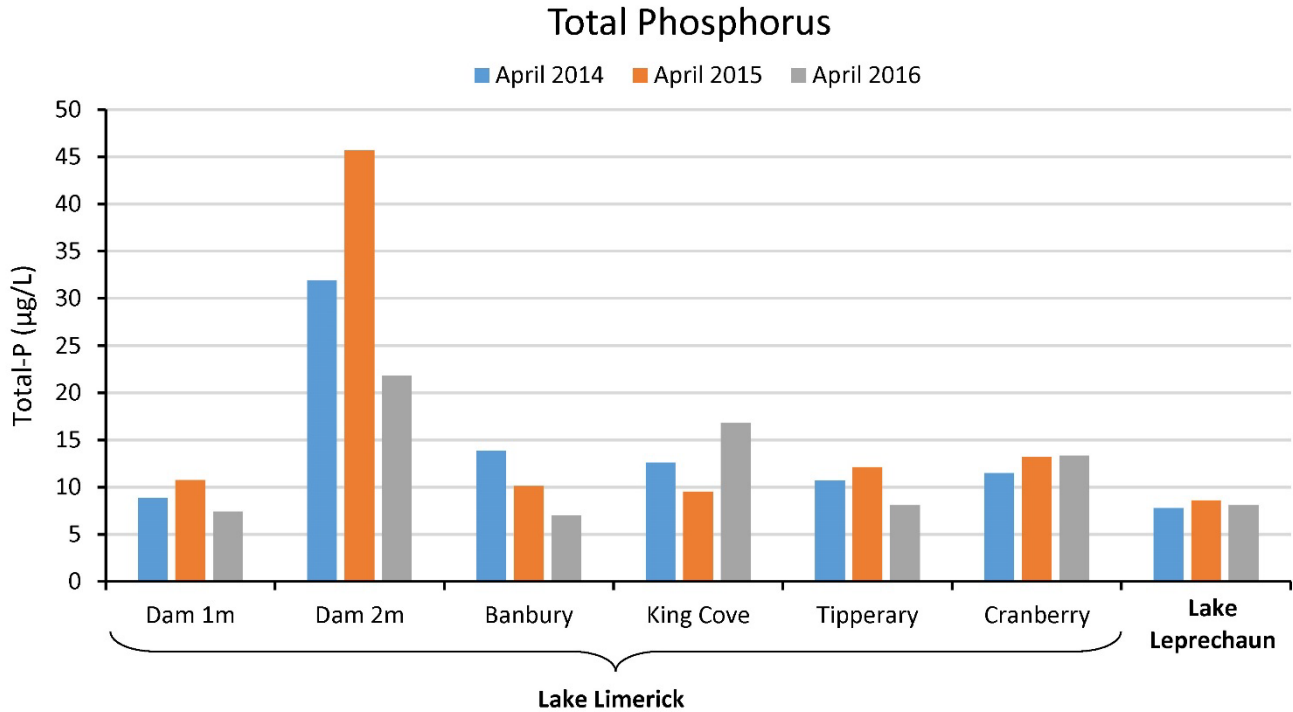
In April 2016, concentrations of total phosphorus (TP) were higher at the 2 m depth at the dam site (21.9 µg/L) than at any of the other sampling locations in Lake Limerick (Figure 32). The next highest concentrations of TP were measured at the King Cove site (16.8 µg/L) and at Cranberry (13.4 µg/L). The lowest concentrations of total phosphorus were observed at Tipperary and Banbury and at the surface at the Dam site (8.1 µg/L, 7.0 µg/L, and 7.4 µg/L respectively).

Figure 32 – Total phosphorus concentrations at the water quality monitoring sites within Lake Limerick and Lake Leprechaun on April 9th, 2014; April 2nd, 2015; and April 21st, 2016. The method detection limit for total phosphorus analysis is 2.0 µg/L.

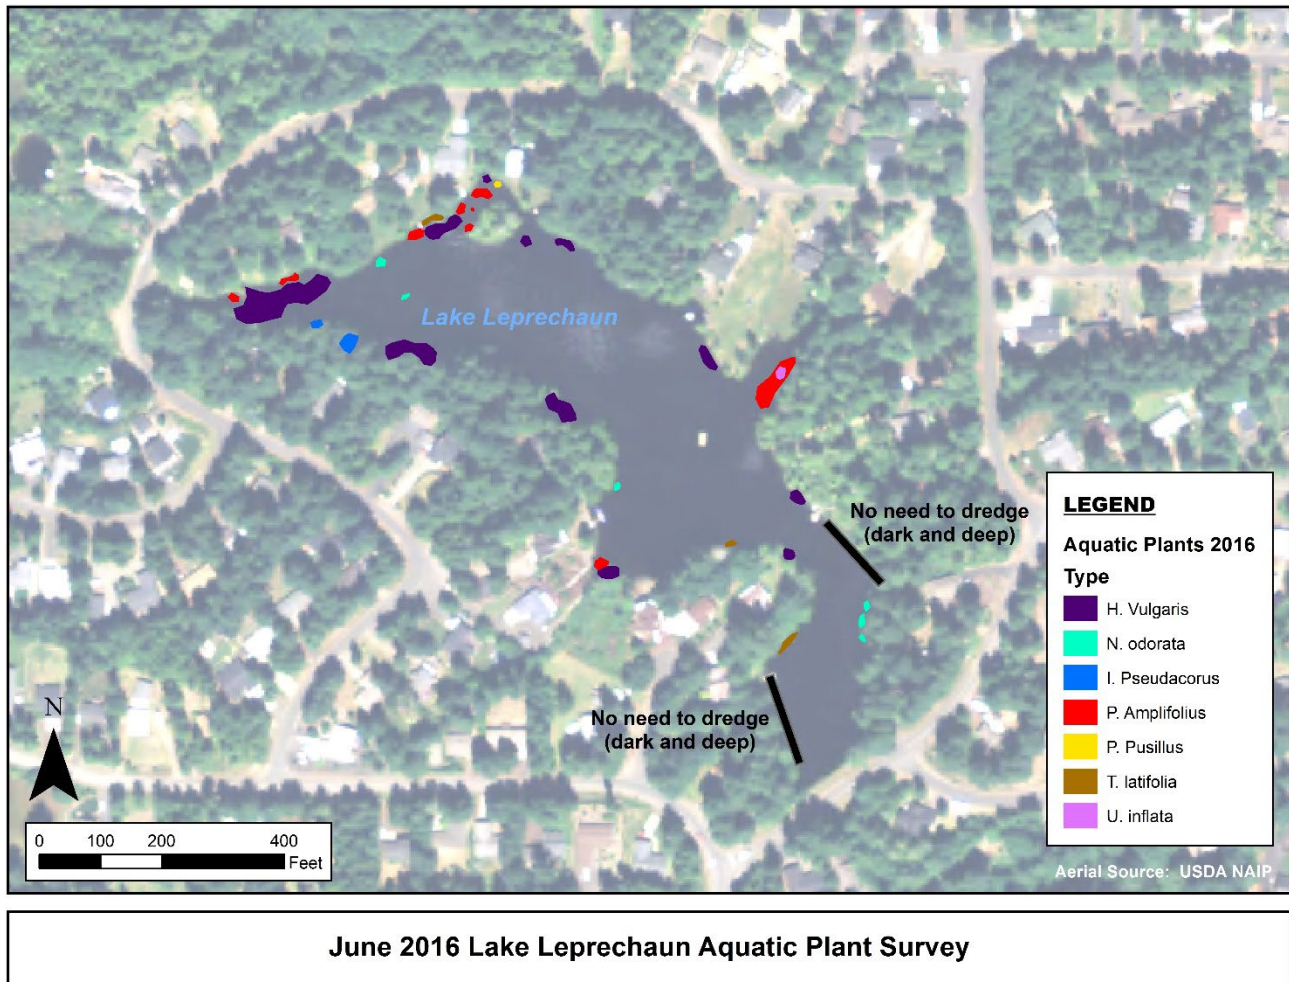
A more detailed survey of aquatic plants in Lake Leprechaun was conducted in June 2016 (Figure 34). The survey indicated that *Hippuris vulgaris* (mare's tail) continues to succeed in and dominate the aquatic plant community in Lake Leprechaun. In addition, *Potamogeton amplifolius* (largeleaf pondweed) and *Nymphaea odorata* (white waterlily) were observed in a few locations around the edge of the lake. Near the launch area, there were clusters of mare's tail as well as largeleaf pondweed, and a small patch of *Potamogeton pusillus* (small pondweed). At three points along the shore there were clumps of *Typha latifolia* (cattails). Near the inlet, there was a fairly large patch of largeleaf pondweed that also contained *Utricularia inflata* (inflated bladderwort). Yellow iris (*Iris pseudacorus*) was observed at two points along the southwestern shoreline of the lake. The densest area of plant growth in June was in the western end of the lake, where there was a large region of mare's tail. By September, this patch had grown considerably, extending out into the central portion of the lake and around the swimming raft (Figure 35).

The June 2016 plant survey in Lake Leprechaun also identified two near-shore areas close to the lake outlet that would not need to be dredged should any dredging occur in Lake Leprechaun. Plant growth is naturally impeded in these areas as they receive little light and are deep in comparison to other shoreline areas (Figure 34).

Figure 34 – Map of aquatic plant distribution in Lake Leprechaun in June 2016.

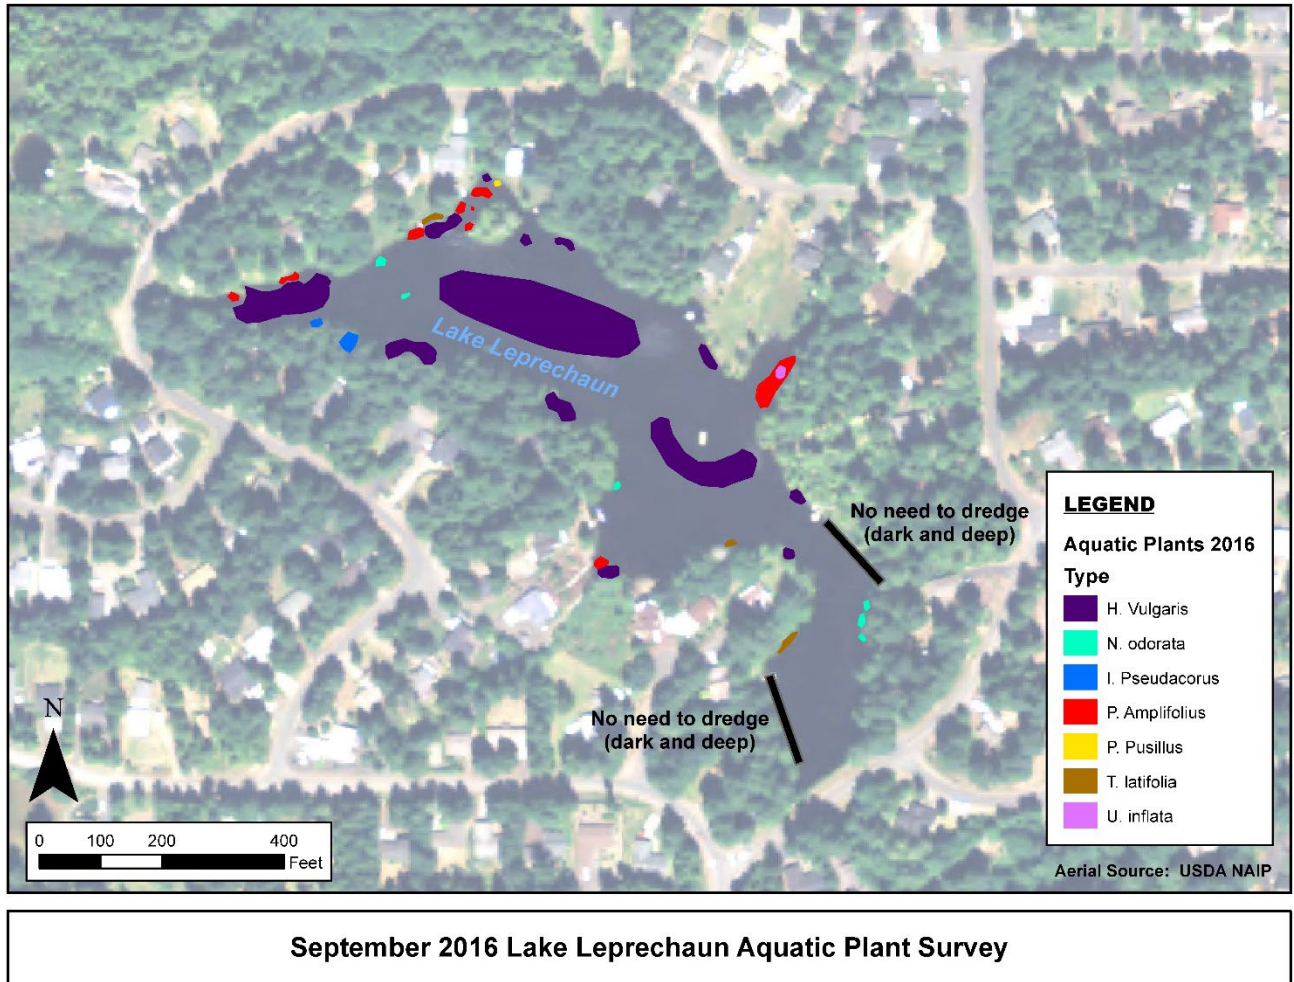
Figure 35 – Map of aquatic plant distribution in Lake Leprechaun in September 2016
