**Technical Status and Monitoring Results Memorandum
For
Lake Limerick 2019**

DECEMBER 2019

Lake Committee
Lake Limerick Country Club

LAKE ADVOCATES

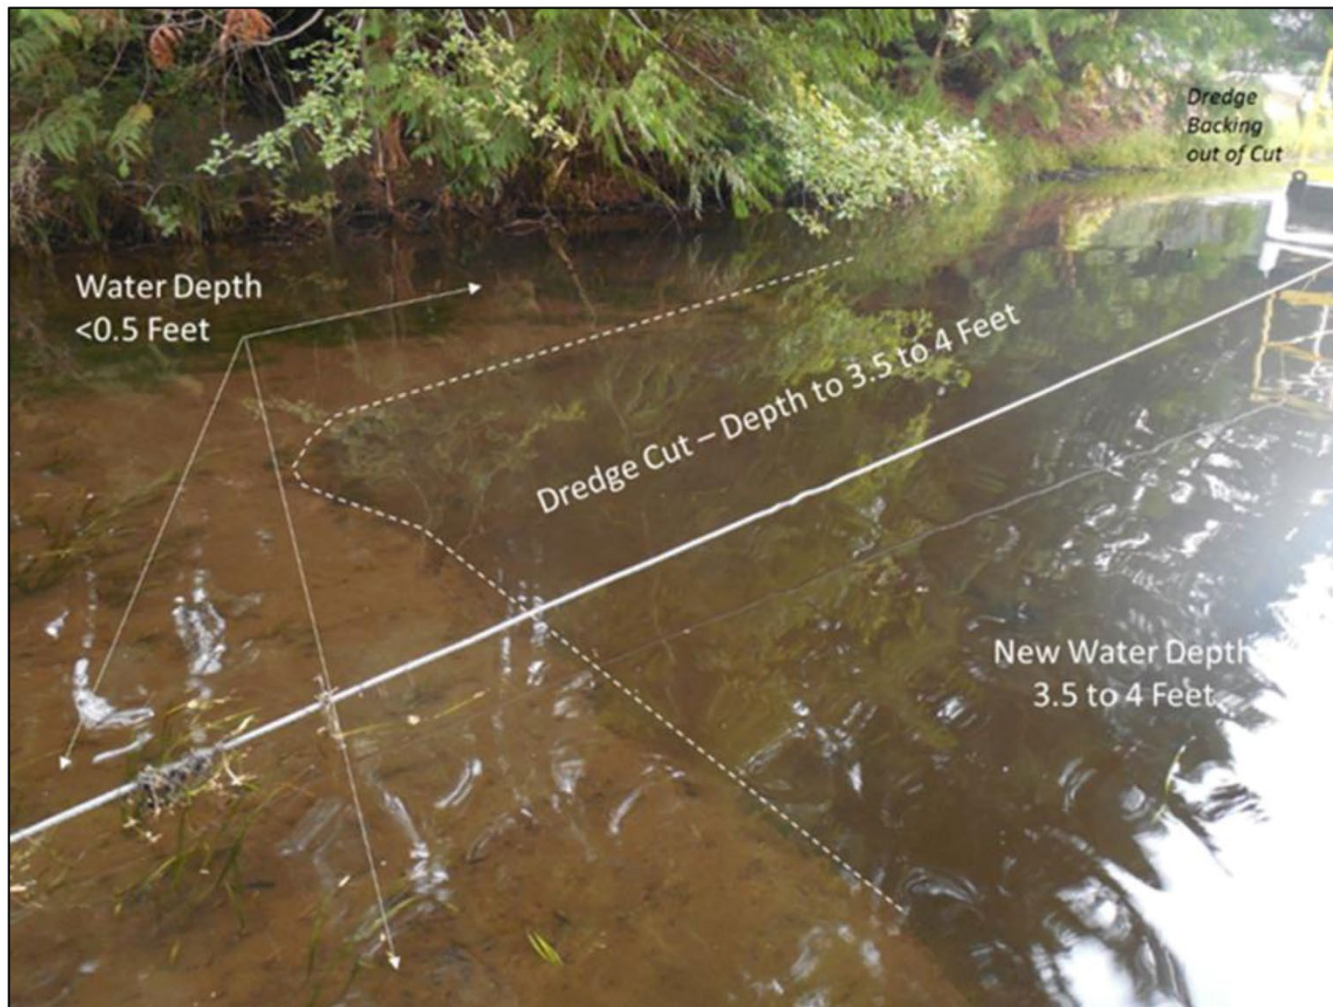
When the dredging was conducted, the MudCat cut a channel in the sediment, removing the accumulated material (Figure 7-10). As the dredging occurred, some additional material sloughed from the banks of the newly cut channel and was suctioned up, adding to the total volume of material being dredged (Figure 7-11). As the material was removed from the newly cut channel, it exposed hard sediments (Figure 7-12), improving benthic habitat. Water quality monitoring during dredging ensured that containment structures were functioning properly. Turbidity monitoring during dredging indicated that the design of the dredging equipment and set-up successfully minimized turbidity impacts. Turbidity was monitored during dredging operations above dredging in the tributary, below the dredge (roughly 150 feet and inside the turbidity curtain) for an early warning site, and 300 feet downstream of the work site (outside of the turbidity curtain) (MIC 2016). Turbidity remained low throughout the project and no violations occurred (MIC 2016).

Figure 7-10 – Sloughing in dredged channel

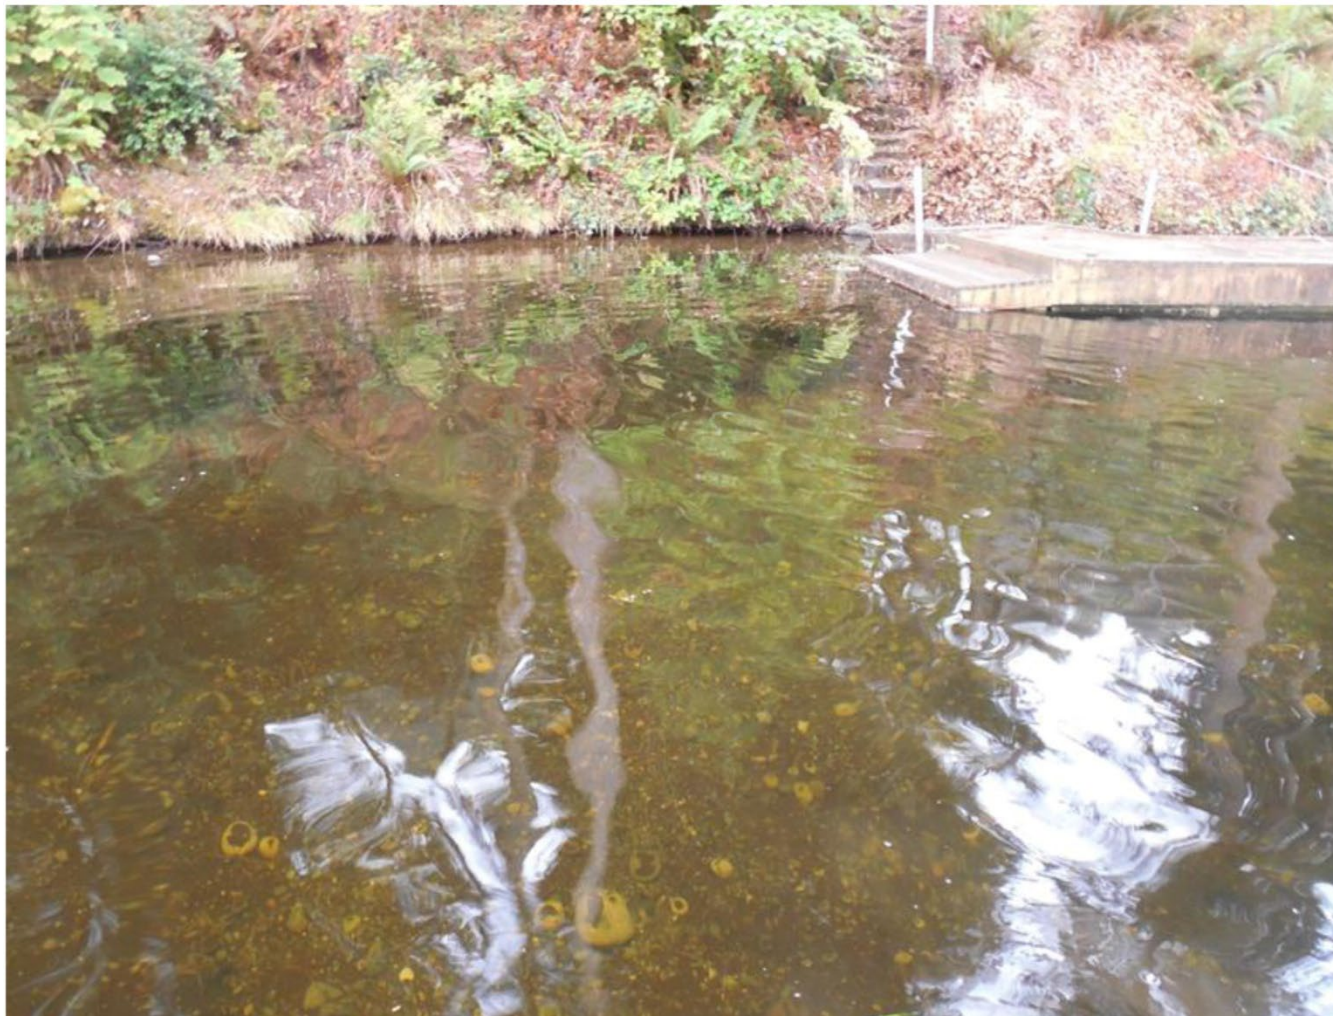
Figure 7-11 – Exposure of hard sediments as a result of dredging

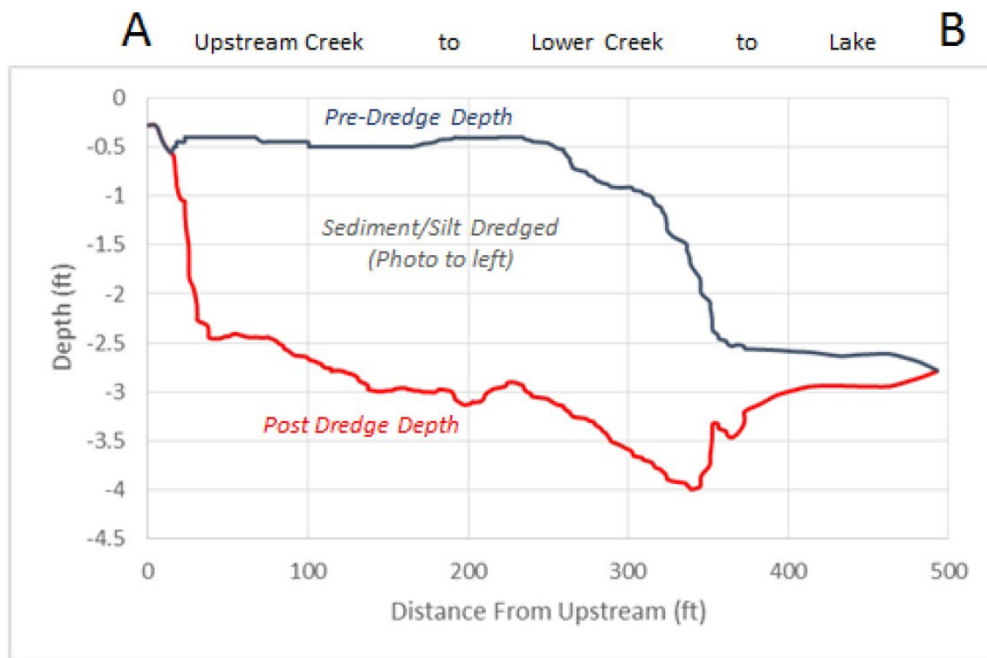
Detailed topographic/bathymetric transect profiles were completed within one week upon completion of dredging in each of the coves. In King's cove, the dredging improved the gradient of the thalweg, increasing the water depth by 2 to 2.5 feet along most of the thalweg (Figures 7-13 and 7-14). Dredging increased the depth of the water throughout the northeastern portion of the cove, especially near the mouth of the inlet (Figure 7-15).

Figure 7-13 – Thalweg gradient for inflows into King's Cove, before and after dredging

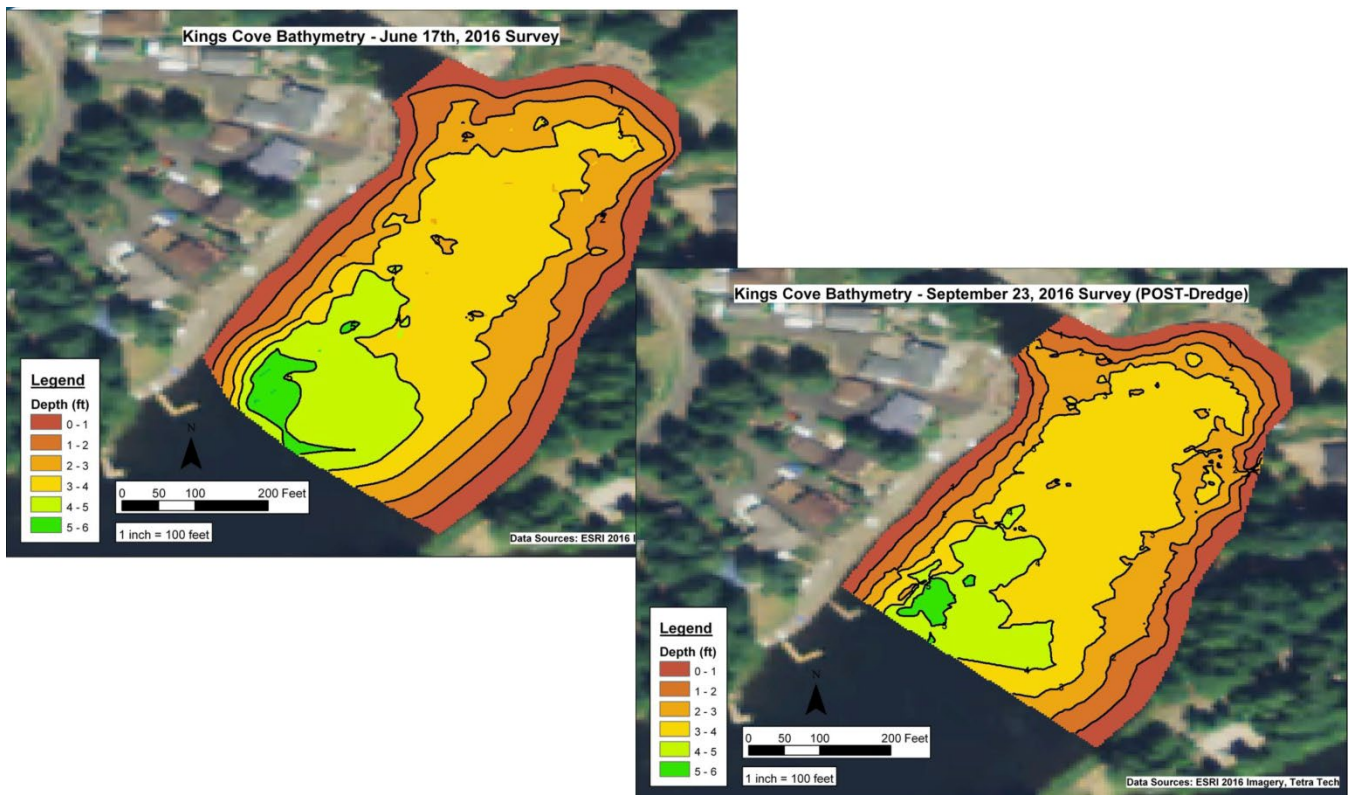
Figure 7-14 – King's Cove bathymetry before and after dredging

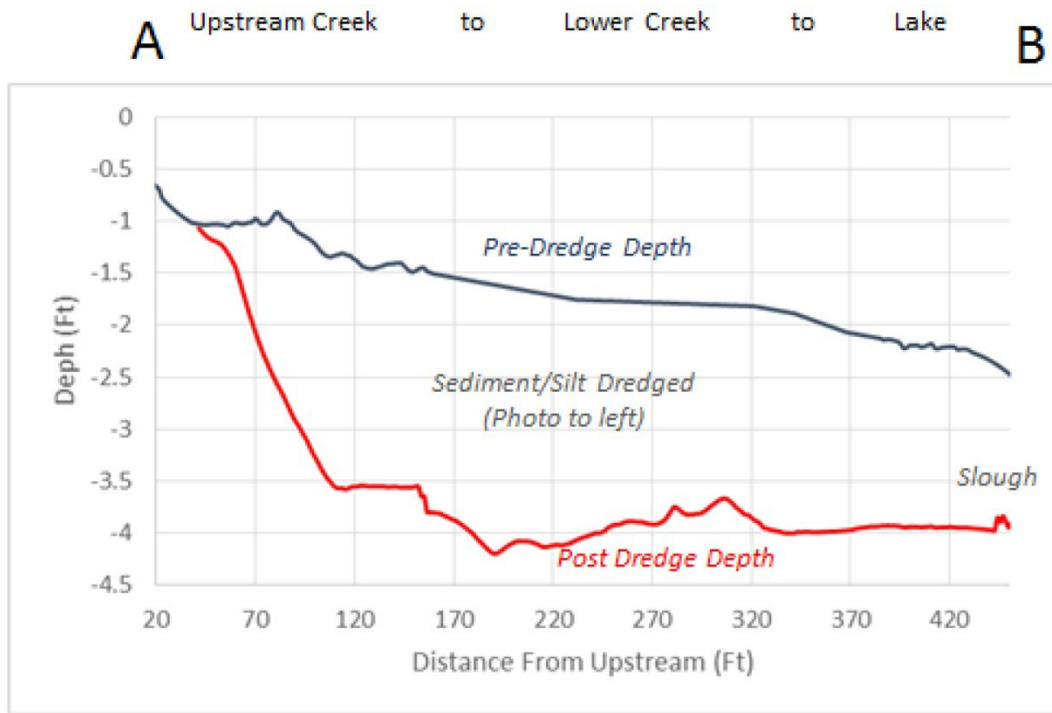
The gradient of the thalweg was also improved in Cranberry Cove (Figures 7-16 and 7-17). Water depth increased by approximately 2 feet along the length of the thalweg (Figure 7-16). In addition, dredging increased the depth of the water throughout the center of the cove, in particular near the Cranberry Creek inlet (Figure 6-17). The post-dredging substrate in this cove was composed of moderate-to-large round cobbles (MIC 2016).

Figure 7-2 – Thalweg gradient for inflows into Cranberry Cove, before and after dredging

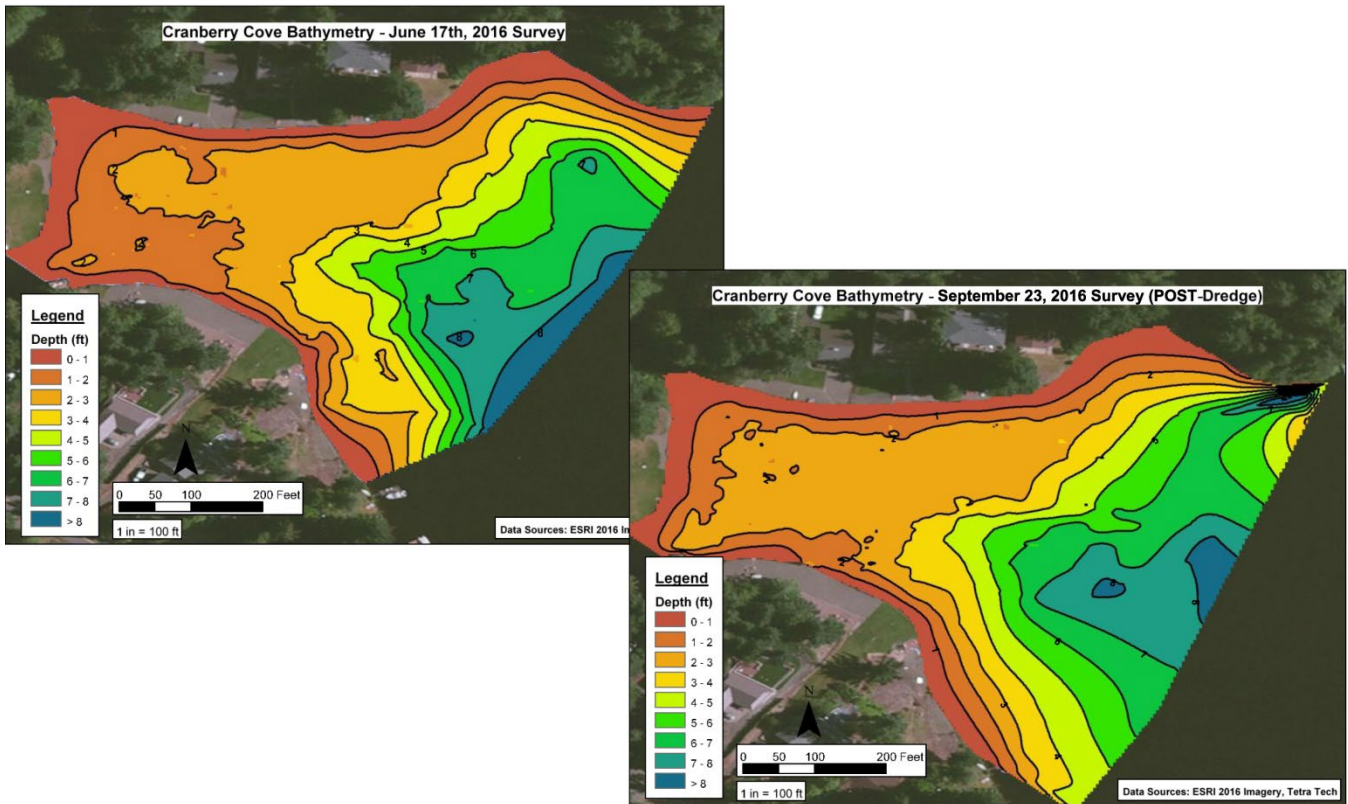
Figure 7-17 – Cranberry Cove bathymetry before and after dredging
