**Technical Status Memorandum
For
Lakes Limerick and Leprechaun 2014
Aquatic Plant Management**

December 2014

Prepared for
Lake Committee
Lake Limerick Country Club

Prepared by
Tetra Tech, Inc.

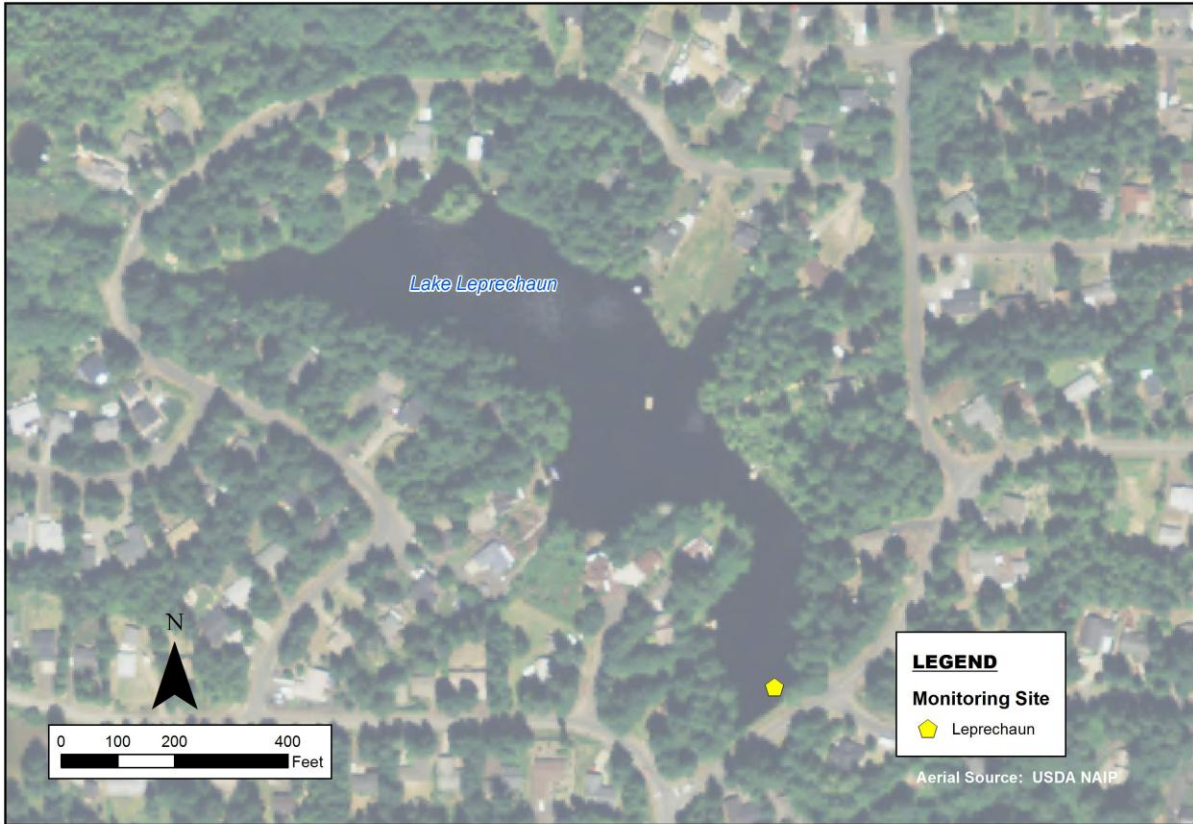
Figure 26. Lake Leprechaun water quality monitoring site.

2014 Lake Leprechaun Water Quality Monitoring Site
