**Technical Status Memorandum
For
Lakes Limerick and Leprechaun 2015
Aquatic Plant Management**

DECEMBER 16, 2015

Lake Committee
Lake Limerick Country Club

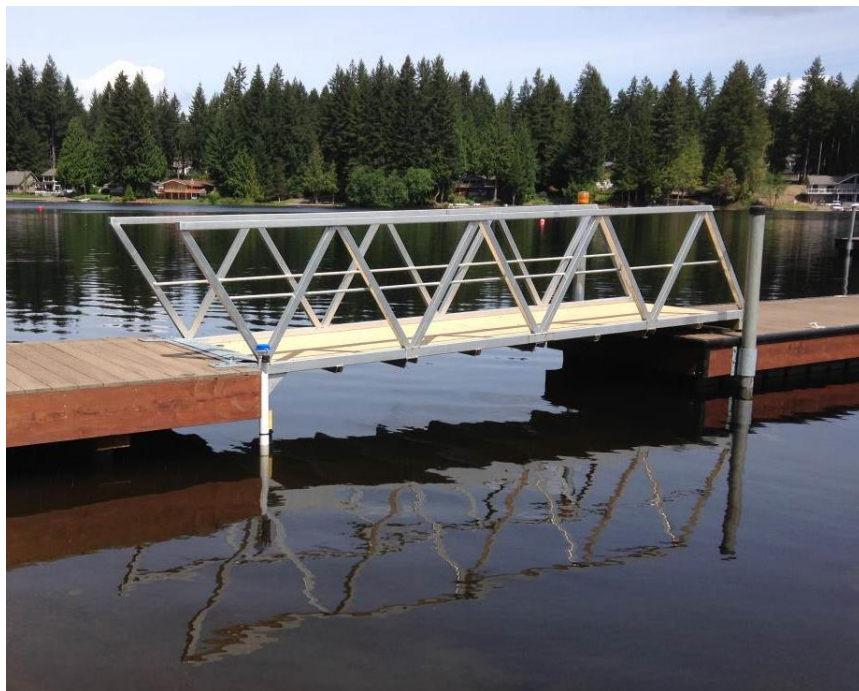
Figure 11 – Level logger located at the Lake Limerick Country Club dock.

During 2015, water level monitoring continued at the Lake Limerick inn dock (Figure 11) and below the Lake Limerick dam (Figure 12). The loggers at these sites provide accurate lake level data at 60 minute intervals by recording water pressure (in feet of water). No data was available from 6/3/2015 – 7/3/2015. Precipitation data was obtained from the KWASHELT3 weather station, located at the tip of the small extension of Lake Limerick along its north shore (King Cove).

During 2015, in conjunction with water level monitoring, water temperature was monitored continuously (at 60-minute intervals) at the Lake Limerick inn dock (Figure 11) and below the Lake Limerick dam (Figure 12). Monitoring occurred from December, 2014 through early November, 2015, although no data was recorded from 6/3/2015 – 7/3/2015. The air temperature record for the full period was downloaded from the KWASHELT3 weather station, located at the northeast end of King Cove.

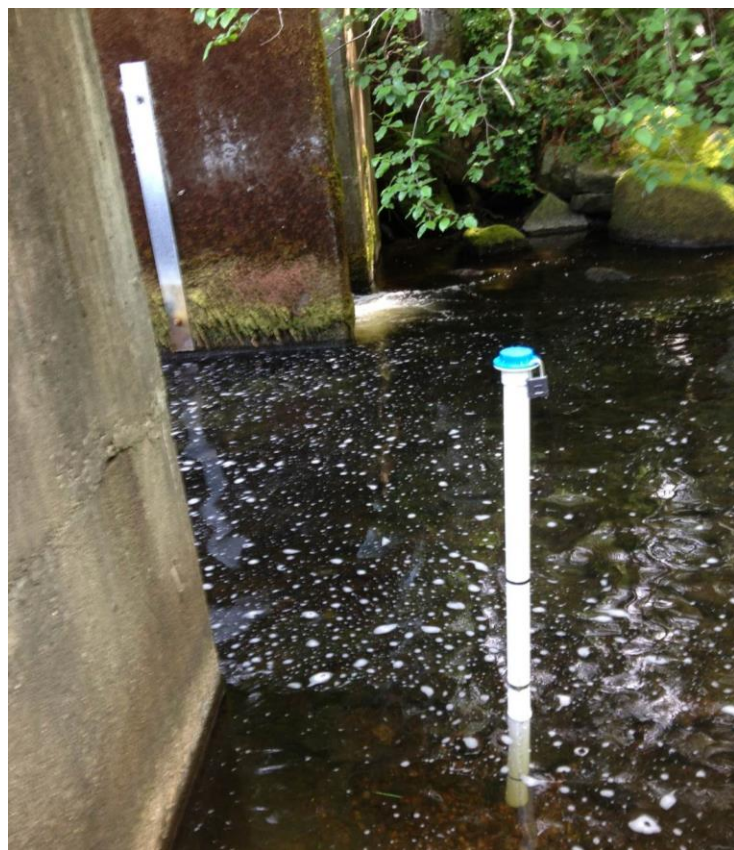
Figure 12 – Level logger located below the Lake Limerick dam

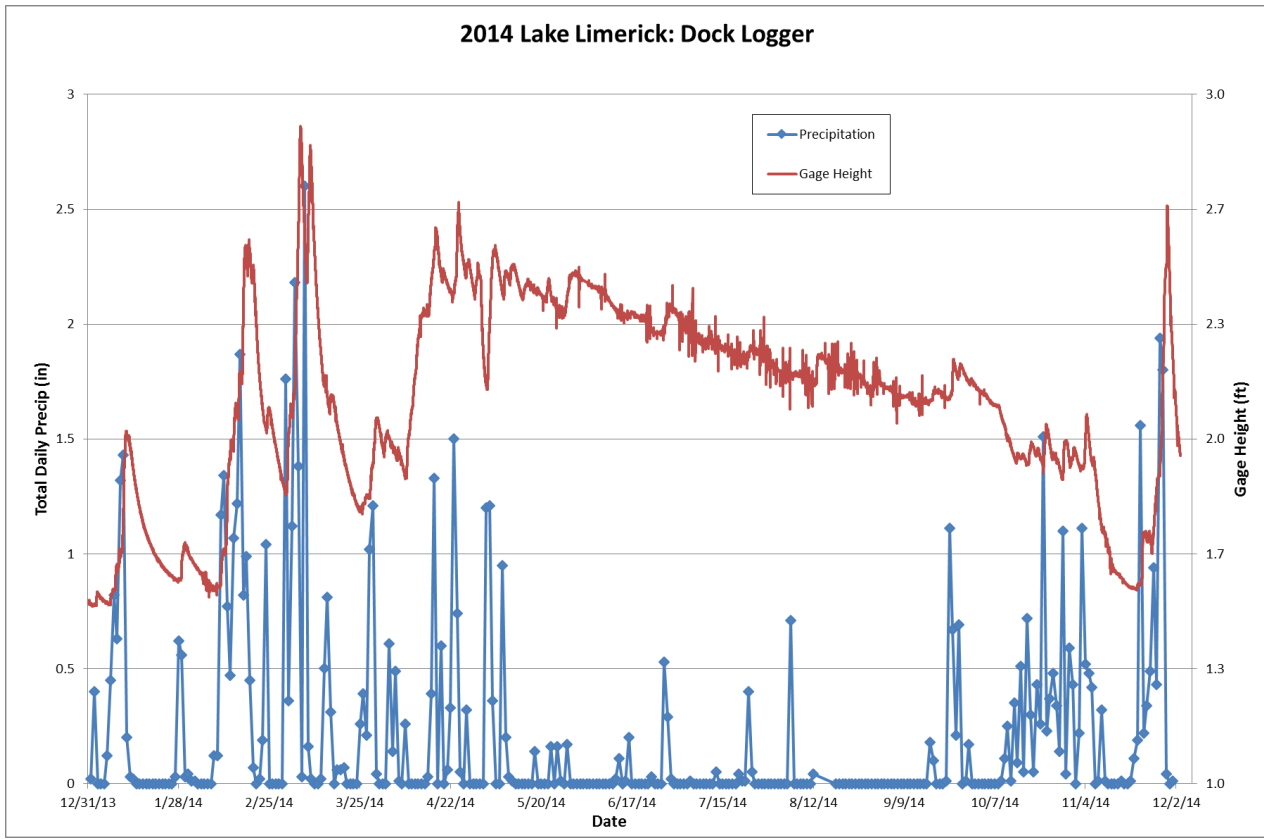
Figure 15 – Continuous record of lake level in Lake Limerick from December 2013 through November 2014 and daily precipitation within this same time period.

Water level records from December 2013 through November 2014 for Lake Limerick and the Lake Limerick dam outlet are shown in Figures 15 and 16, respectively. The figures also include the precipitation record for the same time period.

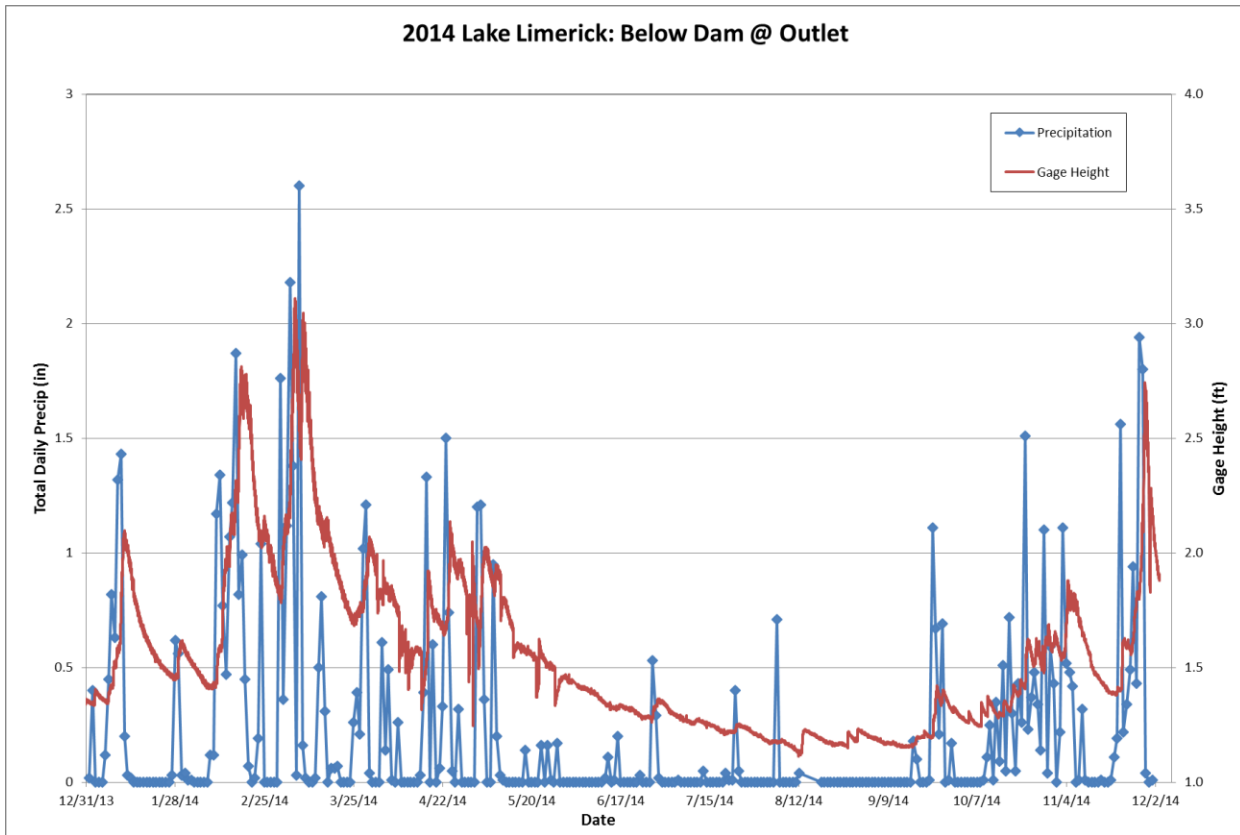
Figure 16 – Continuous record of water level below the Lake Limerick dam from December 2013 through November 2014 and daily precipitation within this same time period.

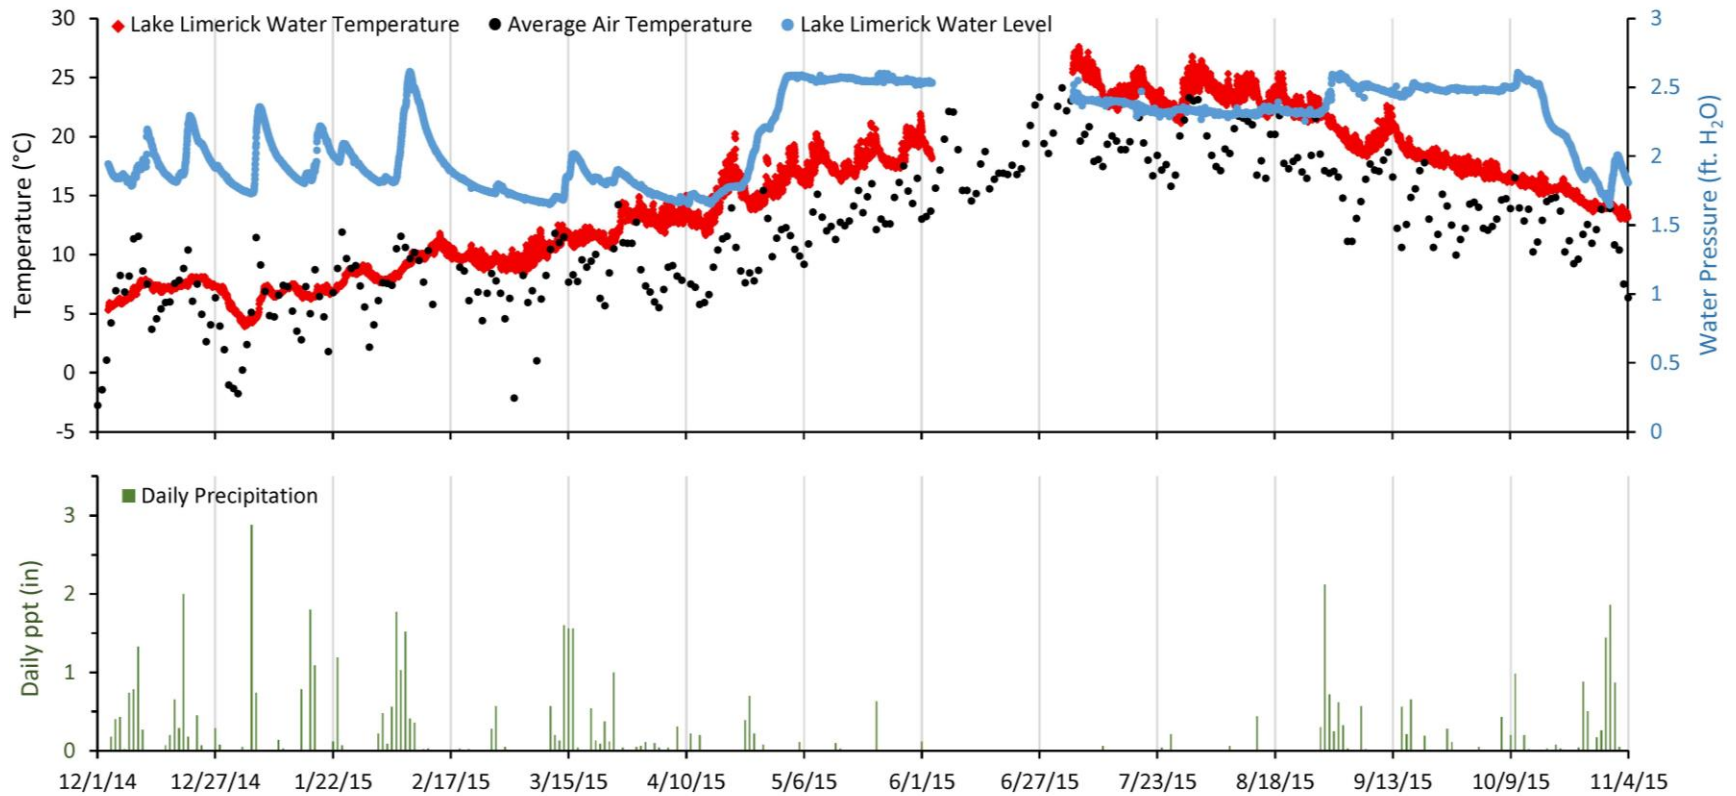
Figure 17 - Lake Limerick water temperature, Lake Limerick water level, average air temperature, and daily precipitation from December, 2014 through early November, 2015. Precipitation and air temperature data from the KWASHELT3 weather station, located at the tip of the small extension of the lake along the north shore (King Cove). Water level and temperature logger for Lake Limerick located at the inn dock.

From December, 2014 through early November, 2015, average air temperature ranged from -2.8 to 24.1 °C (Figure 17). Air temperatures were lowest in December, 2014 and January and February, 2015, and highest in July and August, 2015. During this same period, surface water temperatures recorded at the Lake Limerick inn dock ranged from 3.9 to 27.6 °C (Figure 17), and water temperatures recorded at the dam outlet ranged from 4.4 to 27.5 °C (Figure 18). Water temperatures at both sites varied seasonally, and were lowest in December, 2014 and January, 2015, and highest in July and August, 2015. Throughout the year, there was little to no difference between water temperatures at the inn dock, located between the lake inlet (Cranberry Creek) and the lake outlet, and water temperatures at the lake outlet, at the dam outlet site (Figures 17, 18, and 19). Accordingly, it appears that there is no significant thermal gain in the reservoir between the inlet and the outlet given the prevailing wind is from the SW, which limited the potential thermal gain from the open water as measured at the Lake Limerick inn dock nearest the major inlet inflow versus the open water near the outlet temperature measurements.

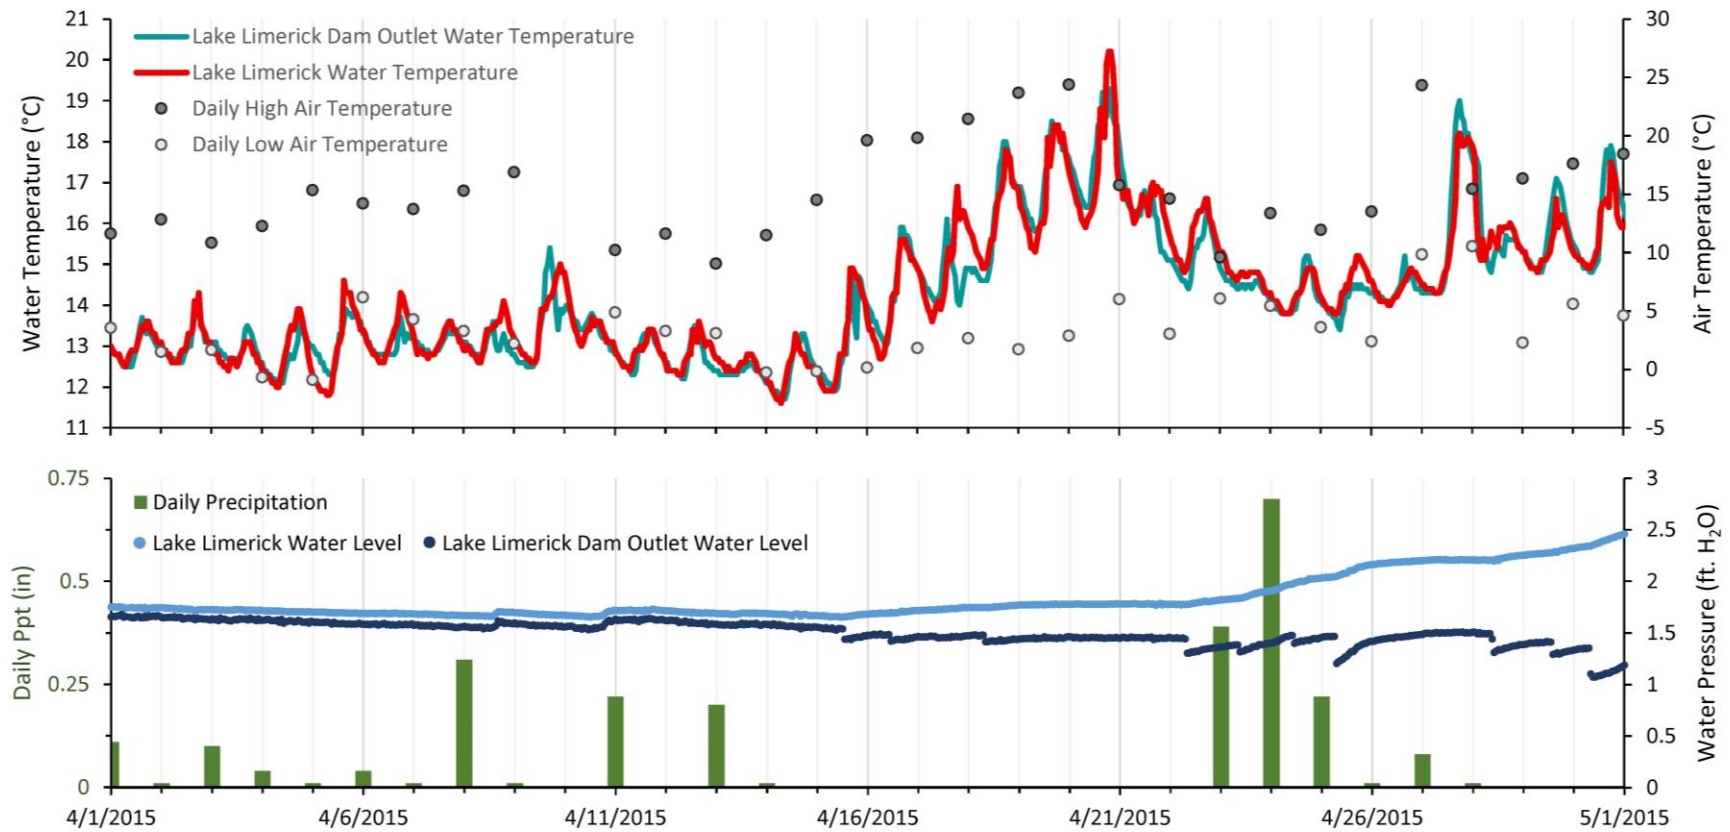
Figure 19 – Water temperature in Lake Limerick and at the Lake Limerick dam outlet during April 2015, and daily high and low air temperatures for the same period. Water level in Lake Limerick and at the Lake Limerick dam outlet in April 2015, and daily precipitation during the same period. Precipitation and air temperature data from the KWASHELT3 weather station, located at the tip of the small extension of the lake along the north shore (King Cove). Water level and temperature logger for Lake Limerick located at the inn dock. Water level and temperature logger for Lake Limerick Dam Outlet located just below the Lake Limerick Dam.

In general, the temperature of surface water in Lake Limerick (and water at the dam outlet) appeared to respond to fluctuations in average air temperature, as the temporal trend in water temperatures mimicked, but slightly lagged, that of average air temperatures (Figures 17 and 18). The lake response to fluctuating ambient air temperatures was evident in April, 2015, and appeared to be greatest either when daily high and low temperatures were both elevated or depressed in comparison to those of the preceding day or when the difference between the daily high and low air temperatures was large (Figure 19).

Water temperatures in Lake Limerick and at the dam outlet varied diurnally (i.e., followed a daily cycle) as well as seasonally (Figure 19). From December, 2014 through early November 2015, the magnitude of the diurnal variation in surface water temperatures in Lake Limerick ranged from 0.2 to 4.3 °C. The diurnal range in water temperatures at the dam outlet was slightly larger: 0.1 to 6.6 °C. Within a given period, the magnitude of the diurnal variation appeared to be greatest when there was a large difference between the high and low air temperatures on the preceding day (e.g., April, 2015 in Figure 19). The magnitude also varied seasonally. The diurnal variation was small and inconsistent during the winter months, but became larger and well defined by the end of March, 2015 and through the summer. By early October, 2015, the diurnal variability had diminished and the pattern had begun to deteriorate. Diurnal variability in surface water temperatures is likely greater in spring and summer months than in the winter because longer days, fewer cloudy days, and seasonal differences in the angle and position of the sun mean that net solar radiation is greater in these months. The increase in solar energy overpowers wind mixing, and the lake slowly stratifies, forming a surface layer that readily warms during the day and cools at night in response to changes in direct solar radiation and corresponding fluctuations in ambient air temperatures. This causes the observed diurnal variation in water temperatures. With the onset of fall, this process reverses itself: net solar energy decreases, the surface layer of the lake cools and the lake is mixed by wind, leading to the observed deterioration of the diurnal temperature variation in surface waters.

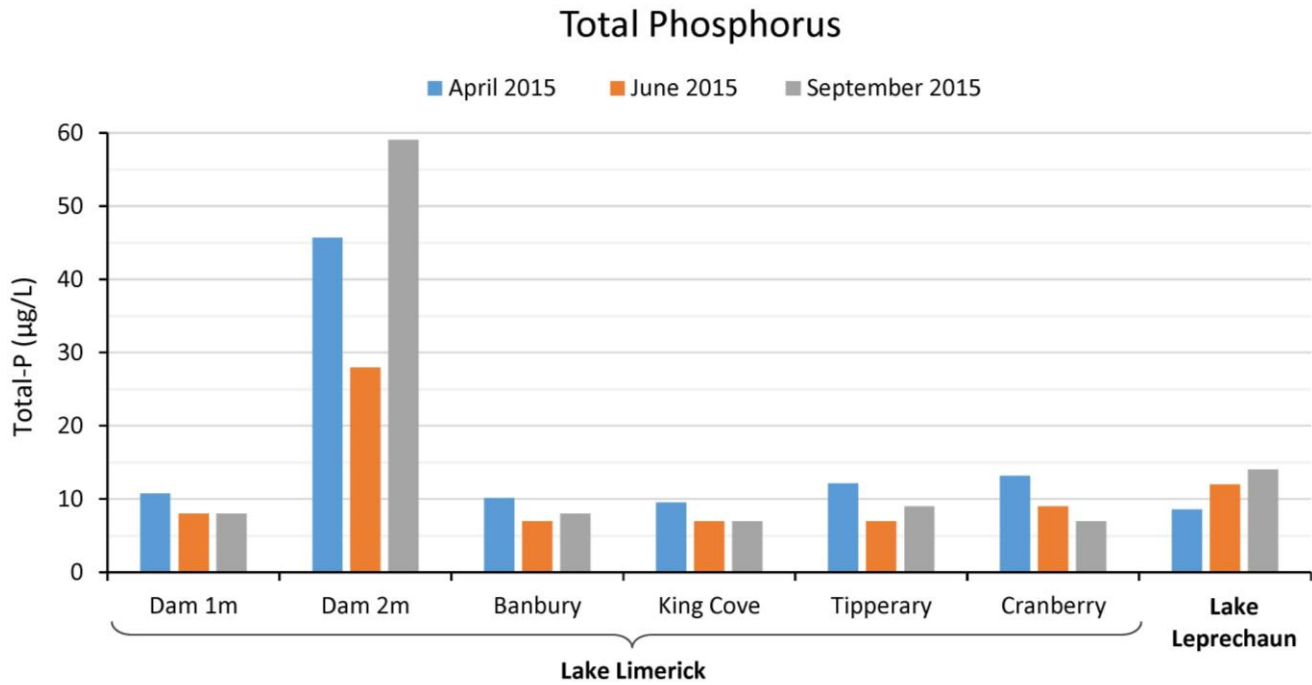
Figure 21 – Total phosphorus concentrations at the water quality monitoring sites within Lake Limerick and Lake Leprechaun on April 2nd, June 3rd, and September 2nd, 2015. The method detection limit for total phosphorus analysis is 2.0 µg/L.

During the 2015 monitoring period, concentrations of total phosphorus (TP) were higher at the 2 m depth at the dam site than at any of the other sampling locations in Lake Limerick (Figure 21). Among the remaining five sampling locations, TP was highest at the Cranberry site in April (13.2 µg/L) and June (9.0 µg/L) and at the Tipperary site (9.0 µg/L) in September. Concentrations of total phosphorus

were similar between June and September at all sampling locations except for the 2 m depth at the dam site (Figure 21).

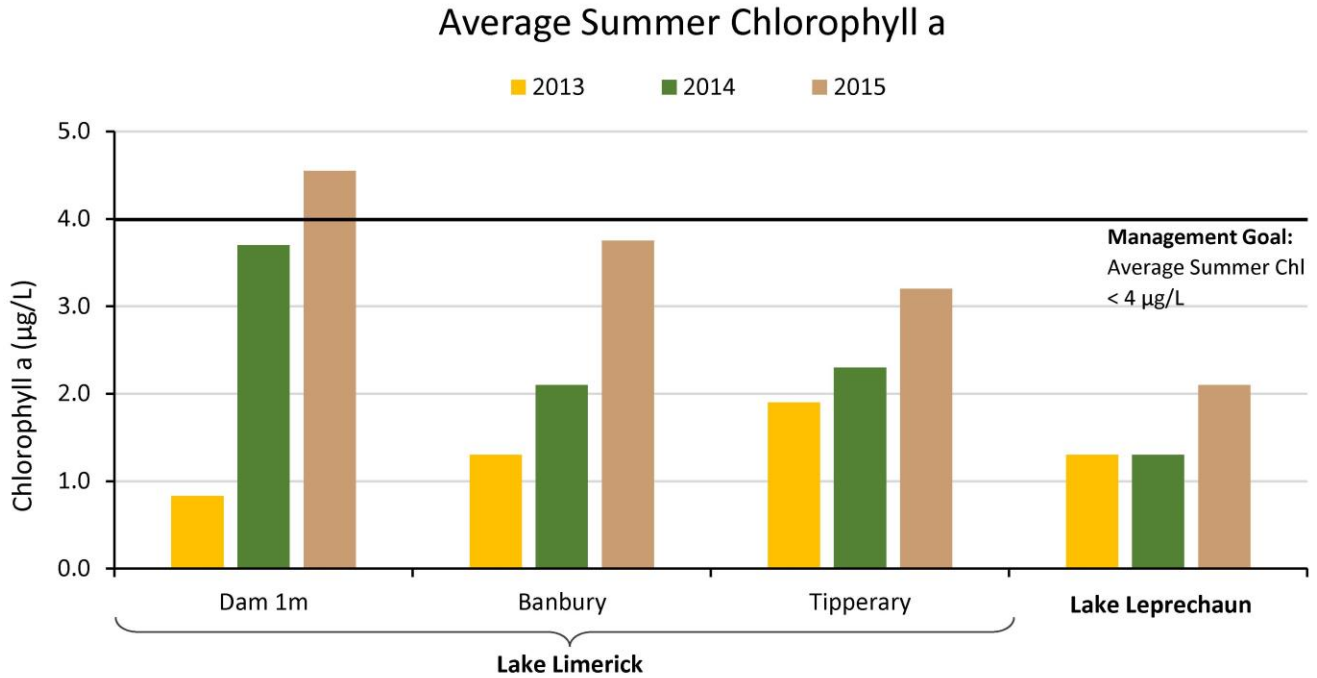
Figure 31 - Average summer concentrations of Chlorophyll a at the Lake Limerick and Lake Leprechaun sampling sites in 2013, 2014, and 2015. Note: 2013 averages are for August and September 2013; 2014 averages are for June, July, August, and September 2014; and 2015 averages are for June and September 2015. The method detection limit for chlorophyll a analysis is 0.1 µg/L.

At the Banbury, Dam 1 m, and Tipperary sites, the annual and summertime average concentrations of chlorophyll *a* were higher in 2015 than in either 2013 or 2014 (Figure 31). 2015 average concentrations of phaeophytin *a* were lower in 2015 than in 2014, but higher than in 2013. Summer average concentrations of phaeophytin *a* were lower in 2015 than in either 2013 or 2014 (Figure 32). The summer average Chl:TP was higher in 2015 than in 2013 or 2014, likely because of the dry climatic conditions, as discussed above (Figure 33). The lower percentage in 2015 than in 2013 or 2014 phaeophytin *a* relative to chlorophyll *a* was consistent with this trend (Figure 34).

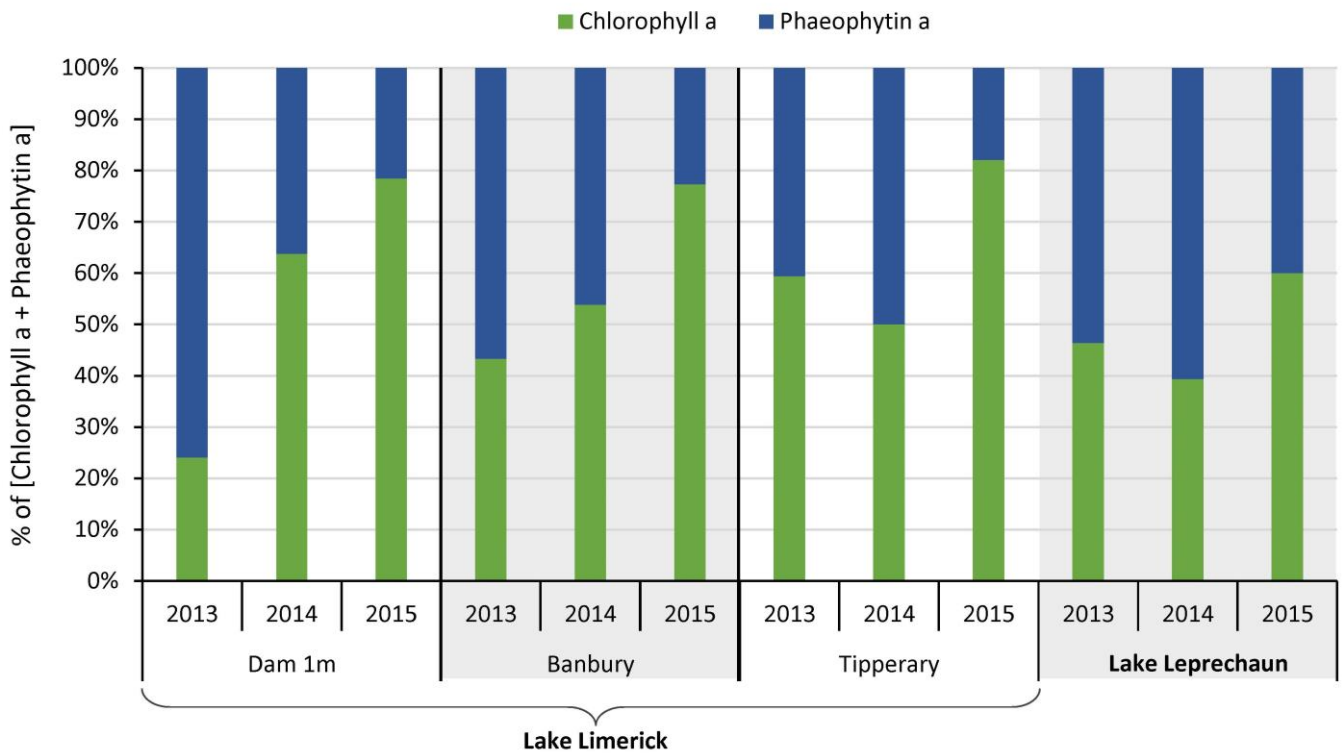
Figure 34 – Average summer concentrations of chlorophyll *a* and phaeophytin *a* as a percent of the sum of the concentrations of the two parameters during 2013, 2014, and 2015. Note: 2013 averages are for August and September 2013; 2014 averages are for June, July, August, and September 2014; and 2015 averages are for June and September 2015.

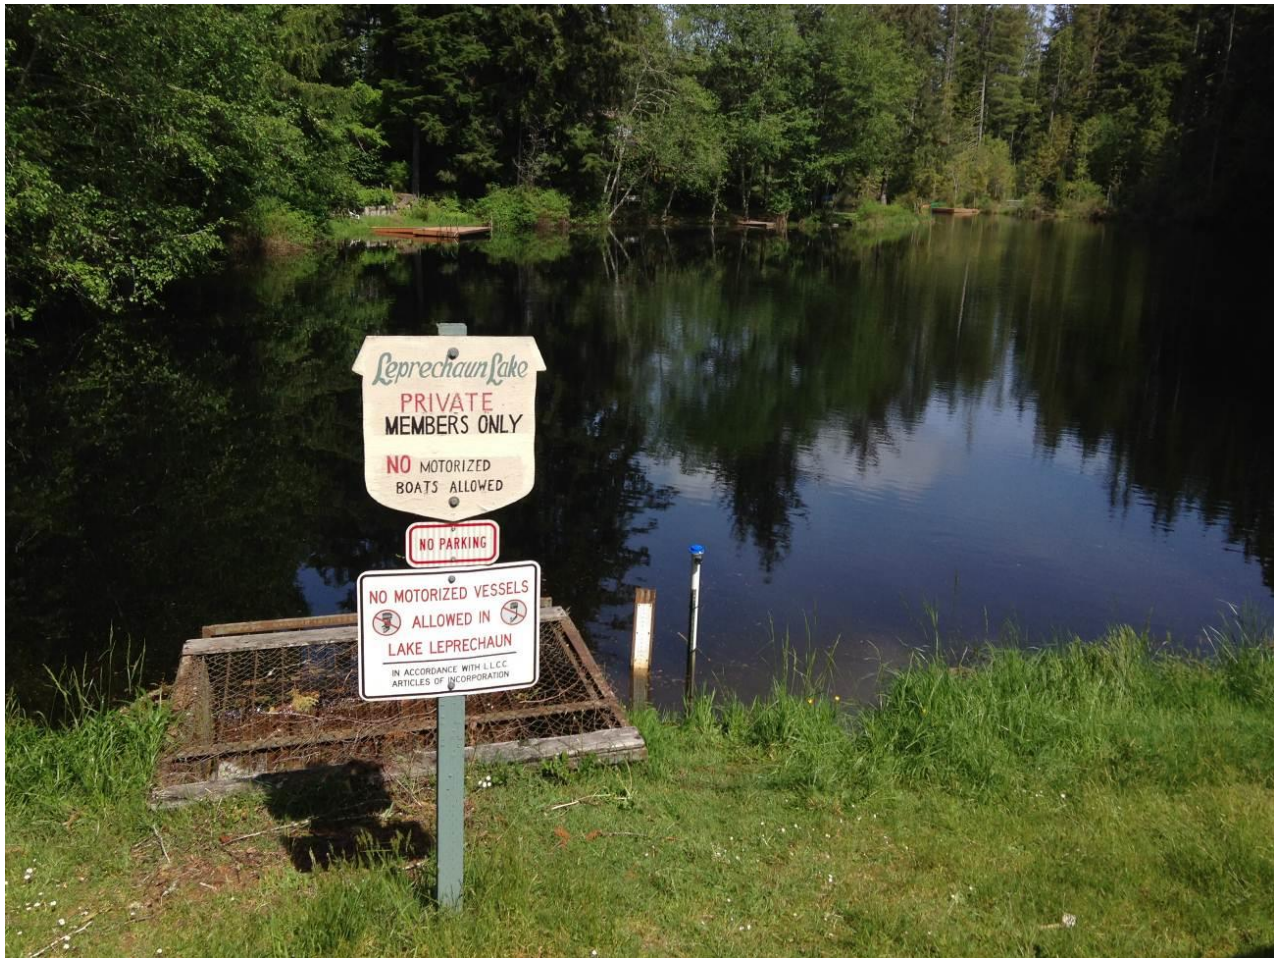
Figure 41 – Lake Leprechaun level logger

During 2015, lake level monitoring continued near the outlet of Lake Leprechaun (Figure 41). The logger at this site provides accurate lake level data at 60 minute intervals by recording water pressure (in feet of water). Precipitation data was obtained from the KWASHELT3 weather station, located at the tip of the small extension of Lake Limerick along its north shore (King Cove).

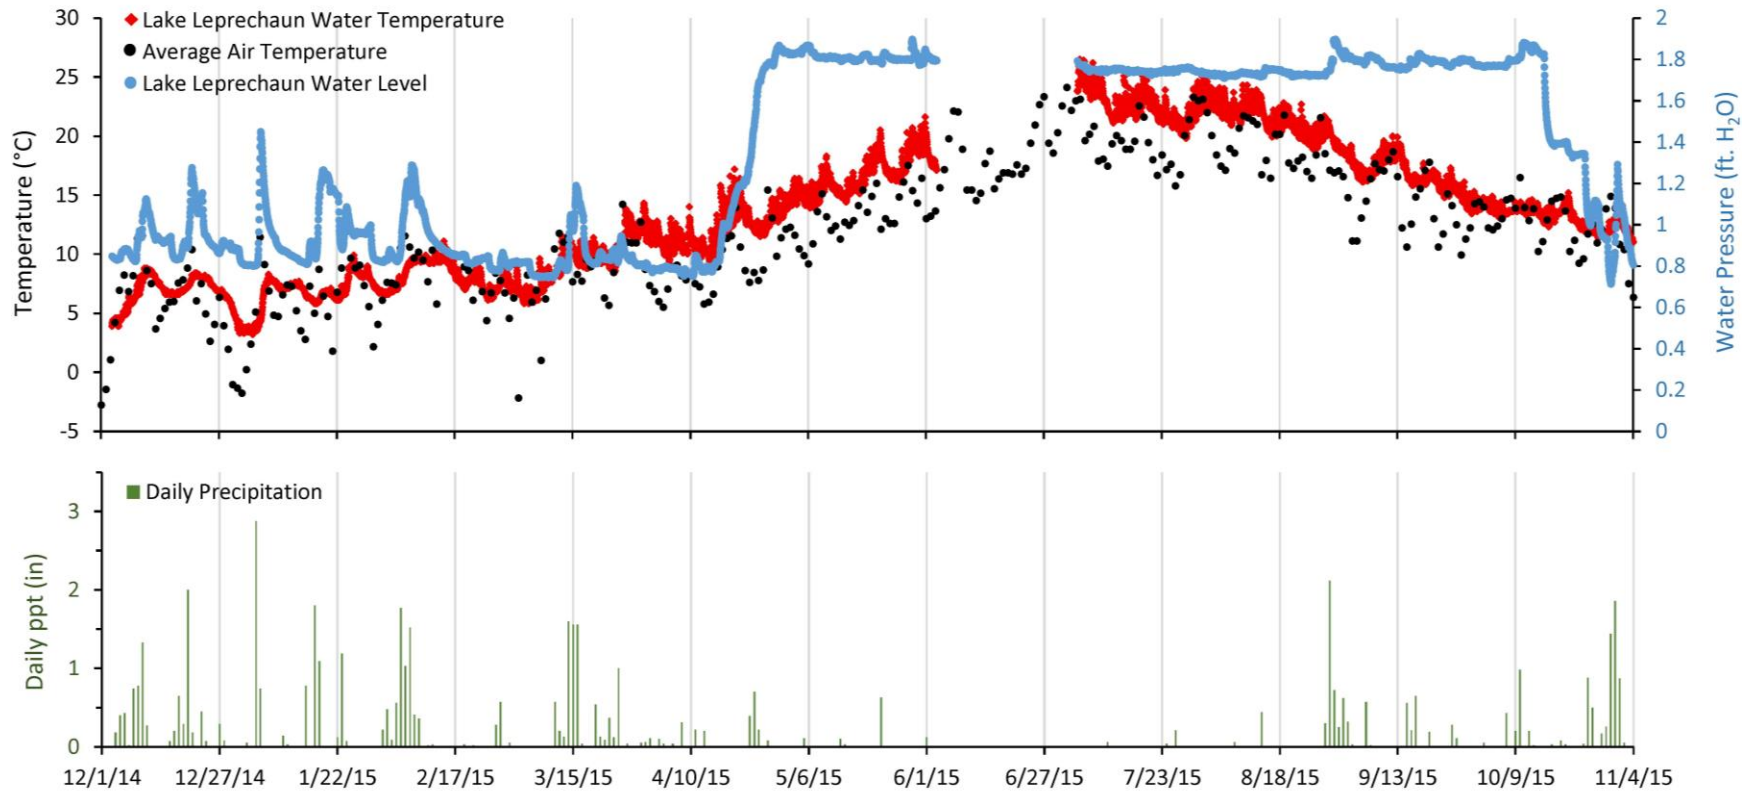
Figure 45 – Lake Leprechaun water temperature, Lake Leprechaun water level, average air temperature, and daily precipitation from 12/1/2014 to 10/1/2015. Precipitation and air temperature data from the KWASHELT3 weather station, located at the tip of the small extension of Lake Limerick along its north shore (King Cove). Water level and temperature logger for Lake Leprechaun located near the outlet structure.

During the monitoring period, average air temperature ranged from -2.8 to 24.1 °C (Figure 45). Air temperatures were lowest in December, 2014, and January and February, 2015, and highest in July and August, 2015 (Figure 45). Surface water temperatures in Lake Leprechaun during this same period ranged from 3.2 to 26.5 °C, a slightly lower range than observed in Lake Limerick or at the Lake Limerick dam outlet (Figure 45). Water temperatures in Lake Leprechaun varied seasonally, and were lowest in December, 2014 and January, 2015, and highest in July and August, 2015.

As at the Lake Limerick monitoring sites, the temperature of surface water in Lake Leprechaun appeared to respond to fluctuations in average air temperature, displaying a similar temporal pattern (Figure 45). The degree of response appeared to be influenced by the same set of factors mentioned in section 2.4. In addition, surface water temperatures in Lake Leprechaun varied diurnally. From December, 2014 to early November, 2015, the magnitude of the diurnal variation in surface water temperatures in Lake Leprechaun ranged from 0.2 to 5.4 °C. The magnitude changed seasonally, as was observed in Lake Limerick and at the Lake Limerick dam outlet (Figure 46). A more in-depth analysis of these trends is available in section 2.4.

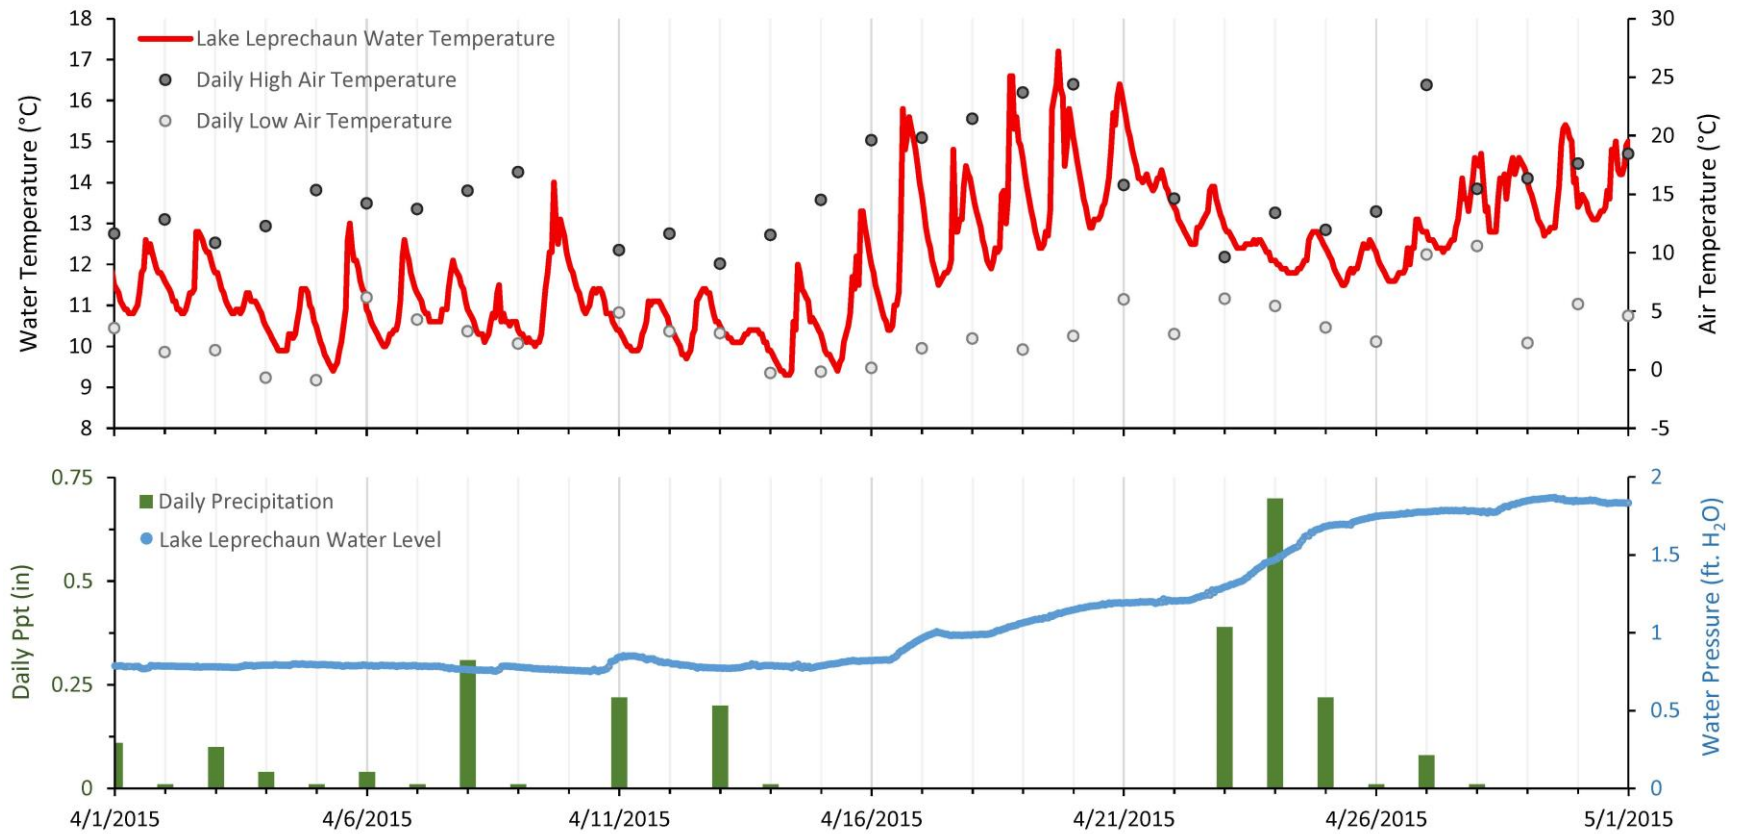
Figure 46 – Water temperature in Lake Leprechaun and daily high and low air temperatures during April 2015. Water level in Lake Leprechaun in April 2015, and daily precipitation during the same period. Precipitation and air temperature data from the KWASHELT3 weather station, located at the tip of the small extension of the lake along the north shore (King Cove). Water level and temperature logger for Lake Leprechaun located near the outlet structure.
