# 2016 Lake Limerick Dredging: Final Report

Lake Limerick Country Club  
790 East St. Andrews Drive,  
Shelton, WA 98584

Marine Industrial Construction, LLC

October 8<sup>th</sup>, 2016

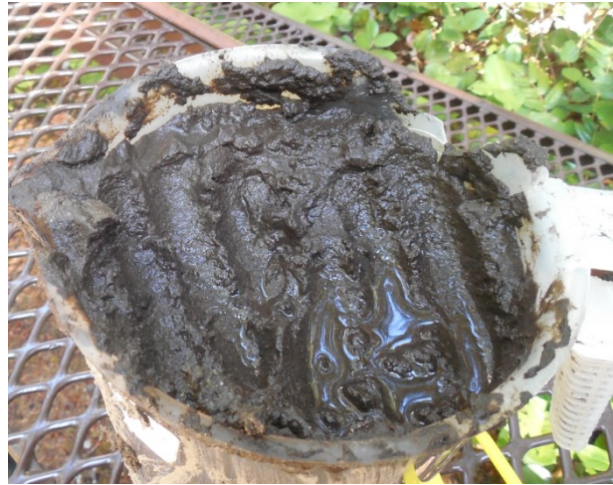
*Figure 2. Sediments from dredging.*

The sediments are variable but overall the sediments are fine silts and decomposed organic material (Figure 2). Overall the majority of the material passed a US Standard sieve # 230 indicating very fine materials. Minor components of fine sands are present, with occasional small woody debris and some cobble near the bottom of the original lake/stream bed. Preliminary assessment at Lake Limerick has found that this sediment has accumulated within the lake but is particularly deeper deposits in the primary tributaries of Beaver Creek and Cranberry Creek. Over 89% of the watershed area is coming from Cranberry Creek, Leprechaun Creek, Beaver Creek and the Unnamed Creek in Kings Cove (5,764 acres).

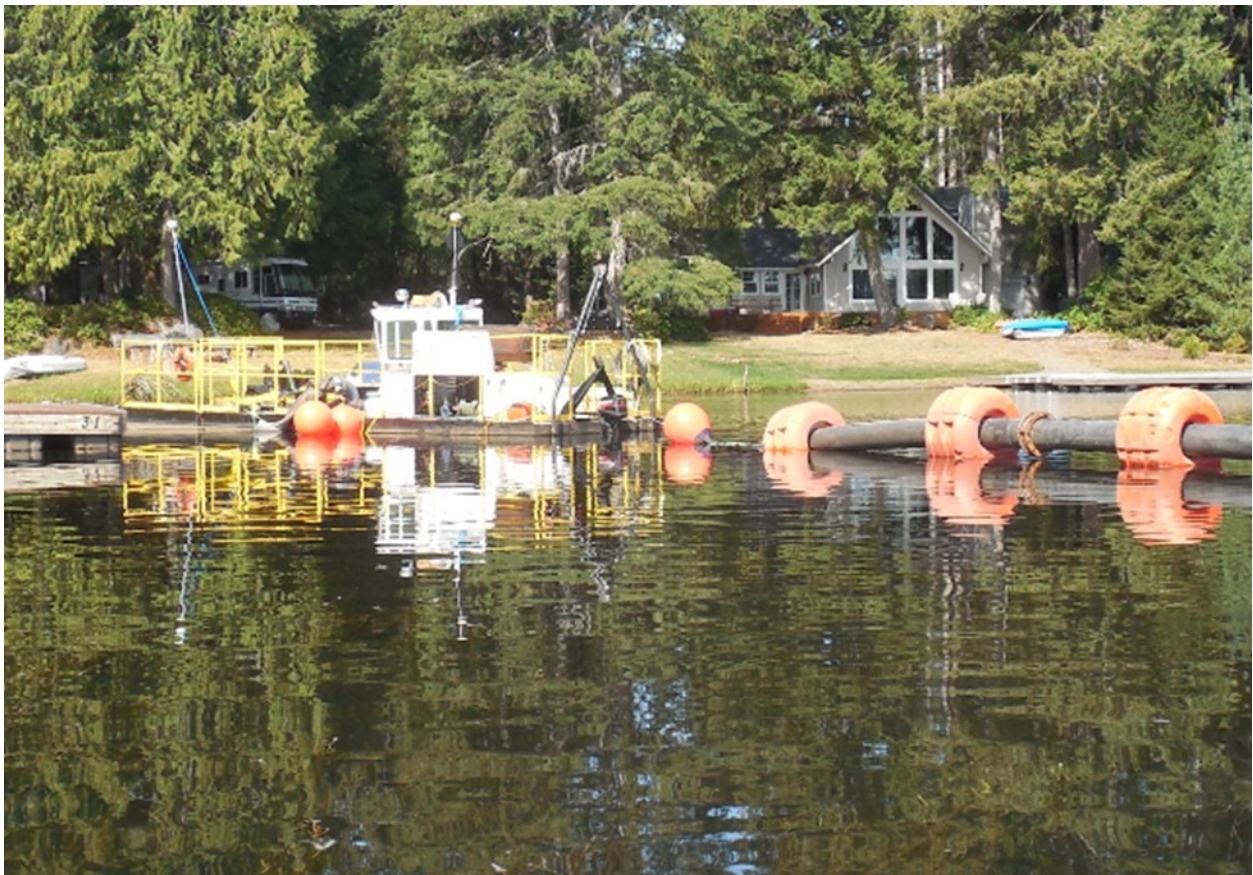
*Figure 4. MudCat dredge deployed at Lake Limerick.*

Mechanical approaches are better with coarser and harder sediments, ability to work in tight areas, significant amounts of debris or distant disposal locations. Hydraulic dredges are typically preferred in shallower deposit, when pumping distances are relatively short in distance. The main way to compare dredges is to evaluate the pump capacity and this is typically determined by the pump intake/outtake diameter.

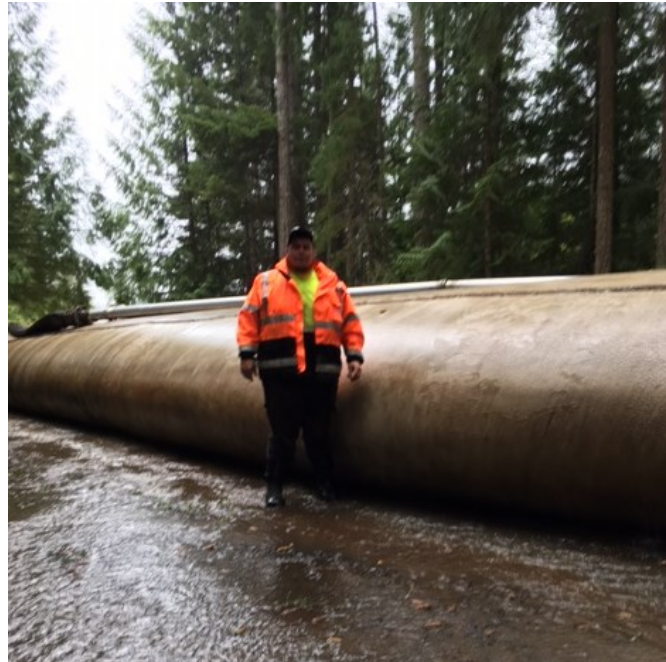
Figure 8. Matt Fobert (Supervisor) standing by dewatering bag.

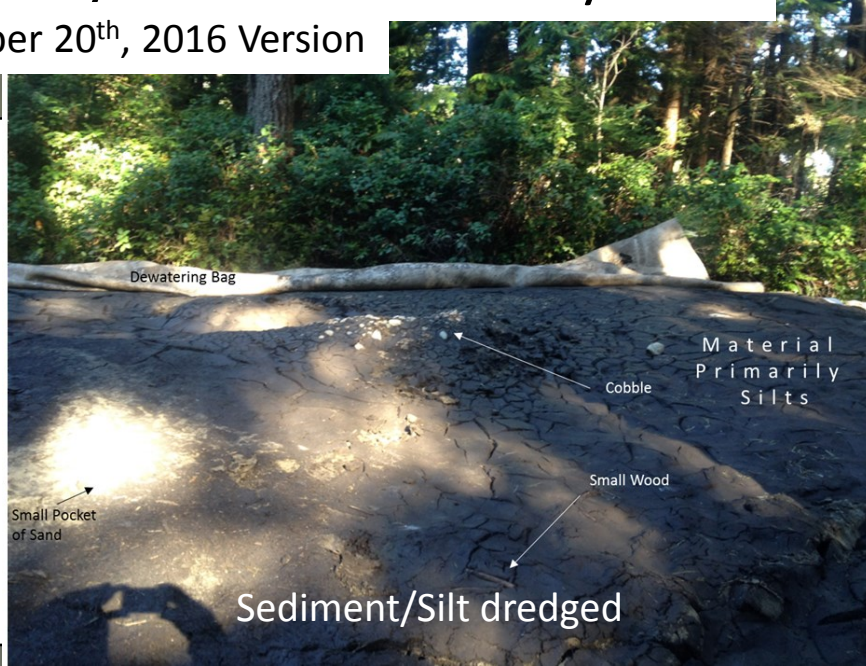
# Cranberry Creek & Cranberry Cove

All in-water dredging in Cranberry Cove was completed between 8/29/16 and 9/8/16

Survey data was collected September 12, 2016 and combined with dredging logs (sediment encountered noted on map). Post dredging substrate was moderate to large round cobble (minor amounts of fine sediments in near shore locations expected to slough with higher flows). Sediments removed were very fine sand and silt. Average sediment depths of 2.5 to 3 feet were removed.

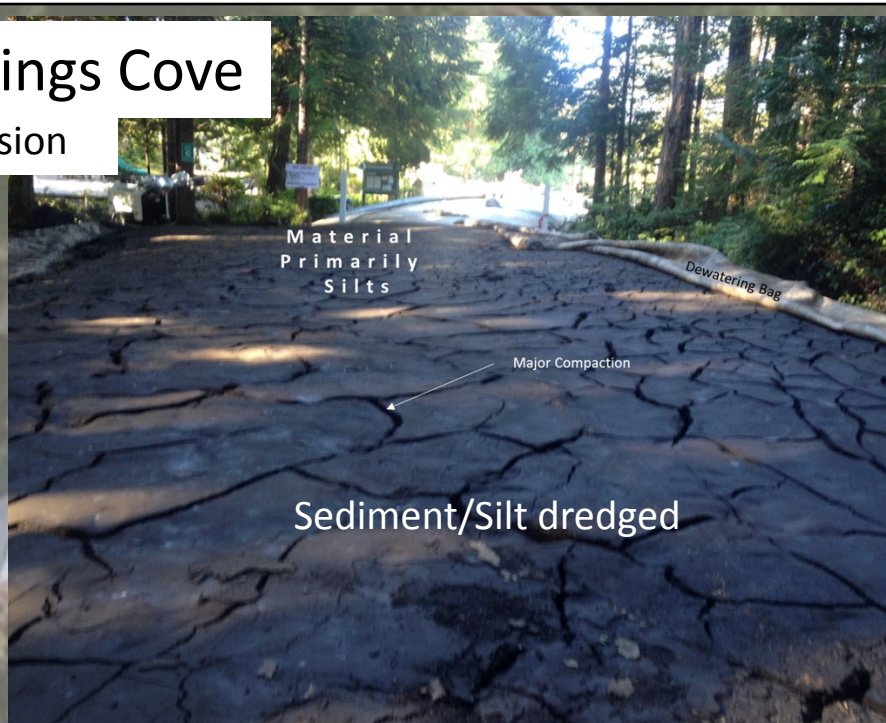
# Beaver Creek & Kings Cove

All in-water dredging in Kings Cove was completed between 8/8/16 and 8/24/16

Survey data was collected September 12, 2016 and combined with dredging logs (sediment encountered noted on map). Post dredging substrate was moderate to large round cobble (minor amounts of fine sediments in near shore locations expected to slough with higher flows). Sediments removed were very fine sand and silt. Average sediment depths of 3 to 4 feet were removed.

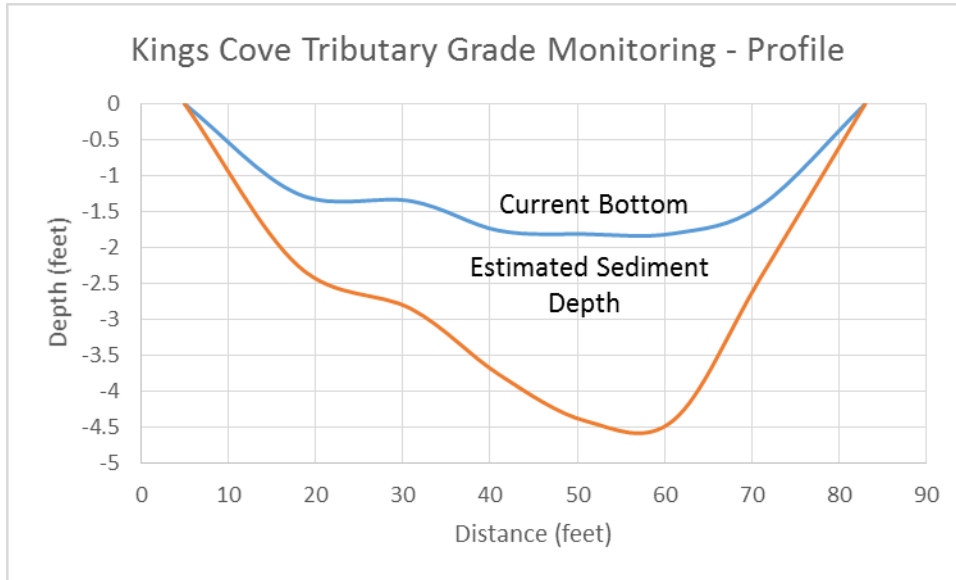
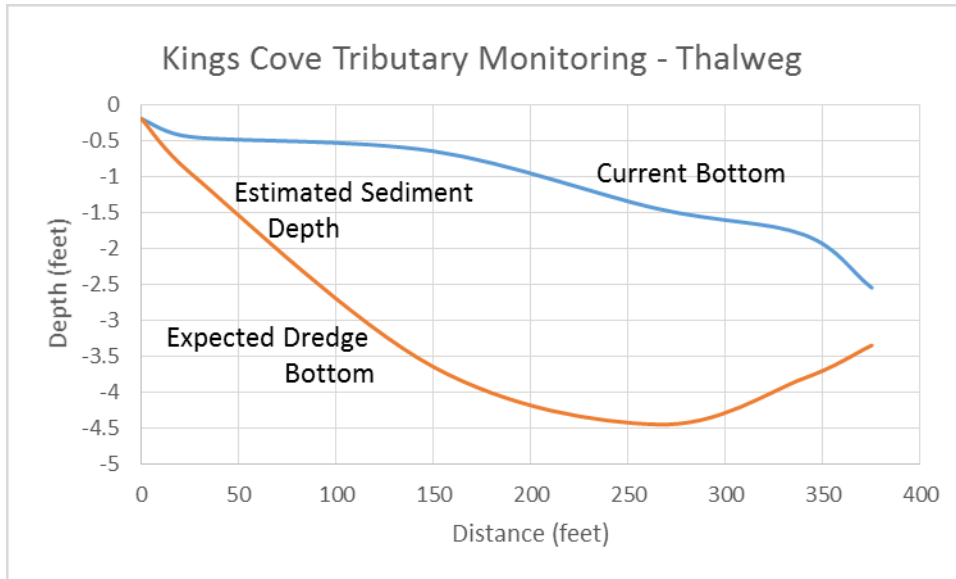
Sediment depths were observed to be variable and noted. A steel post was used to penetrate the sediments until resistance was observed. The water depths were recorded from water surface to tops

of sediment. The post was removed and estimated sediment depth measured (constant post depth minus water depths). The depths and estimated sediment depths are presented below for a profile and transect in the tributary inlet (data collection is indicated on the following map).

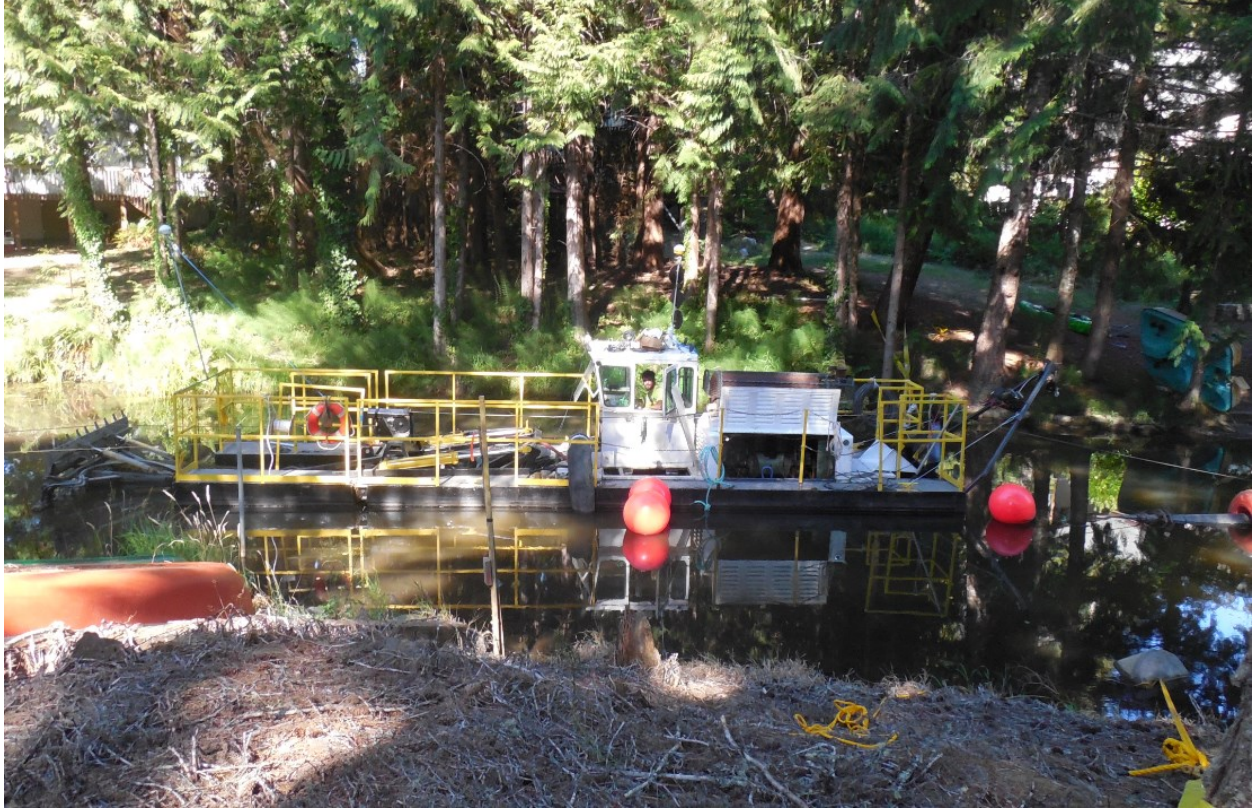
*MudCat Dredging upper end of Kings Cove Tributary*

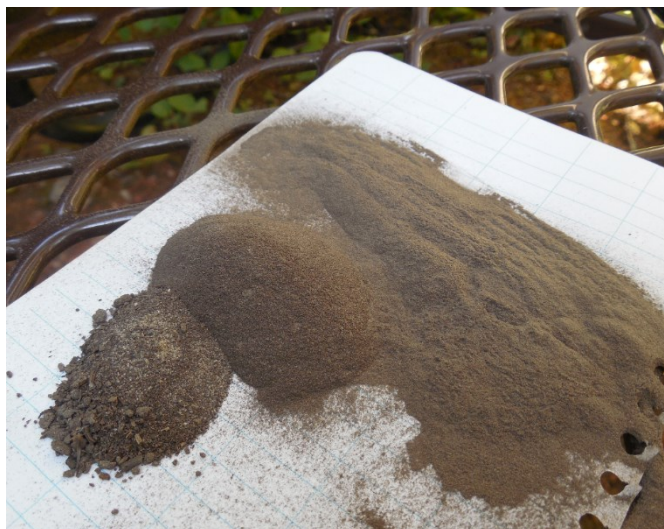
We are noting clogging on the dewatering bags due to the extremely large amount of very fine materials resulting in long dewatering time. This is causing dredging to stop and wait for dewatering. We are setting up another large dewatering bag up (early in the week) from the existing bags to dewater into the existing dewatering (TESC) area (up towards restrooms). We have ordered several custom sized smaller dewatering bags to be placed on top of the existing bags near the shelter and dock (narrow and long) which should arrive

late this week and early next week. Since dewatering times are the limiting factors we will continue to install and configure additional dewatering capabilities. Storage area in Log Toy Park is very limited given the material we are encountering and the site conditions (i.e. slopes on ground, vegetation present, access, width of lay down area, etc.).

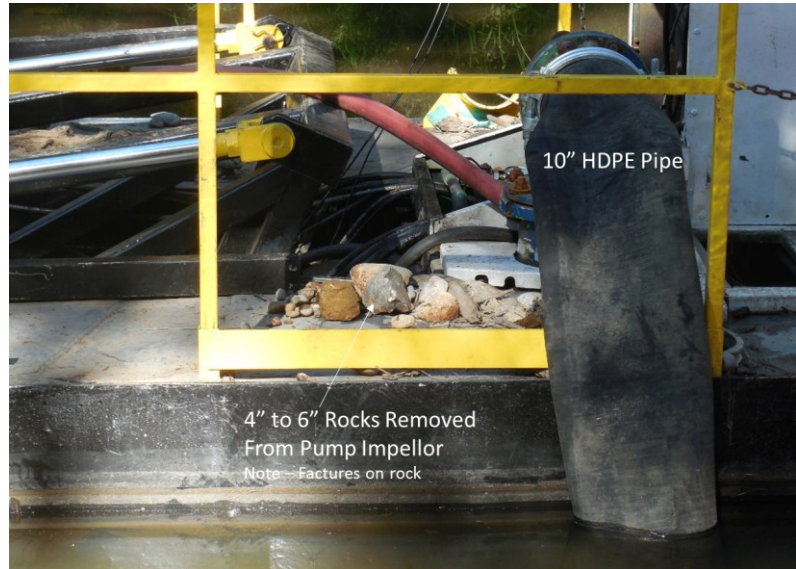
Lake Limerick Safety Meeting at 7:00 am. Pumping into Bag 2 during day with MudCat (5 x 15 to 30 min production runs). Huge amounts of sloughing noted at upper end of prism. Covered/dredged area in depth at 0.5 foot of water and area of roughly 25 feet in length and 8 to 10 feet in width. Dredging depth to roughly 4 to 5 feet of sediment. Solids concentration running very high at close to 40%. Have only about 10 feet remaining to top of dredging prism. Slough from upstream and side slope occurring

during work. Anthropogenic rock removed (buried in 1 feet of muck under laid by more muck). Flocculent running at 35 on gage. Dewatering in Bag 2 slow but increased by walking tubes. Bag running at an estimated 30% full of sediment (estimated at approximately 500 cy of compacted materials). Water quality sampling completed.

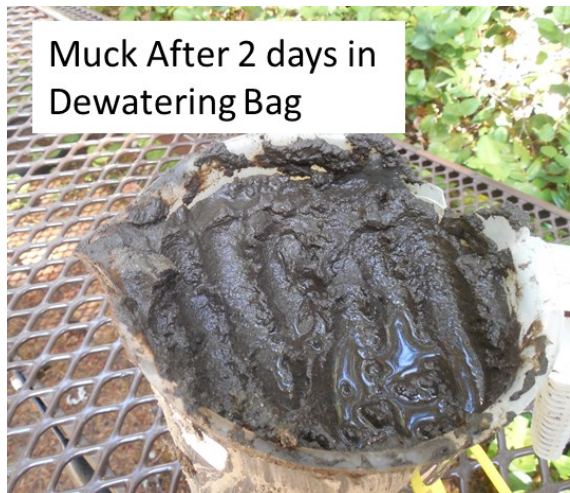
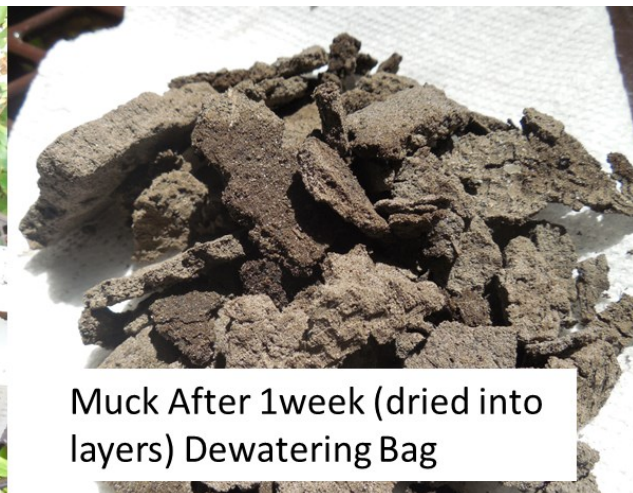
The flocculent has been running from 27 to 35 setting on the injection pump (a low setting and flocculent is being slowly used). Material is being pumped at 10% to 30% solids on average. Lower concentration were encountered (slower dredging) when rock encountered. Prior to flocculent injection the slurry is taking over 45 minutes for initial settle. The material in the water column is very fluid but stabilizes quickly (and passes Paint Filter test very quickly – see photo documentation below). Material is dominantly very fine suspended materials.

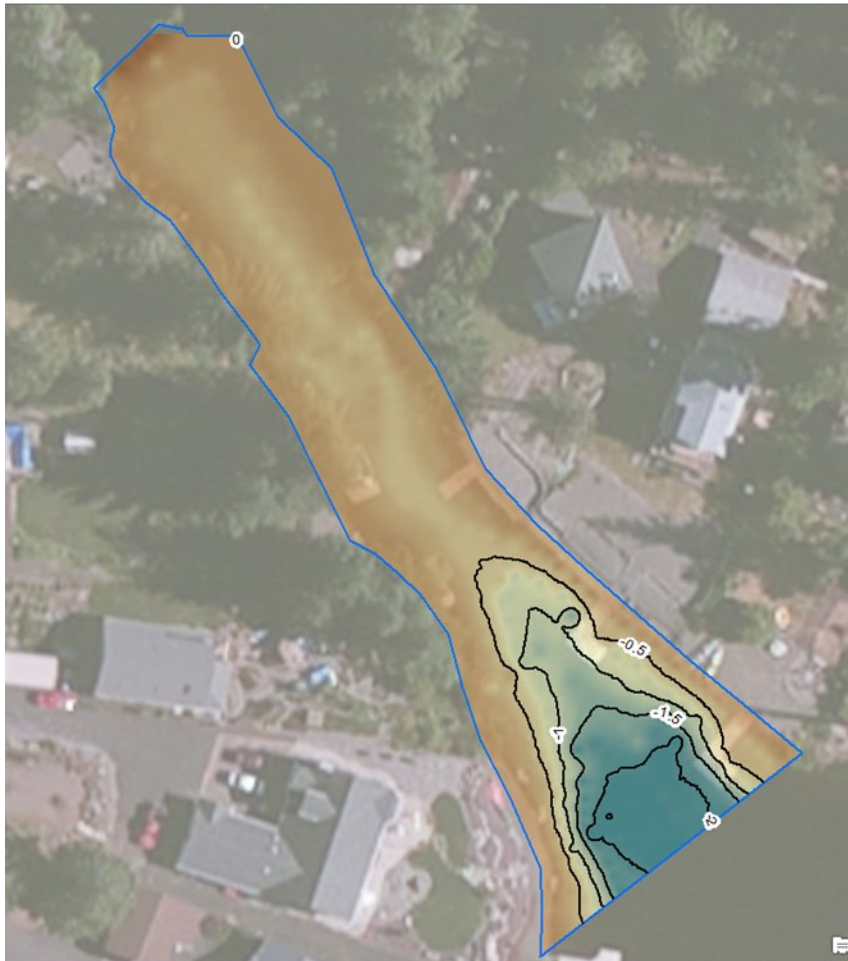
**Pre Dredged Survey from Transect**

A transect down the center is presented which shows where the dredging has stopped. Slough is going upstream to the dredge as it has worked downstream. The depth of the sediment is unknown as we get into the lake since we cannot easily penetrate / sample due to increase water depth. We probe the dredged area and find / feel nominal sediment (couple inches). Propeller wash troughs are apparent in the survey and visually in the tributary / lake due to our boat work required for access. Note this is increasing sloughing actions.

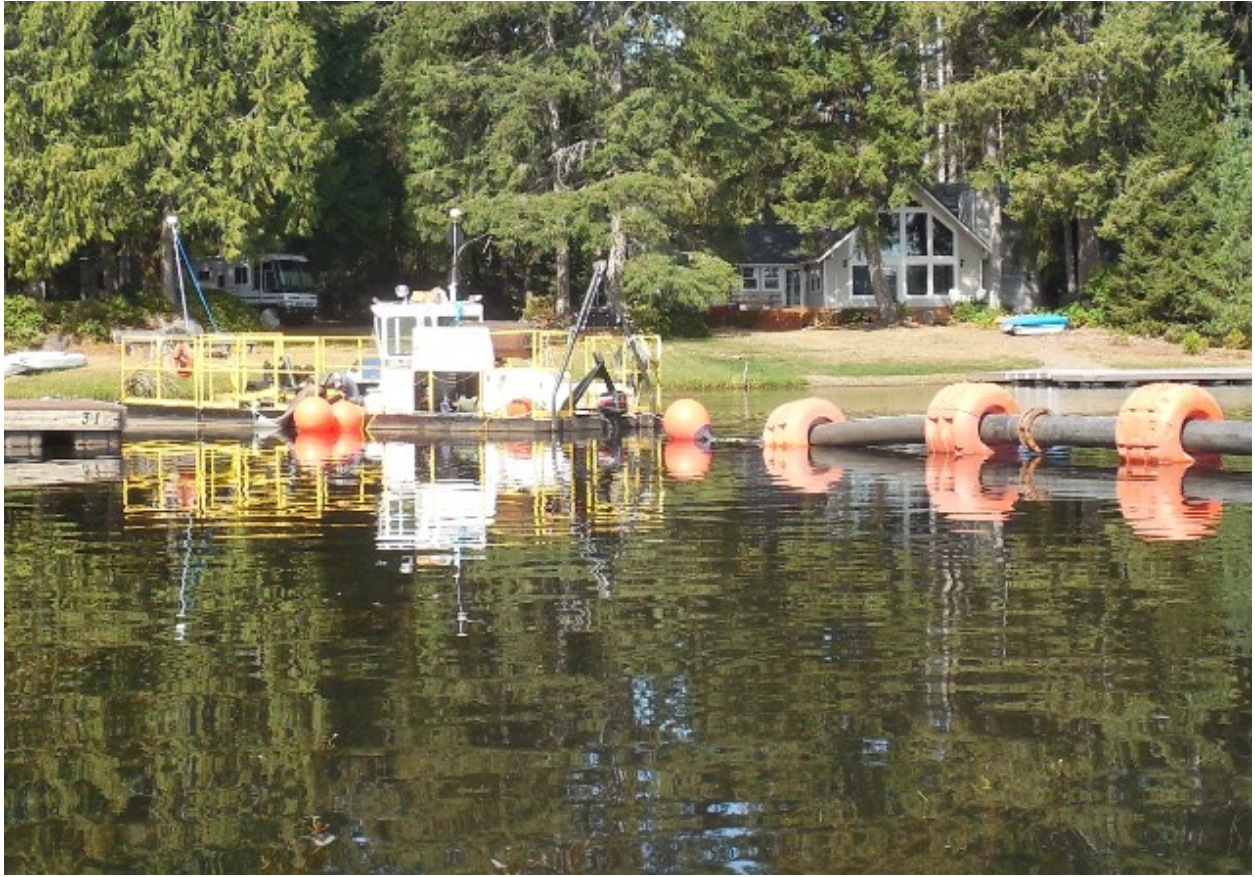
*MudCat Set Up in Cranberry Cove*

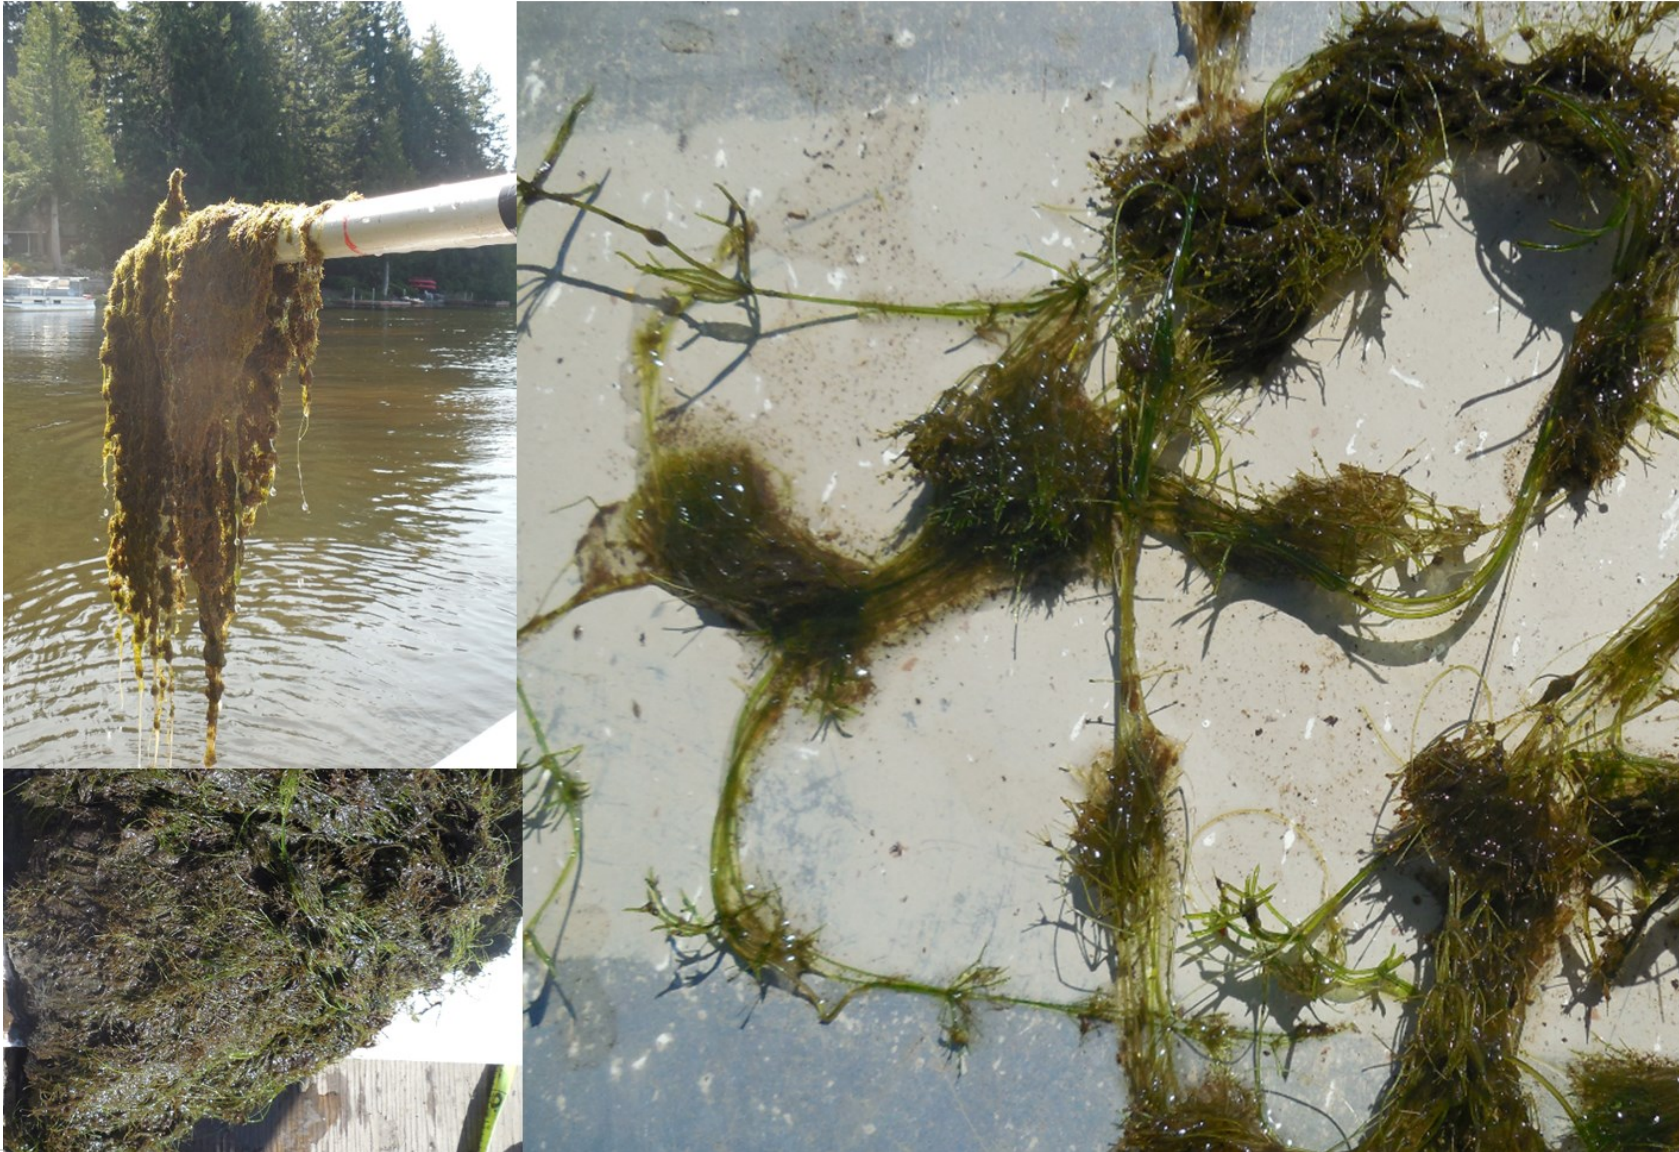
## Thick Matted Weed on Bottom in King Cove Lake – North Side

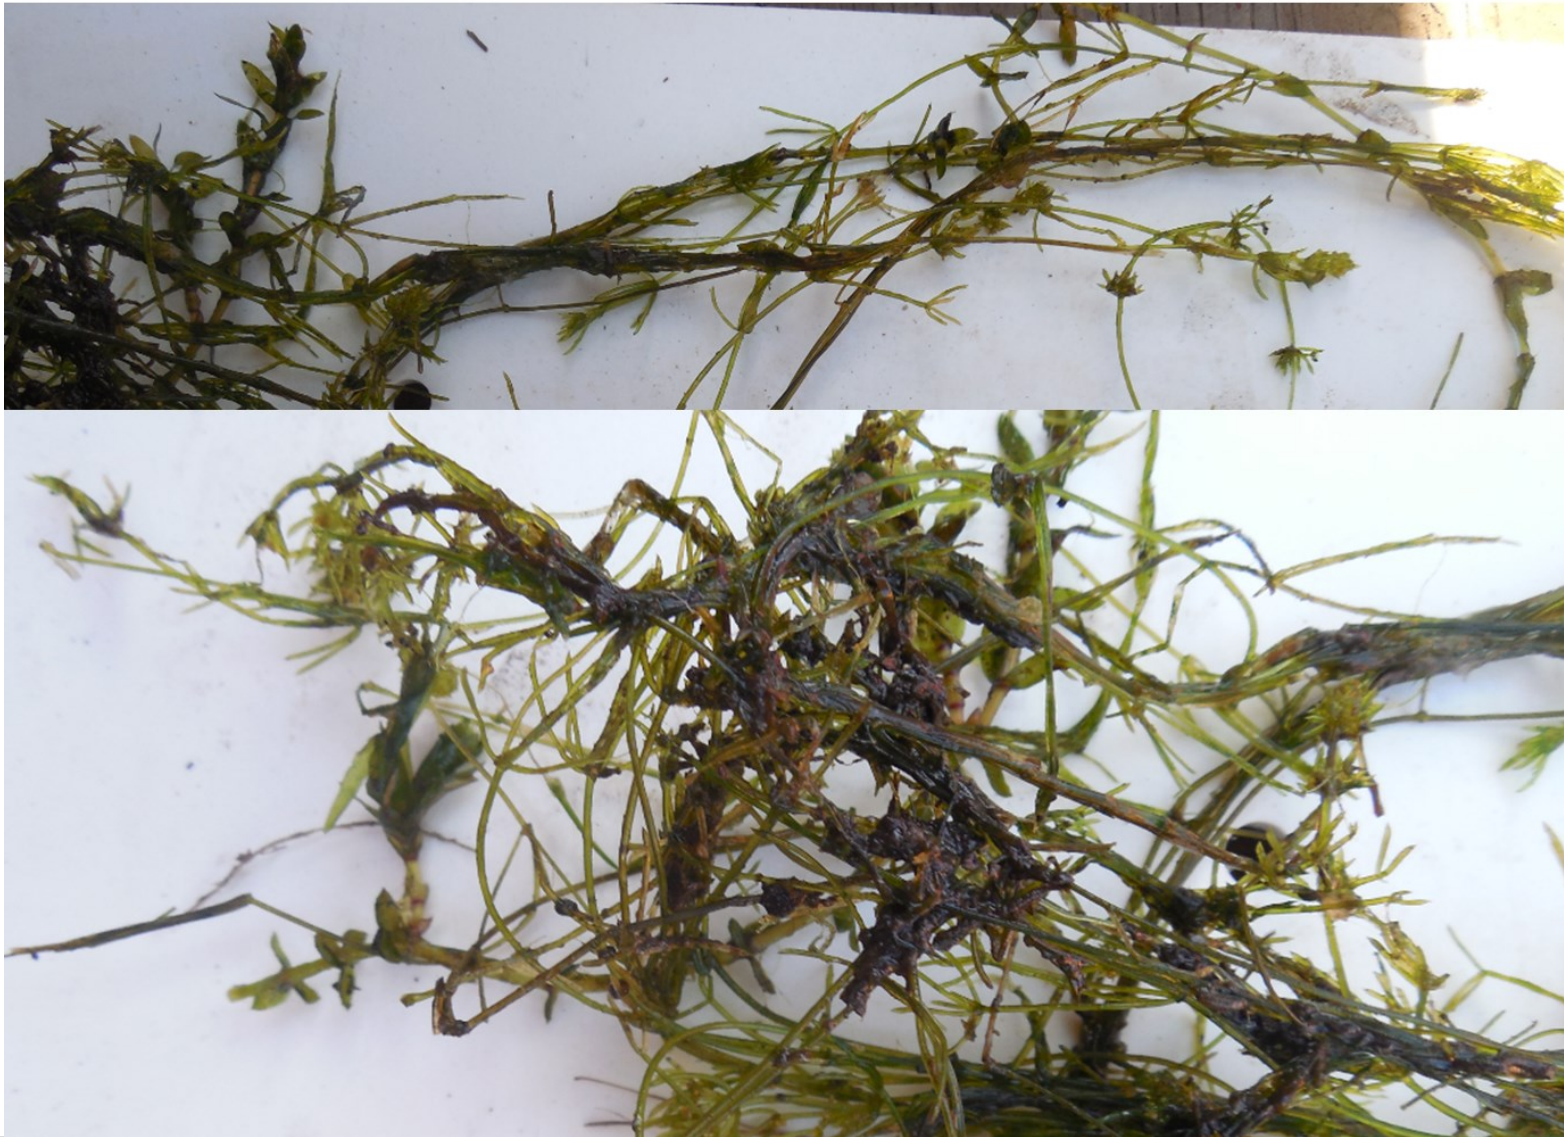
## Aquatic Weed in Cranberry Cove

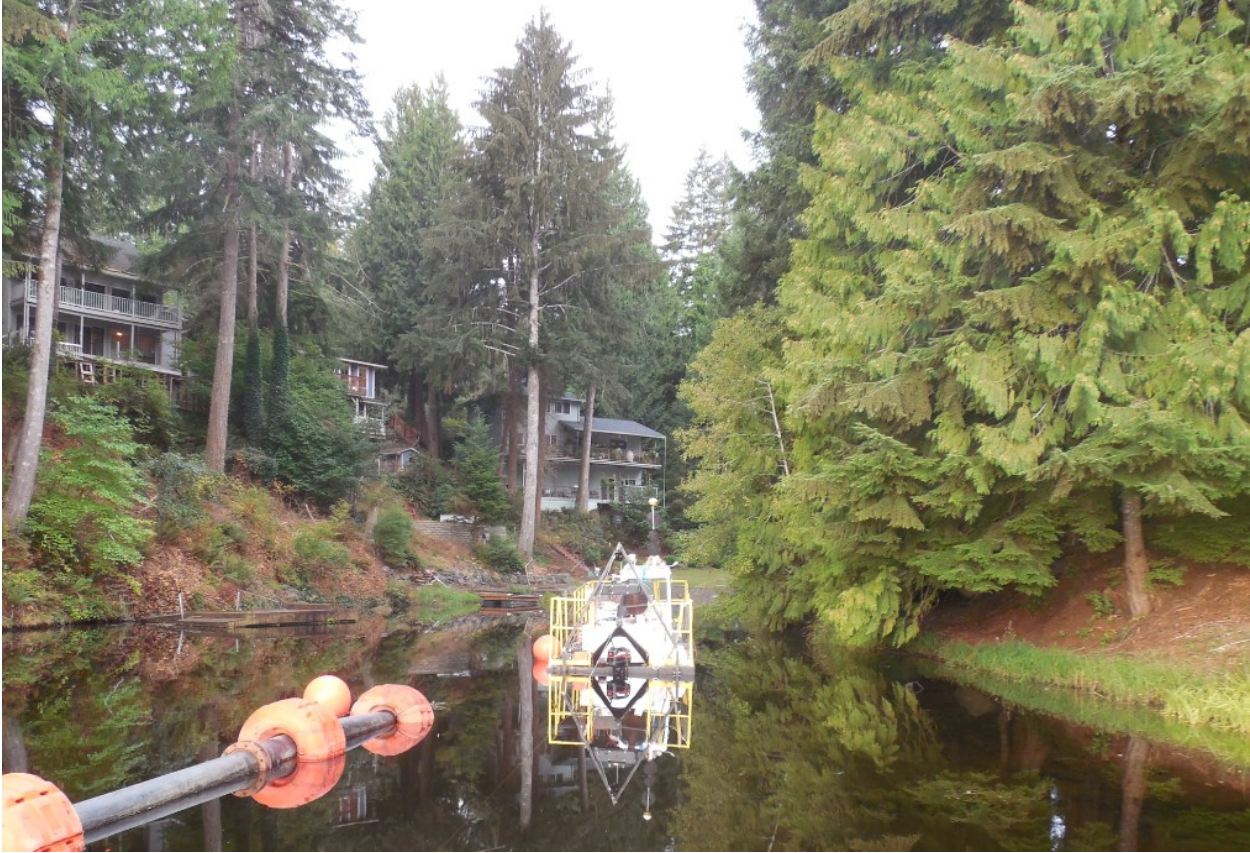
*MudCat Set Up in Cranberry Creek*

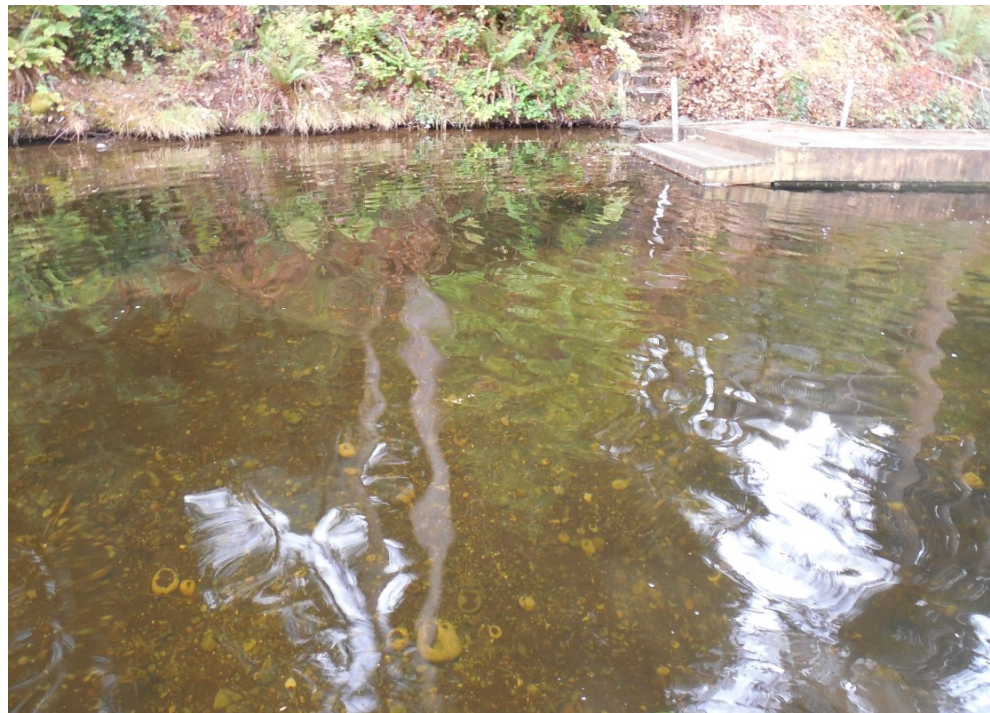
Safety Meeting in morning with crew. Added 130 feet pipe to dredge to access upper reach. Dredging in middle Cranberry Creek. Major jam/clog of small woody required removing top of pump and clearing manually. Good production with major sloughing. Passed area on bend with very thick muck. Attempted to removal small grassy outcrop but encountered rocks. Several other minor clogs from wood and rocks occurred. Torrential rainfall in afternoon. Dredged creek water depth to 3.5 feet. Dewatering into large bag 4 with manifold. WQ sampling. Large cobble and nice gravel habitat is visible in creek after dredging (see photo below).

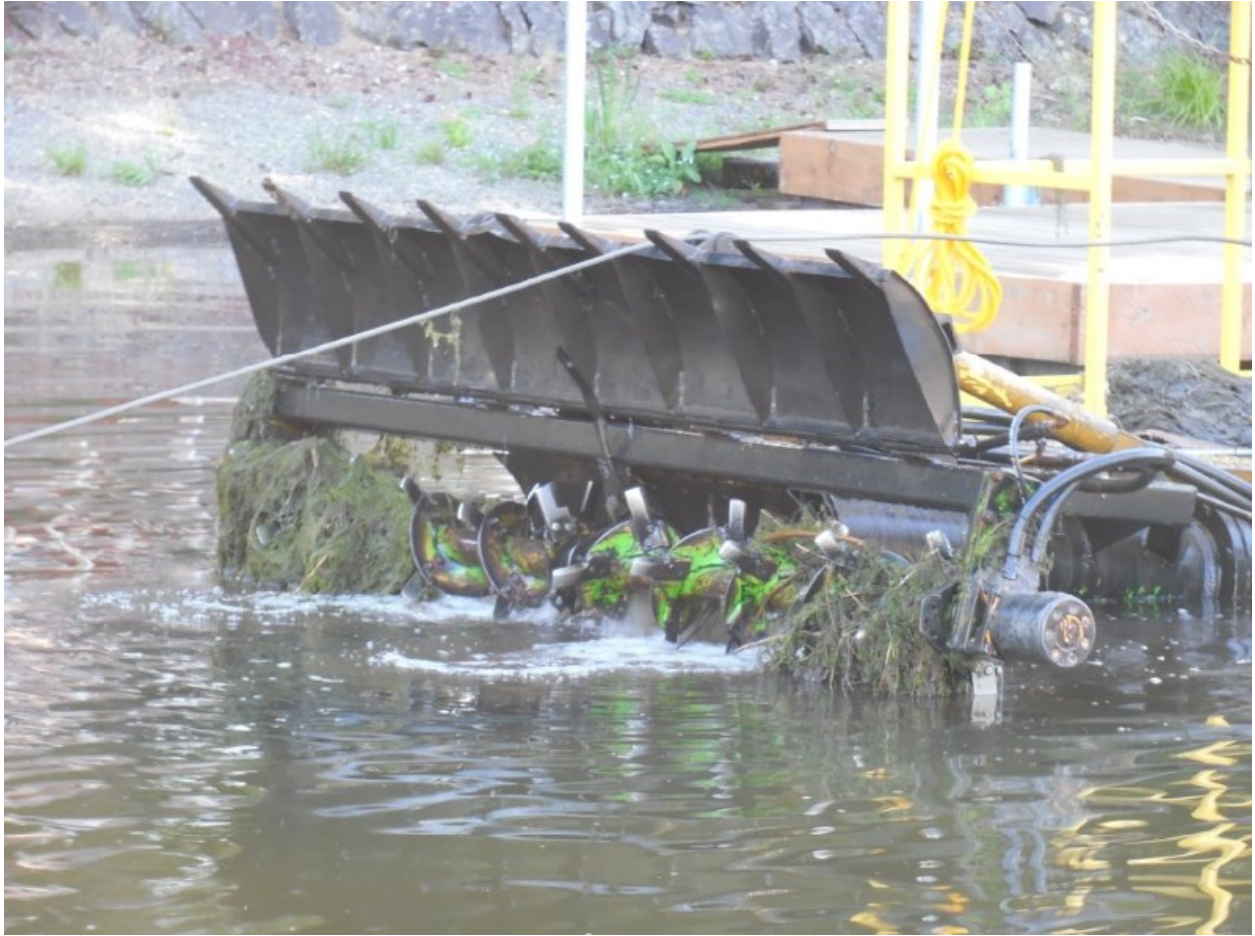
*MudCat Cutters with Vegetation*

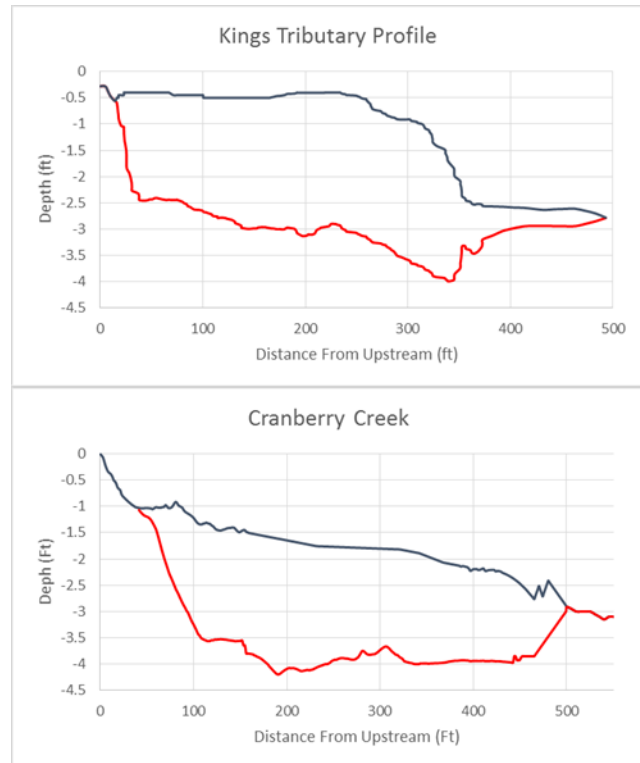
The area of the Cranberry prism is 1.0 acre and Kings Cove is 1.4 acres. Pre dredge and post dredge profiles are presented (to the side) from surveys (on page 13 for Cranberry Cove and page 14 for Kings Cove). The dredging records tracked and inventories of the dredging locations are presented in the following maps (page 8). Sloughing is expected to occur into the areas under the dredging. The dredging percentage of the total prism recorded directly under the dredge is 63 and 35 percent respectively for Cranberry and Kings Cove (as represented on maps on page 8). Note that less area was covered in Kings Cove due to more sloughing on slopes of side channels whereas the bathymetry in Cranberry was flatter requiring more passes to obtain volumes. The primary dredging areas were determined prior to equipment deployment to maximize quantity, future sediment transport, boat access and improve habitat. With the average dredging depth in Cranberry of 3.2 feet and Kings of 3.6 feet the volumes are 3,291 c.y. and 2,899 cy respectively. This is a total of 6,199 total CY and a conservative estimate of only 10% sloughing makes the volumes 6,809 c.y.

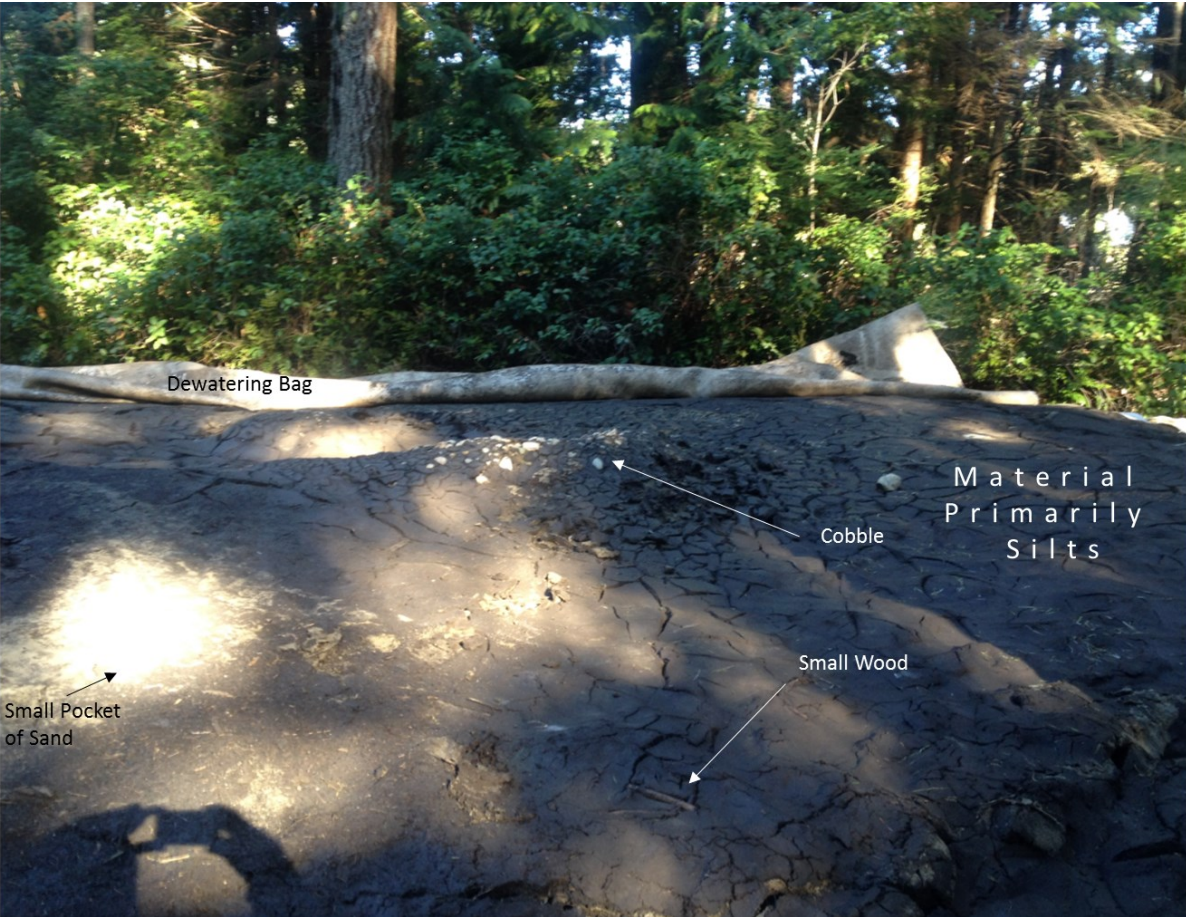
*Compacted Silts*

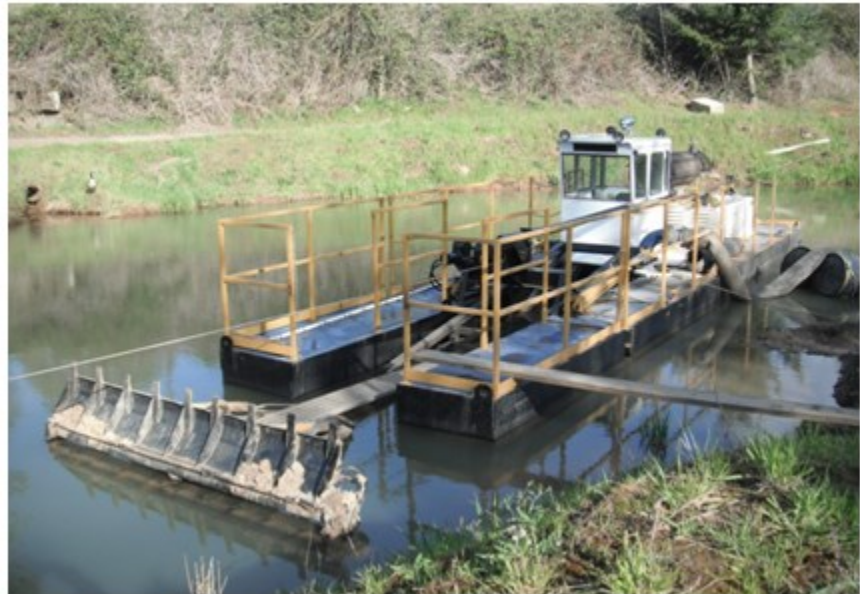
The MudCat features a diesel-powered (Detroit Diesel 6V71 engine) that powers a pumping unit and submersible hydro – solids pump. The unit has a shrouded 8' auger head with a triple sheaved winch. It is constructed from 10 gauge steel pontoon with floatation. The dredge uses a 10" discharge pipe.

The MC-15 MudCat has a front Auger which will breakup and fluidize the materials to be sucked up by a large capacity pump which is rated at 2,000 gallon per minute. This is used in conjunction with our 10" HDPE pipeline The MudCat can be directly transported to the site using a haul truck and launched with a crane.

The MudCat has a winch system on-board to pull itself back and forth in a systematic pattern to remove materials down to 15 feet deep. We also use a skiff to position the

suction dredge. The MudCat is 40 feet long x 8 feet wide and 21,000 lbs. It has production rate which can reach from 10 to 15% solids and remove up to 50 to 80 c.y. per hour solids. It is operated by one crew member and a Mate (on board or on skiff - for positioning assistance and pipe support). Roughly 4000 linear feet of pipe will be used for pumping the material to the in water disposal site. Anchors systems and temporary spuds can be deployed on the MudCat for positioning.

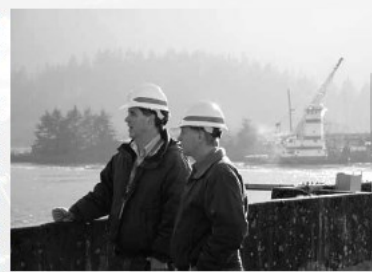
Top: Mechanical engineer Kevin Perletti, left, discusses dredging operations at Bonneville Dam with Rick Mettler, Bonneville Dam's chief of Engineering and Contracts.

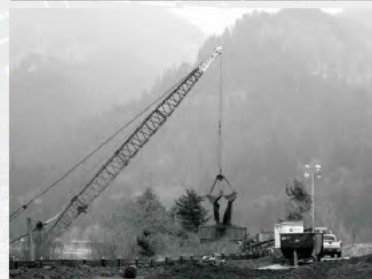
Above: Contractors move sediment from a barge in Bonneville Dam's forebay onto nearby Cascades Island. More than 6,000 cubic yards will be placed and after it dries employees will seed it with native grasses.

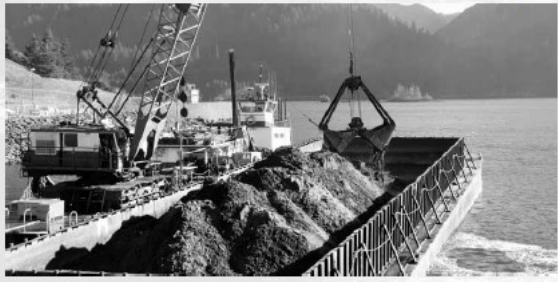
Opposite: Corps contractors dredge sediment near Bonneville Dam. If not removed by dredging, sediment can enter a flow channel where it can settle inside the dam structure, where its removal is much more difficult.
