# 2016 Lake Limerick Dredging: Final Report

Lake Limerick Country Club  
790 East St. Andrews Drive,  
Shelton, WA 98584

Marine Industrial Construction, LLC

October 8<sup>th</sup>, 2016

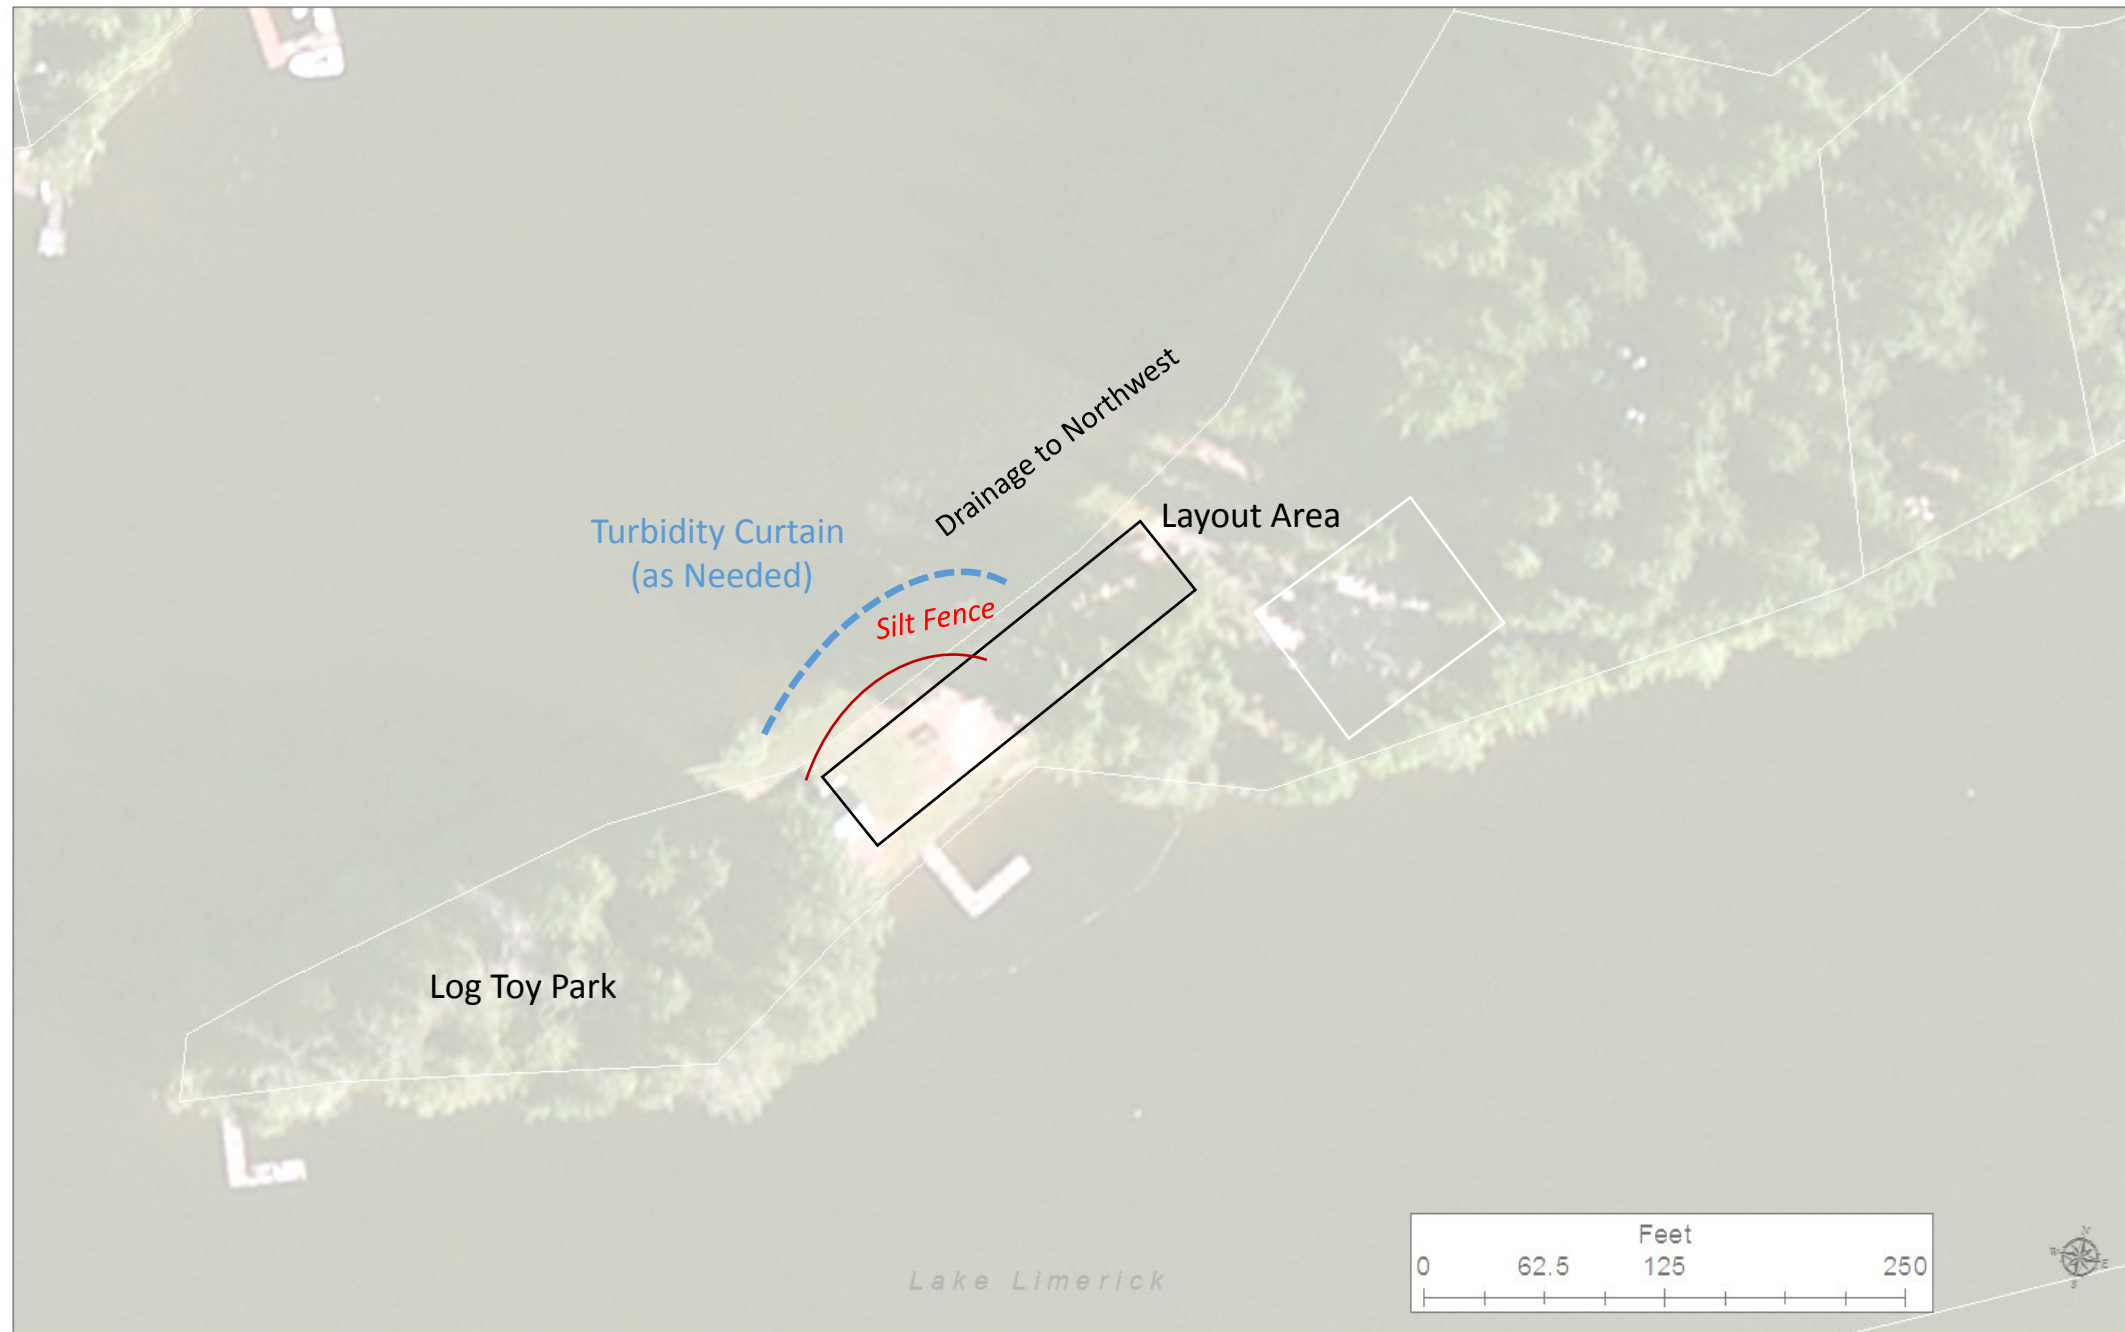
# Disposal Site & Geotextile Configuration

Geotextile / Bio Bags will be used for the dewater and placed in the open area (with sloping drainage to Lake Limerick). The will facilitate effective drainage and allow the bio-bags to be moved and dried material to be stockpiled.
