**Technical Status and Monitoring Results Memorandum
For
Lake Limerick 2017**

OCTOBER 2018

Lake Committee
Lake Limerick Country Club

LAKE ADVOCATES

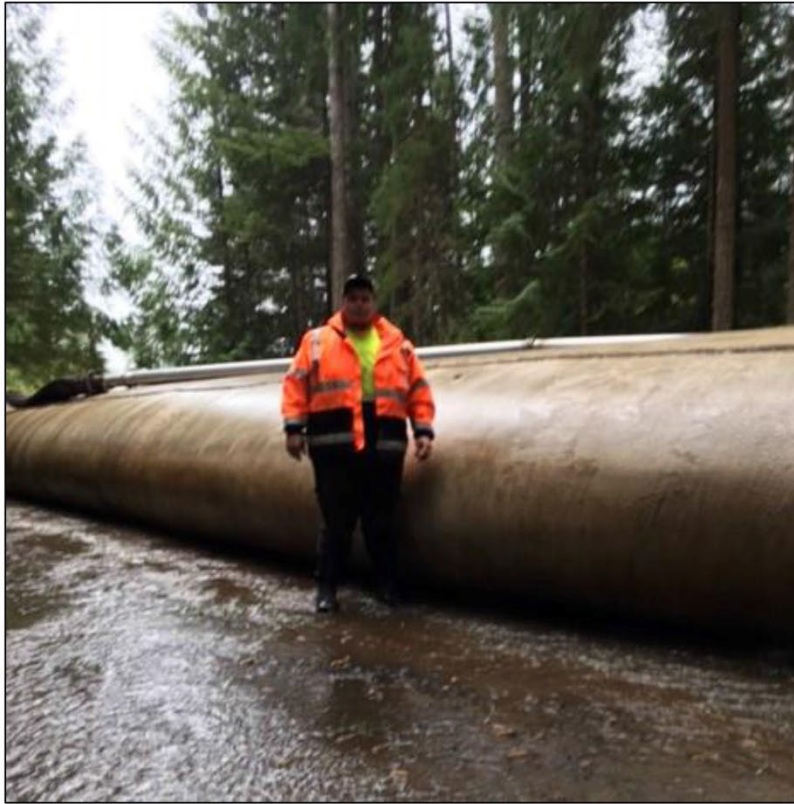
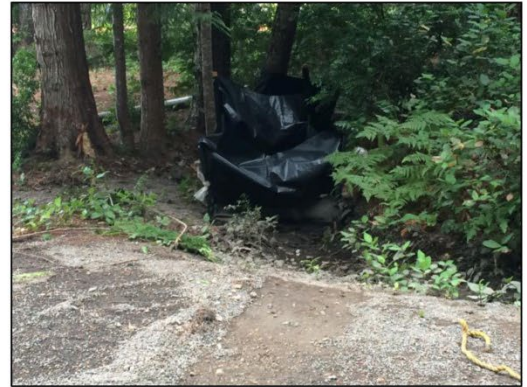
Figure 7-7 - De-watering of dredge material

Dredge Material:
20% Sediment
80% Water

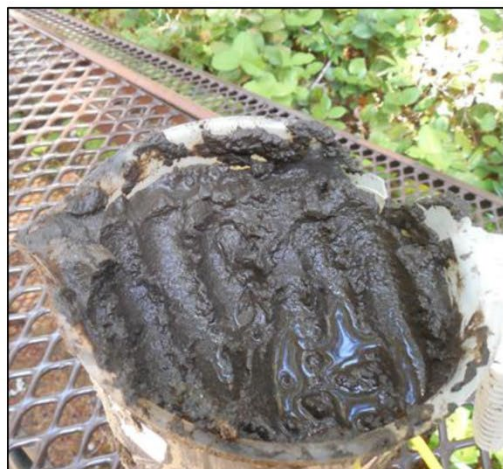
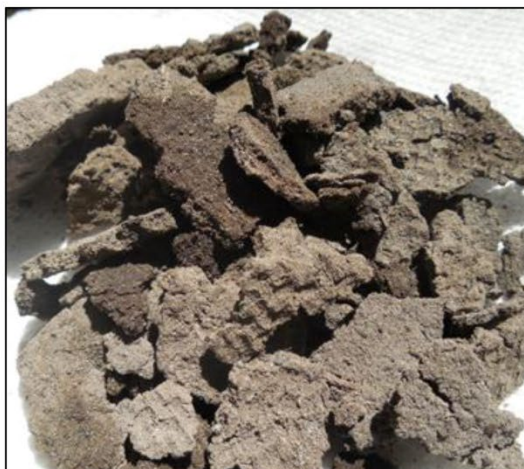
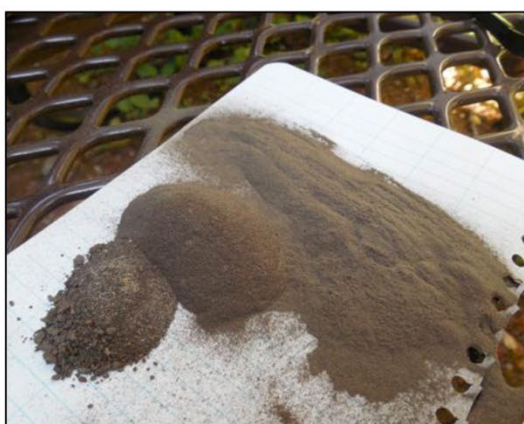
Figure 7-9 – Examples of sediment during stages of the de-watering process

Fresh Sediment

De-Watered Sediment

Dried Sediment

The dredging was conducted using a barge-mounted hydraulic MudCat dredge (Figure 7-3). The MudCat loosened fine sediments with a cutter head and then suctioned the loose material into a pump intake (Figure 7-5), effectively removing the material from the lake bottom while also limiting turbidity impacts (MIC 2016). Dredging began at the upstream end of each job site boundary and proceeded downstream. Turbidity impacts were further limited by the installation of a turbidity curtain along the boundary of the dredging area (Figure 7-4). The pump intake on the MudCat connected to a floating pipeline (Figure 7-4), which transported the dredged material to the de-watering site at Log Toy Park. As the dredge material arrived at the de-watering site, a flocculent was injected into it in order to accelerate the de-watering process (Figure 7-5, MIC 2016). The flocculent used for the Lake Limerick project was Aquamark®, a readily biodegradable organic polymer. After the flocculent was injected, the dredge material was pumped into geosynthetic de-watering bags (Figure 7-6). When it was initially collected, the dredge material was approximately 80% water and 20% sediment (MIC 2016). The de-watering bags allowed water to seep from the dredge materials over a period of days so that the sediment gradually dried out and became compressed (Figure 7-7). After passing through a ground filter cloth and silt fences positioned to block direct re-entry of water into the lake, the clean water runoff from the geo-bags seeped into the ground and was allowed to run into the lake (MIC 2016). Once the de-watering process was complete (after 2-3 days), the de-watering bags were split open to reveal the compacted de-watered material (composed primarily of silt) (Figure 7-8), which was loaded into trucks and transported to a gravel mine for use as fill. The de-watered sediment was significantly lighter and more compact than the original wet material (Figure 7-9).
