Technical Status and Monitoring Results Report for Lake Limerick and Lake Leprechaun 2017 through 2021

MAY 2022

Lake Committee
Lake Limerick Country Club

LAKE ADVOCATES

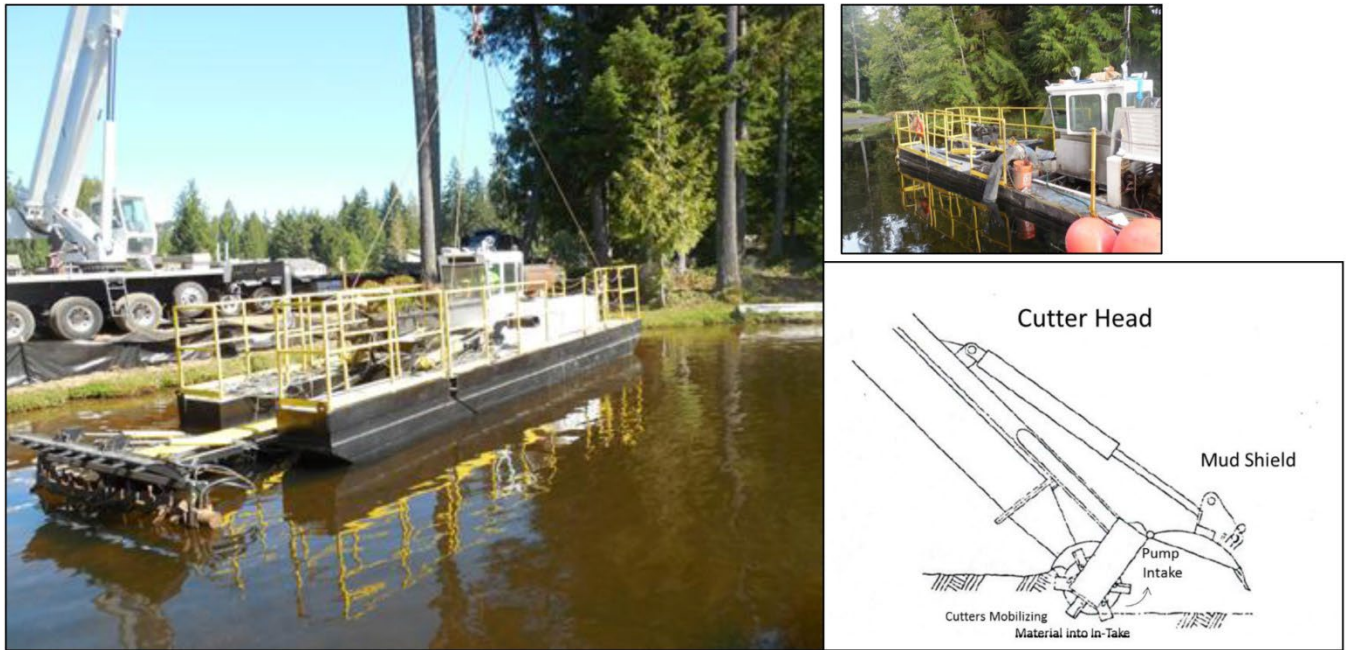
Figure 7-3 – Equipment used to conduct dredging in Lake Limerick

MudCat Dredge

The dredging was conducted using a barge-mounted hydraulic MudCat® dredge (Figure 7-3). The MudCat® loosened fine sediments with a cutter head and then suctioned the loose material into a pump intake, effectively removing the material from the lake bottom while also limiting turbidity impacts (MIC 2016). Dredging began at the upstream end of each job site boundary and proceeded downstream. Turbidity impacts were further limited by the installation of a turbidity curtain along the boundary of the

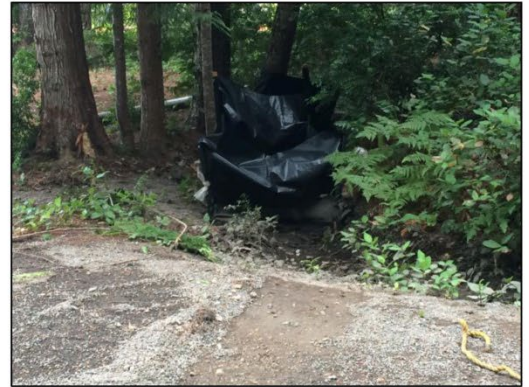
Figure 7-7 - De-watering of dredge material

Dredge Material:
20% Sediment
80% Water
