Technical Monitoring Report and Management Actions: Lake Limerick and Lake Leprechaun

Robert Plotnikoff and Harry Gibbons
LAKE ADVOCATES

Technical Monitoring Report and Management Actions: Lake Limerick and Lake Leprechaun (2017 through 2021)

Lake Committee
Lake Limerick Country Club

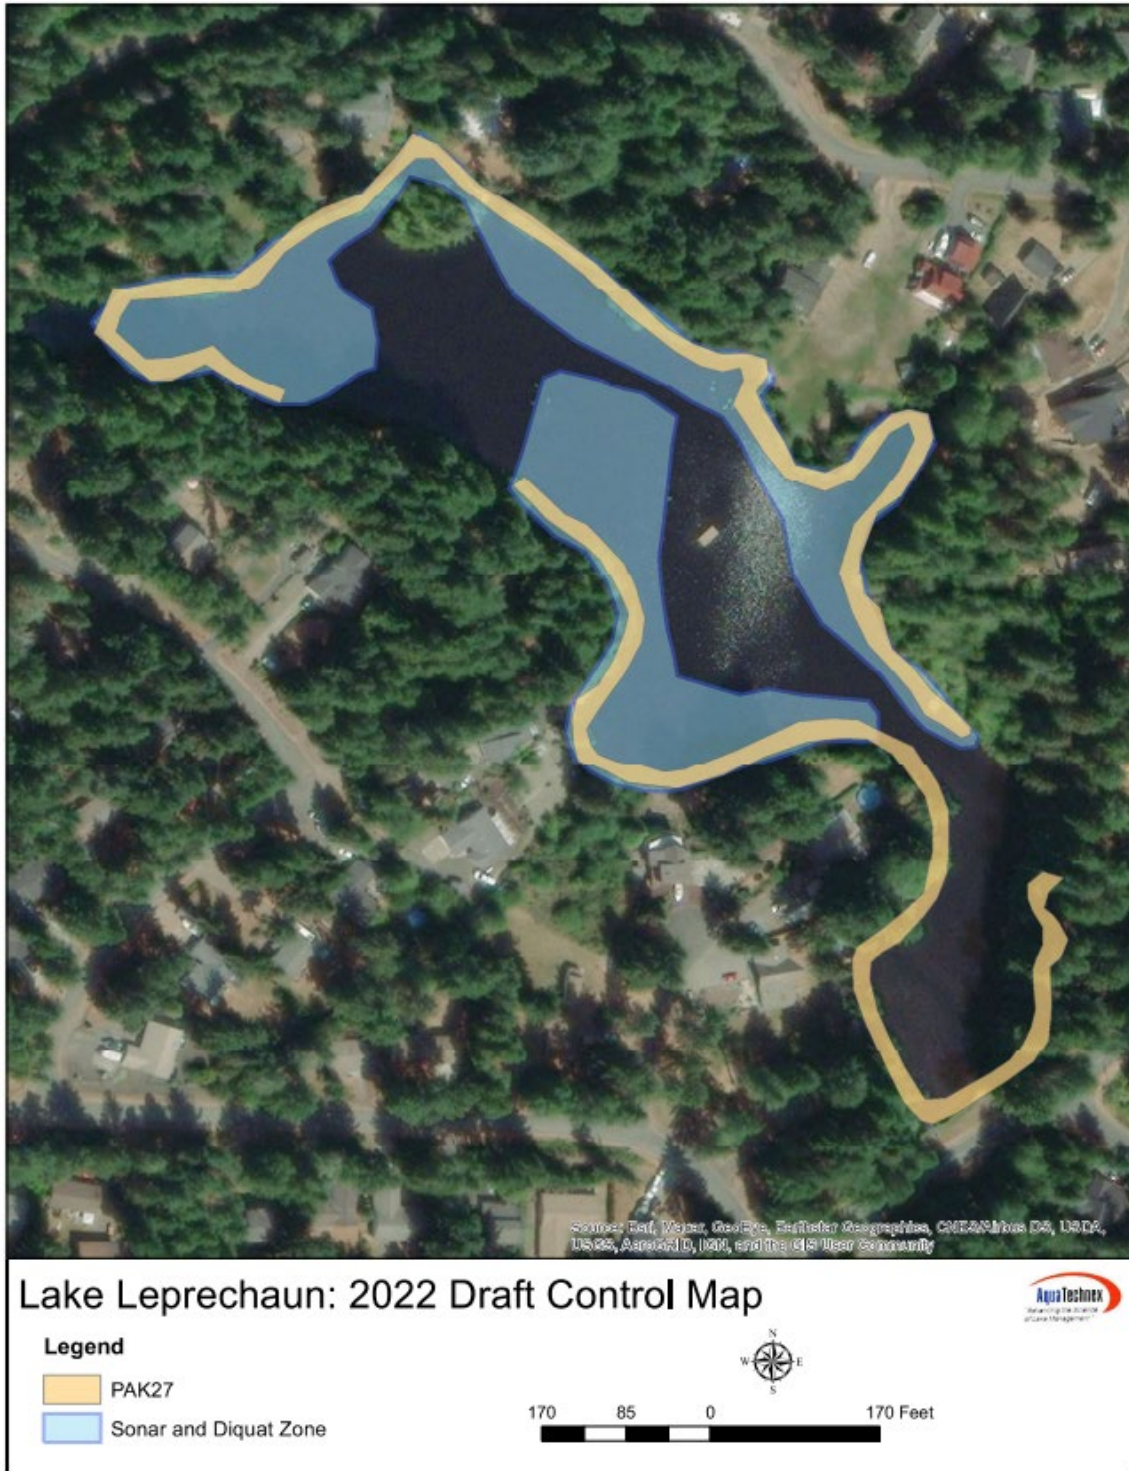
Figure 2.2-10. Revised 2022 aquatic plant treatment areas in Lake Leprechaun. (Courtesy of AquaTechnex)

Vulnerable areas for plant growth in Lake Leprechaun are highlighted by the treatment areas in Figure 2.2-10. Both *Egeria densa* in the south end of Lake Leprechaun and mare's tail in the north and central portion of the lake were of greatest concern in 2020. Continued treatment of these areas in 2022 will encourage sustained progress in controlling distribution of these aquatic plants.

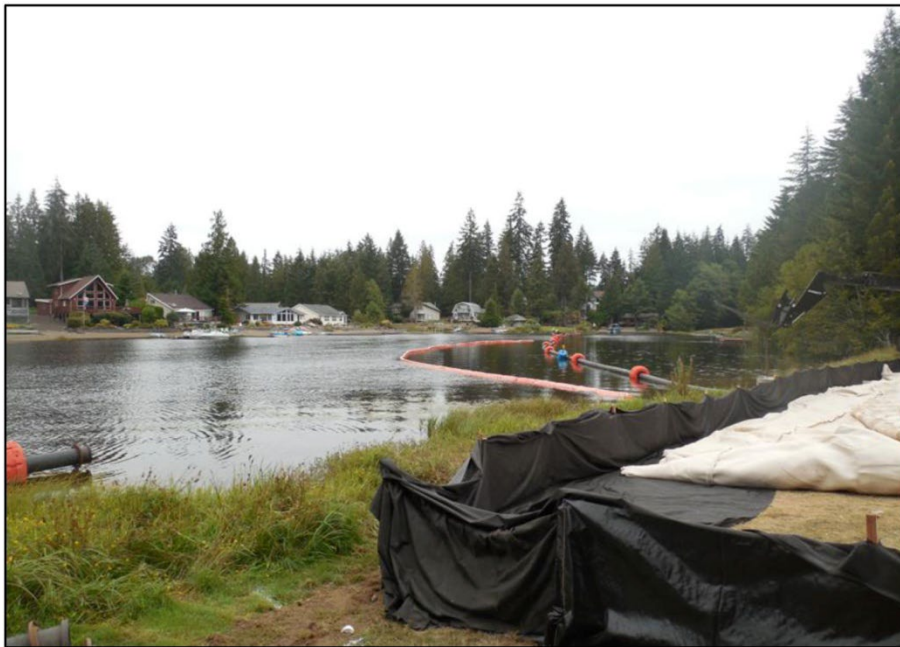
Figure A2-4. Dredging pipeline

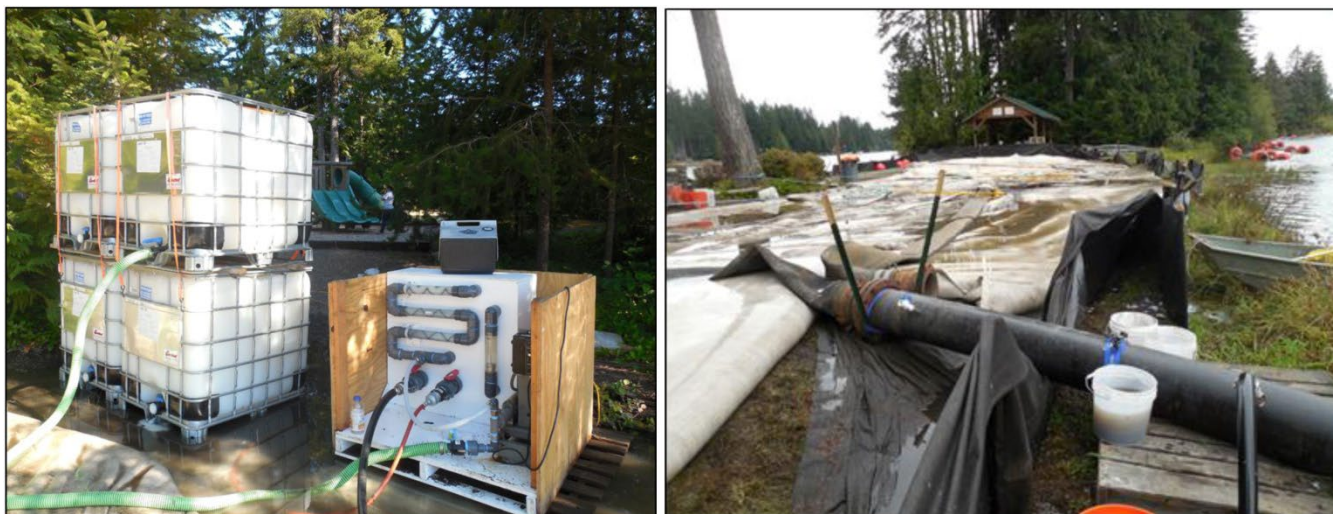
Figure A2-5. Injection of flocculent into dredge material

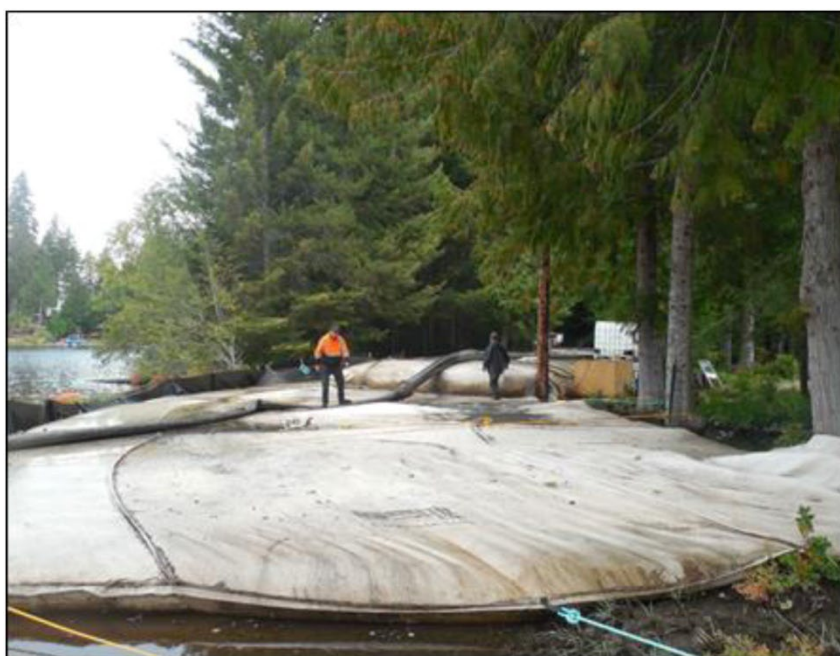
Figure A2-6. De-watering bags

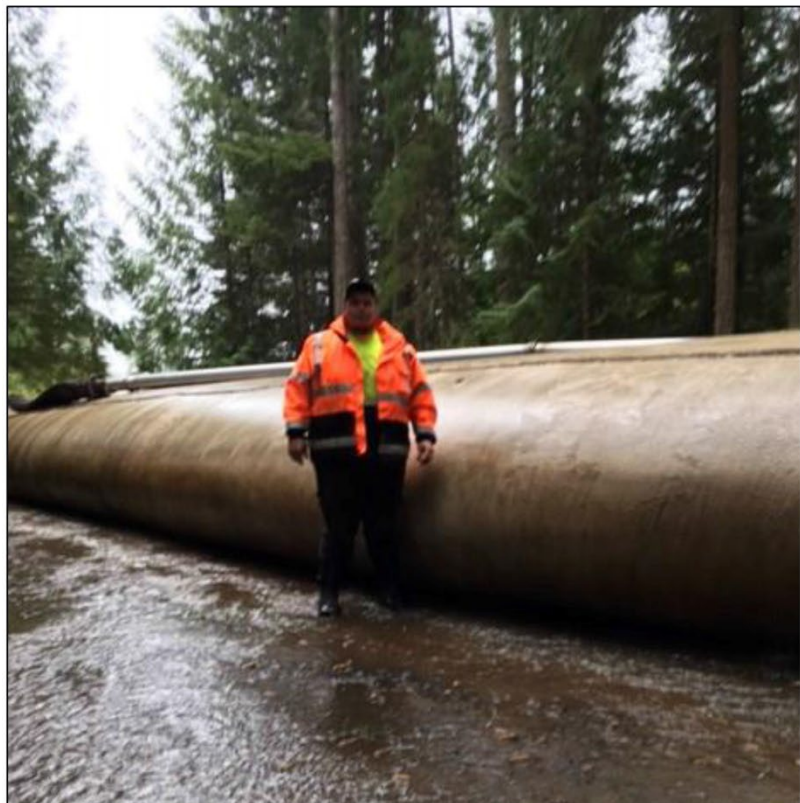
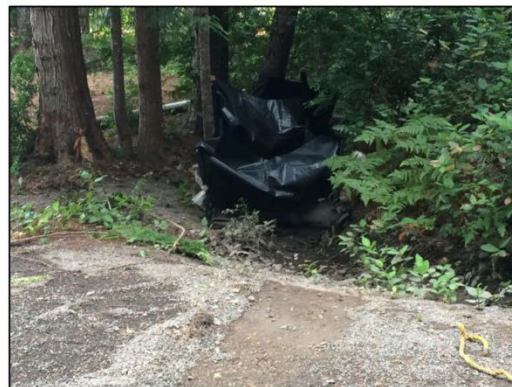
Dredge Material:
20% Sediment
80% Water

Figure A2-7. De-watering of dredge material

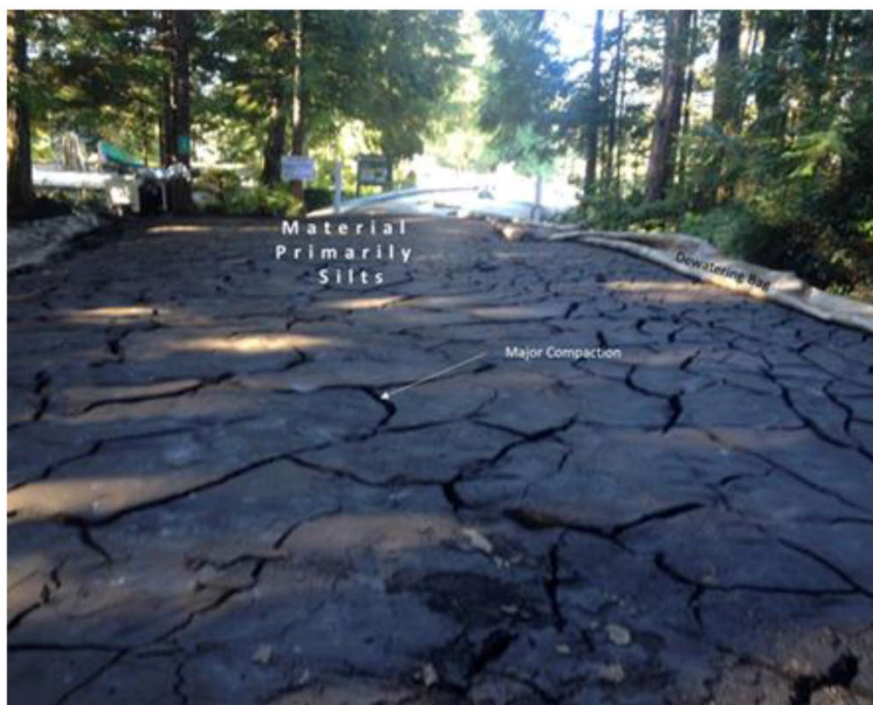
Figure A2-8. De-watered material

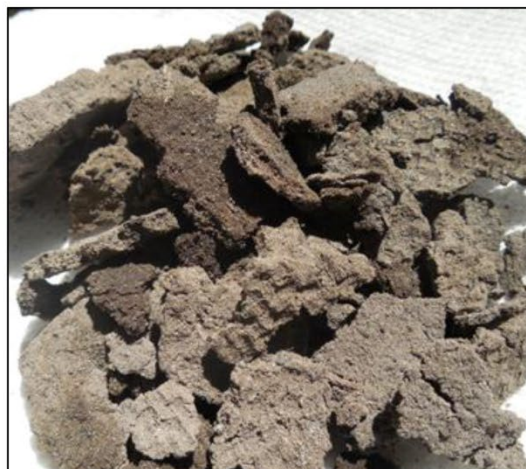
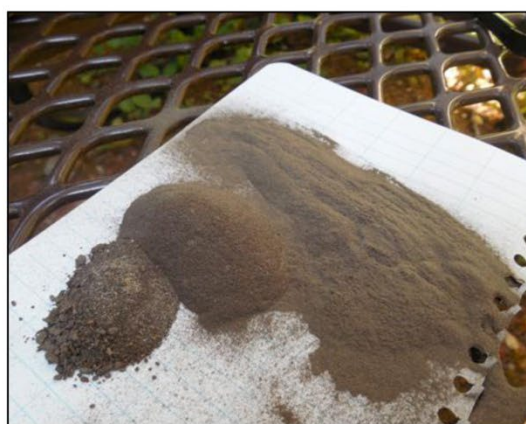
Fresh Sediment

De-Watered Sediment

Dried Sediment

Figure A2-9. Examples of sediment during stages of the de-watering process

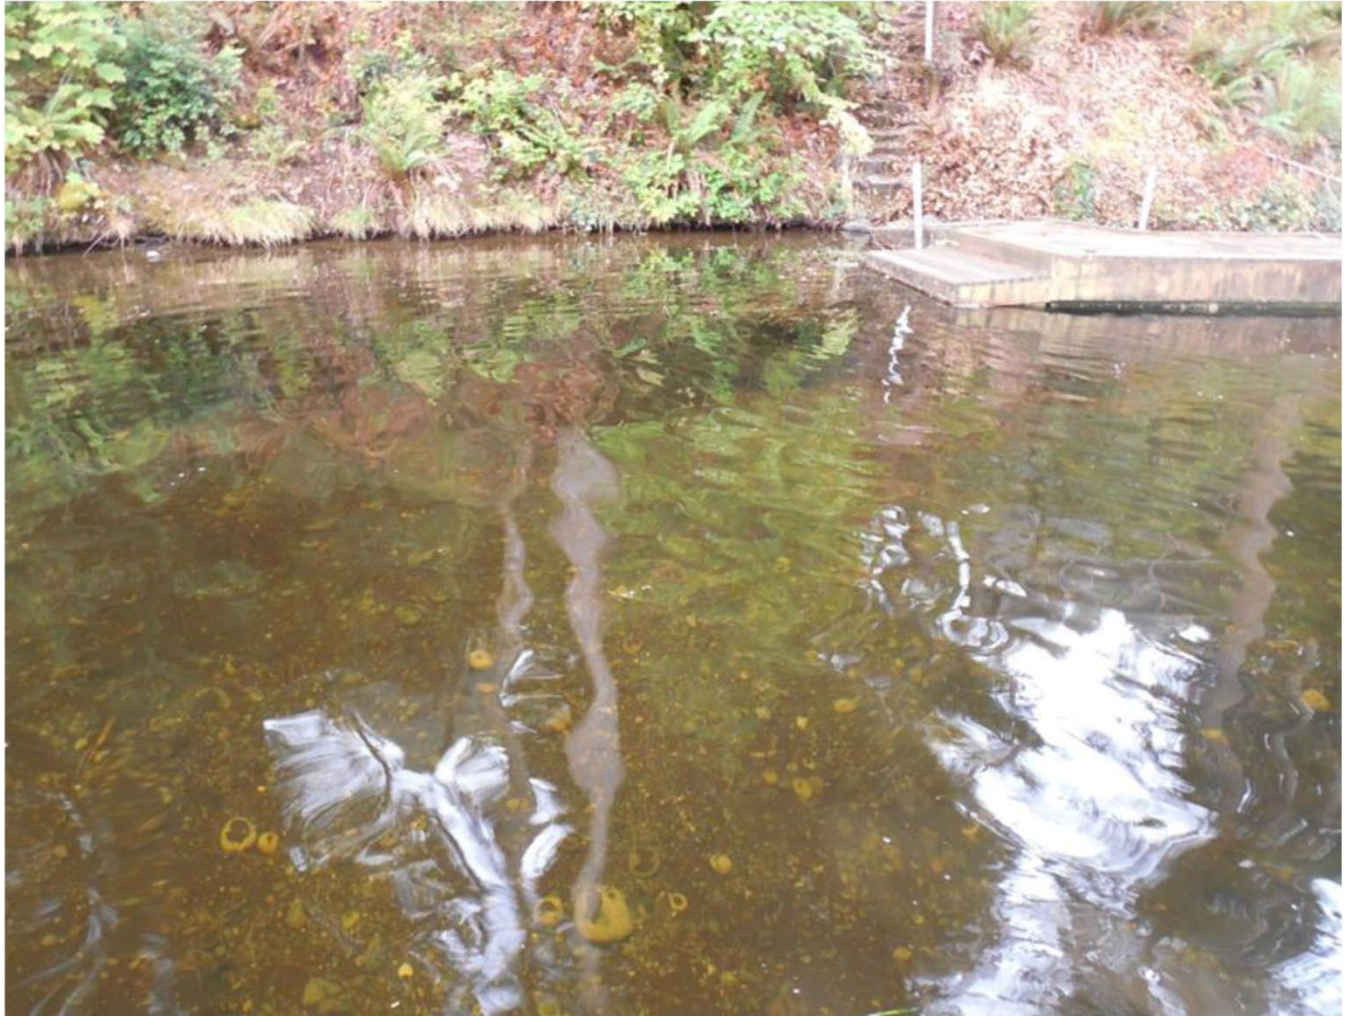
Figure A2-11. Exposure of hard sediments resulting from dredging

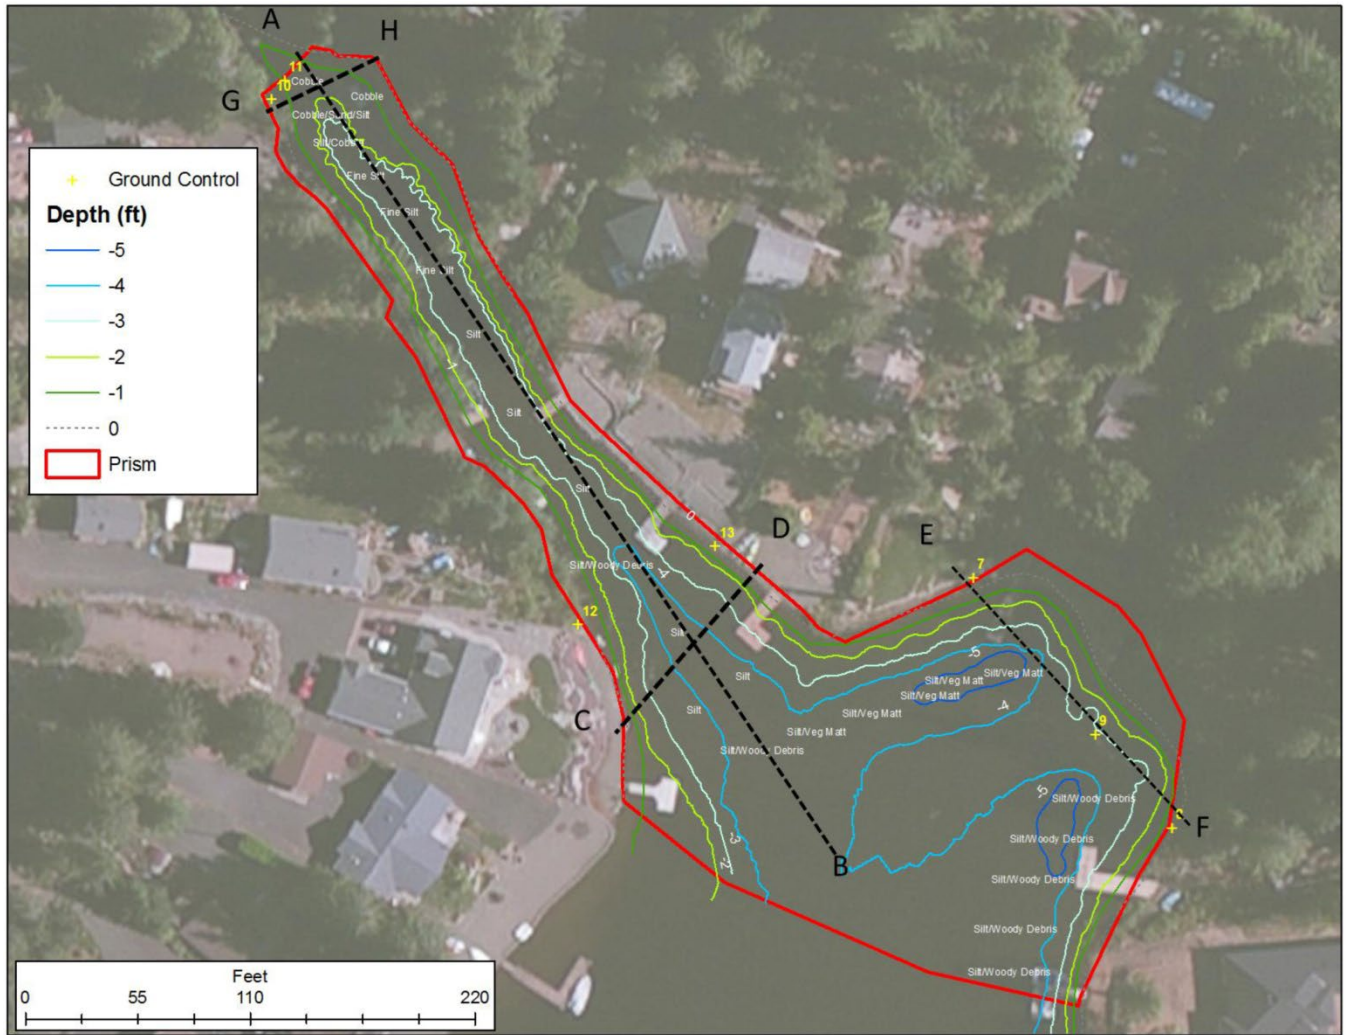
Figure A2-12. Dredging transects in King's Cove

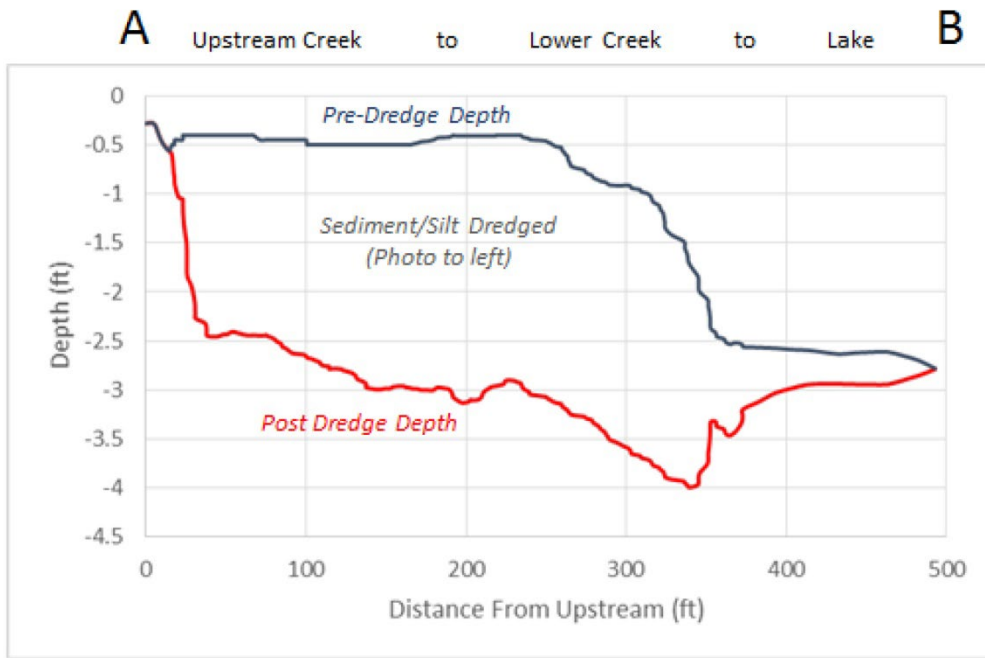
Thalweg Transect: King's Cove

Figure A2-13. Thalweg gradient for inflows into King's Cove, before and after dredging
