**Technical Status and Monitoring Results Memorandum
For
Lake Limerick 2019**

DECEMBER 2019

Lake Committee
Lake Limerick Country Club

LAKE ADVOCATES

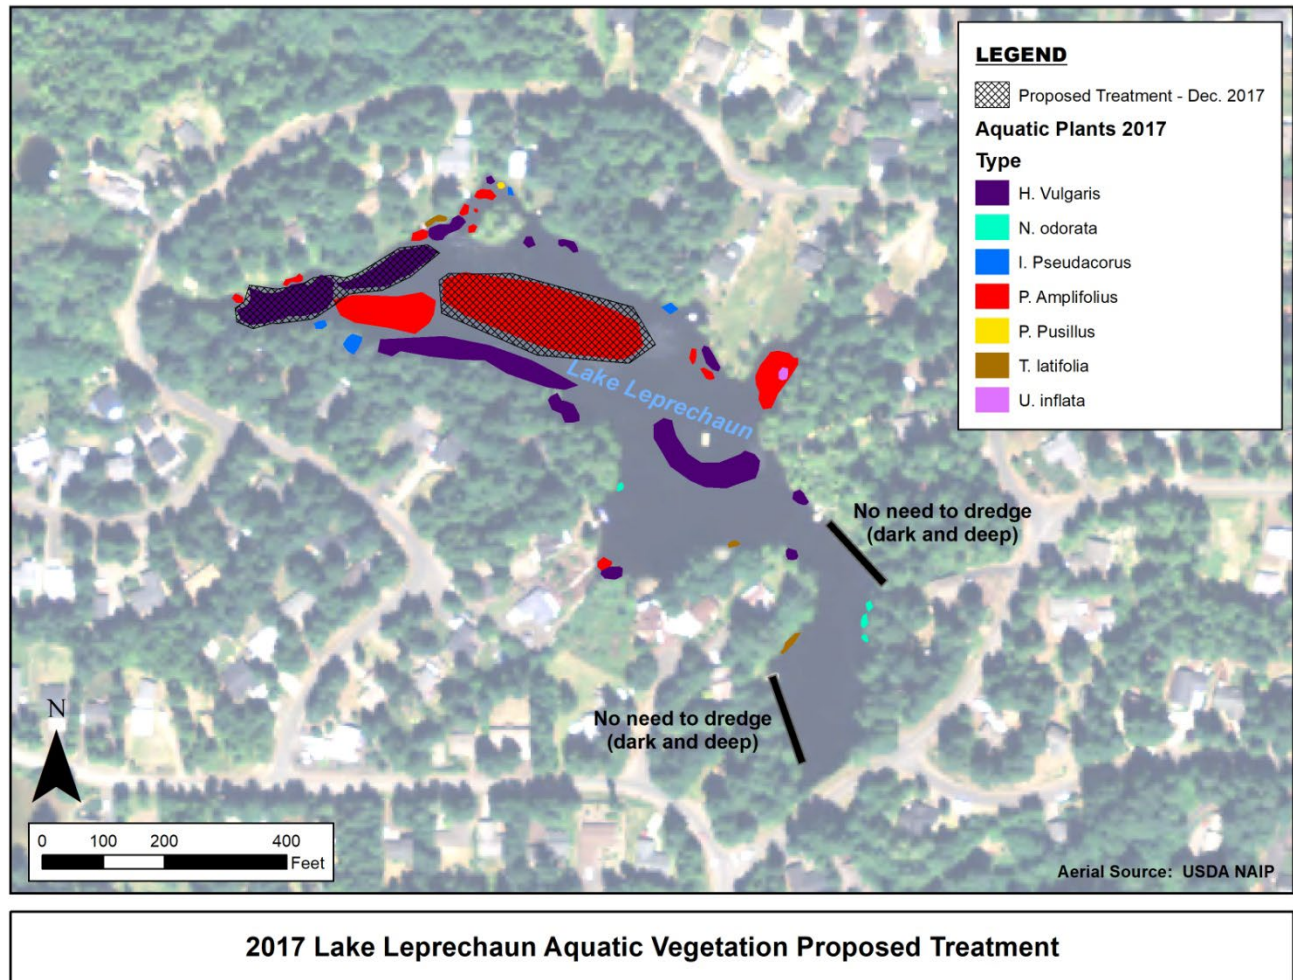
Figure 2.2-1. Aquatic plant 2017 map for Lake Leprechaun showing treatment areas for 2018.

In-lake treatment of non-native and excessively dense aquatic plant growth was targeted for 2018 and 2019 as identified by the 2017 survey (Figure 2.2-1 and Figure 2.2-2). However, other monitoring requirements outlined in the Environmental Permit issued by Mason County for the lake dredging project were completed. Benthic macroinvertebrates were collected in September 2017 in order to monitor progress of potential effects of shifting sediment in the dredged area. This material was expected to be shifted from shallow areas during the high flow input in each of the coves to the deeper areas away from the shoreline.

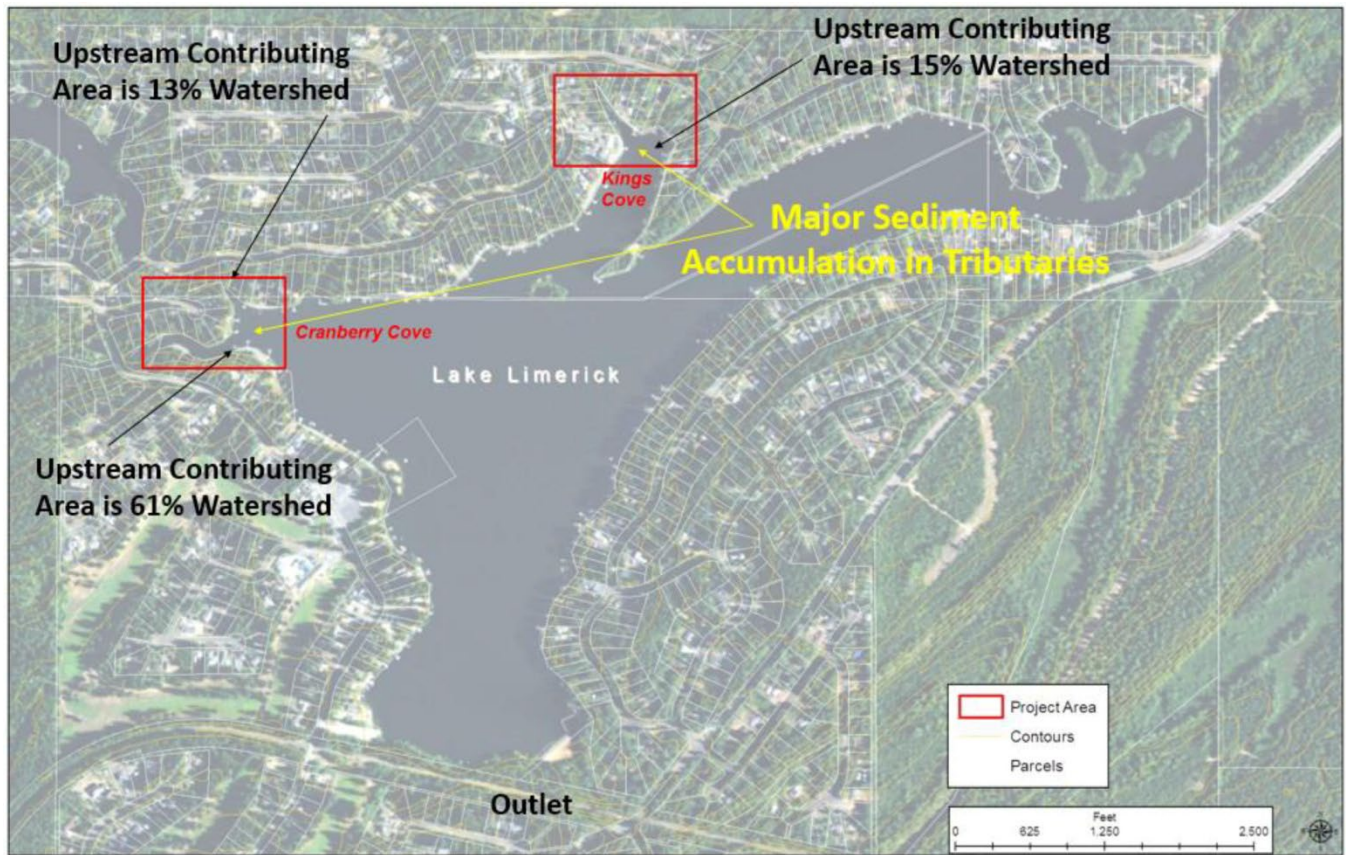
Figure 7-1 – Locations for dredging in Lake Limerick

During summer 2016, two shallow coves in Lake Limerick – King’s Cove and Cranberry Cove– were dredged to remove sediment that had accumulated on the lake bottom (Figure 7-1). Over time, the accumulation of fines (silts and decomposed organic material) at the mouths of the creeks that drain into these coves had covered up potential habitable substrate for aquatic life. In addition, the sediment had filled in the lake bottom, reducing the overall depth of water in these coves by 1 to 5 feet– limiting the ability of boats to access these coves and shrinking the area in which it was possible to swim. The primary objectives of the dredging operation were to: a) improve in-lake fisheries habitat and fish access to streams, and b) provide better access to the coves for recreation. Specific goals were to a) remove a total of 5,000 cubic yards of soft sediment from Kings Cove and Cranberry Cove, b) expose hard sediment to improve habitable areas for benthic communities and fish spawning, and c) improve the thalweg gradient in both coves, allowing remaining soft sediments to be moved during future high flow events and preventing the coves from being clogged for an extended time.

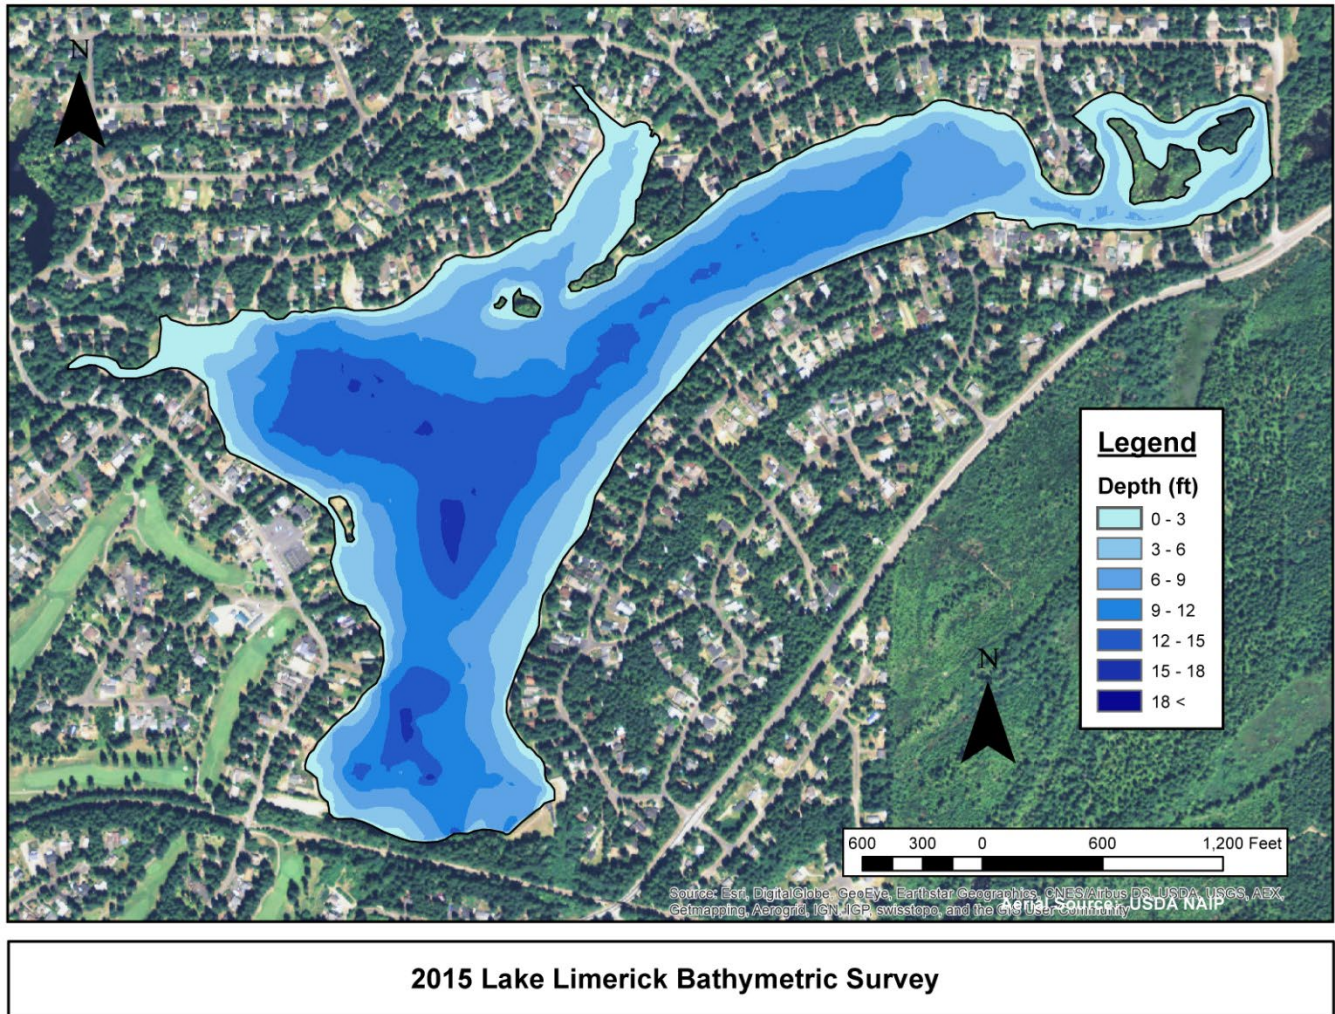
Figure 7-2 – Bathymetry of Lake Limerick. Bathymetric data collected in September 11th, 2015 survey.

On September 11th, 2015, Tetra Tech staff mapped the bathymetry of Lake Limerick using a Lowrance HDS-7 fishfinder/chartplotter with StructureScan HD sonar imaging system and an LSS-2 HD Transom Transducer. This survey confirmed that the northwest corner, by the outlet of Cranberry Creek, was very shallow, as was the small extension of the lake along the north shore (King Cove) (Figure 7-2). In 2016, both the dredging contractor (Marine Industrial Construction) and Tetra Tech independently conducted additional, higher resolution bathymetric surveys of Cranberry Cove and King’s Cove before and after dredging. The pre-dredge surveys were used to plan dredging activities and to establish dredging transects and document volume and area of sediment removal.

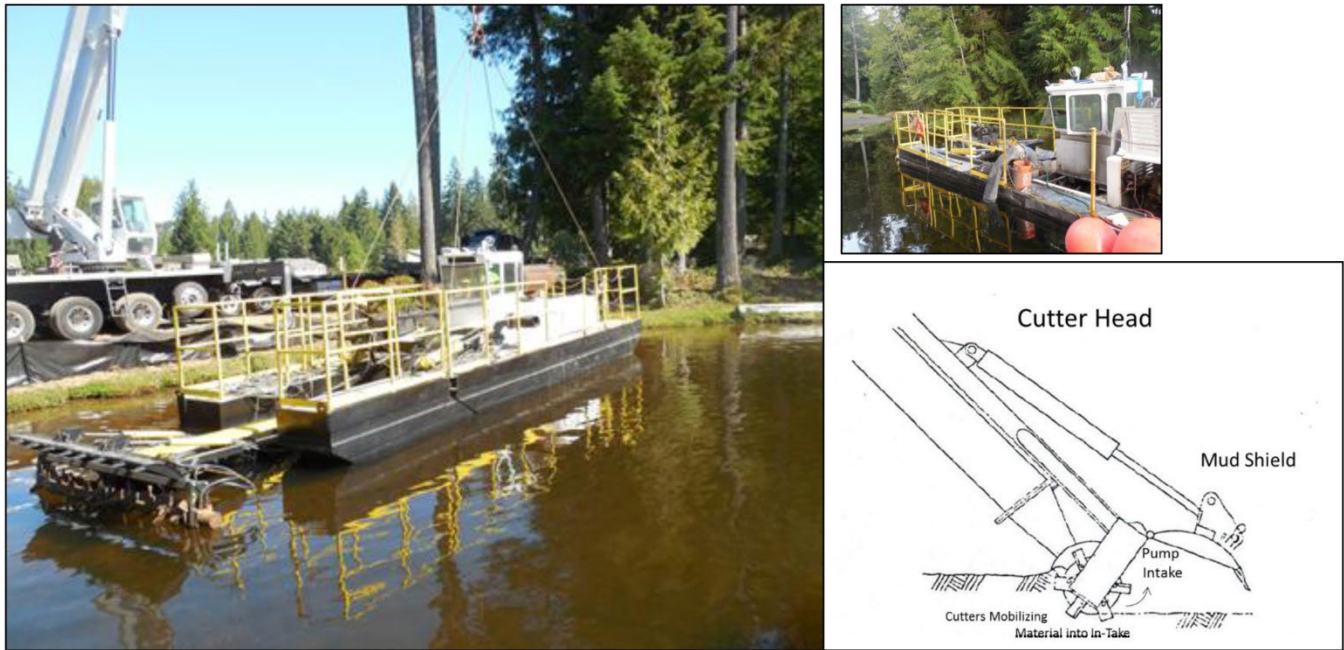
Figure 7-3 – Equipment used to conduct dredging in Lake Limerick

The dredging was conducted using a barge-mounted hydraulic MudCat dredge (Figure 7-3). The MudCat loosened fine sediments with a cutter head and then suctioned the loose material into a pump intake (Figure 7-5), effectively removing the material from the lake bottom while also limiting turbidity impacts (MIC 2016). Dredging began at the upstream end of each job site boundary and proceeded downstream. Turbidity impacts were further limited by the installation of a turbidity curtain along the boundary of the dredging area (Figure 7-4). The pump intake on the MudCat connected to a floating pipeline (Figure 7-4), which transported the dredged material to the de-watering site at Log Toy Park. As the dredge material arrived at the de-watering site, a flocculent was injected into it in order to accelerate the de-watering process (Figure 7-5, MIC 2016). The flocculent used for the Lake Limerick project was Aquamark®, a readily biodegradable organic polymer. After the flocculent was injected, the dredge material was pumped into geosynthetic de-watering bags (Figure 7-6). When it was initially collected, the dredge material was approximately 80% water and 20% sediment (MIC 2016). The de-watering bags allowed water to seep from the dredge materials over a period of days so that the sediment gradually dried out and became compressed (Figure 7-7). After passing through a ground filter cloth and silt fences positioned to block direct re-entry of water into the lake, the clean water runoff from the geo-bags seeped into the ground and was allowed to run into the lake (MIC 2016). Once the de-watering process was complete (after 2-3 days), the de-watering bags were split open to reveal the compacted de-watered material (composed primarily of silt) (Figure 7-8), which was loaded into trucks and transported to a gravel mine for use as fill. The de-watered sediment was significantly lighter and more compact than the original wet material (Figure 7-9).

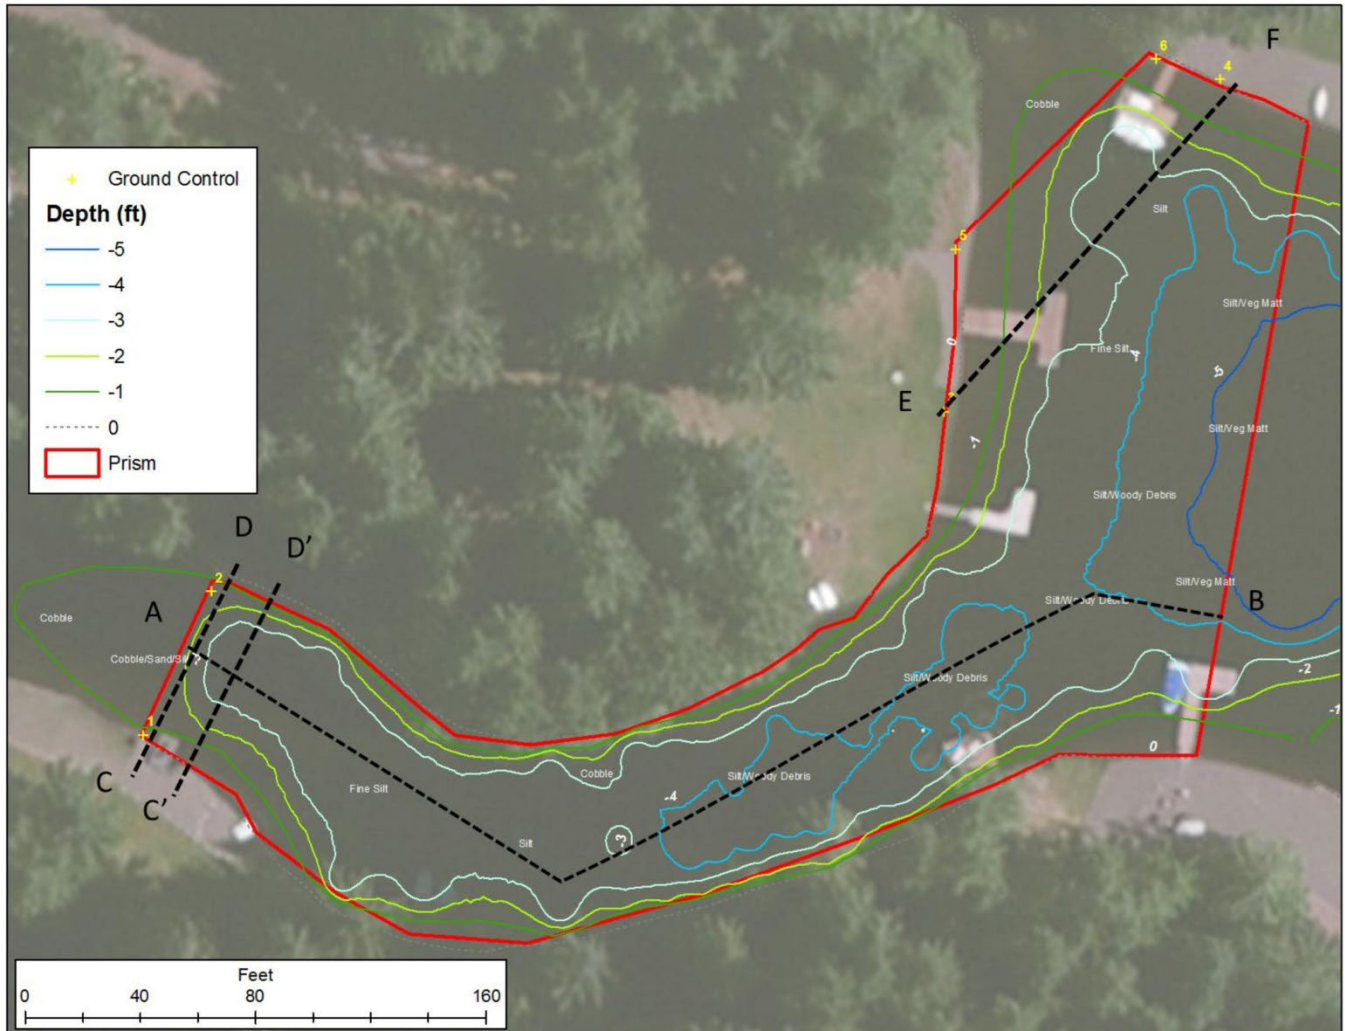
Figure 7-15 – Dredging transects in Cranberry Cove

Detailed topographic/bathymetric transect profiles were completed within one week upon completion of dredging in each of the coves. In King's cove, the dredging improved the gradient of the thalweg, increasing the water depth by 2 to 2.5 feet along most of the thalweg (Figures 7-13 and 7-14). Dredging increased the depth of the water throughout the northeastern portion of the cove, especially near the mouth of the inlet (Figure 7-15).
